Shoreline Change at Roches
Beach, South-Eastern Tasmania
1957-2010

Prepared by: Chris Sharples, School of Geography and Environmental
Studies, University of Tasmania August 2010

Shoreline Change at Roches Beach, South-Eastern Tasmania, 1957 - 2010

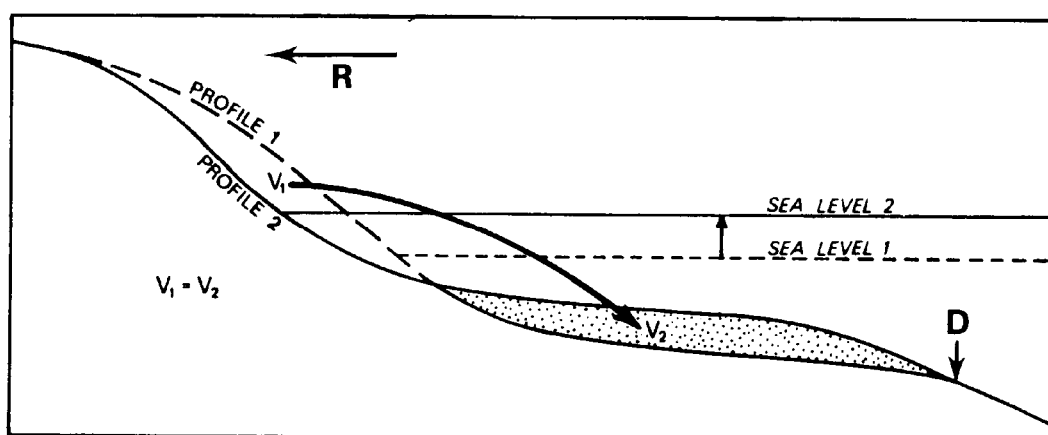
Figure 2: The Bruun Rule in its simplest form. From Bird (1993, p.57, Figure 29), whose original caption to this figure reads: "The Bruun Rule states that a sea-level rise will lead to erosion of the beach and removal of a volume of sand (v_1) seaward to be deposited (v_2) in such a way as to restore the initial transverse profile landward of D, the outer boundary of near-shore sand deposits. The coastline will retreat (R) until stability is restored after the sea-level rise comes to an end. The coastline thus recedes further than it would if submergence were not accompanied by erosion." It is significant that the transverse (equilibrium) profile at Roches Beach is flatter (shallower) than the profile that would be expected from the Bruun Rule (Carley *et al.* 2008, p. 61 & Fig. 13.5), which indicates that other processes are significantly modifying the effects of the Bruun Rule in that coastal process system (see also discussions in Section 3.3 & 5.2).

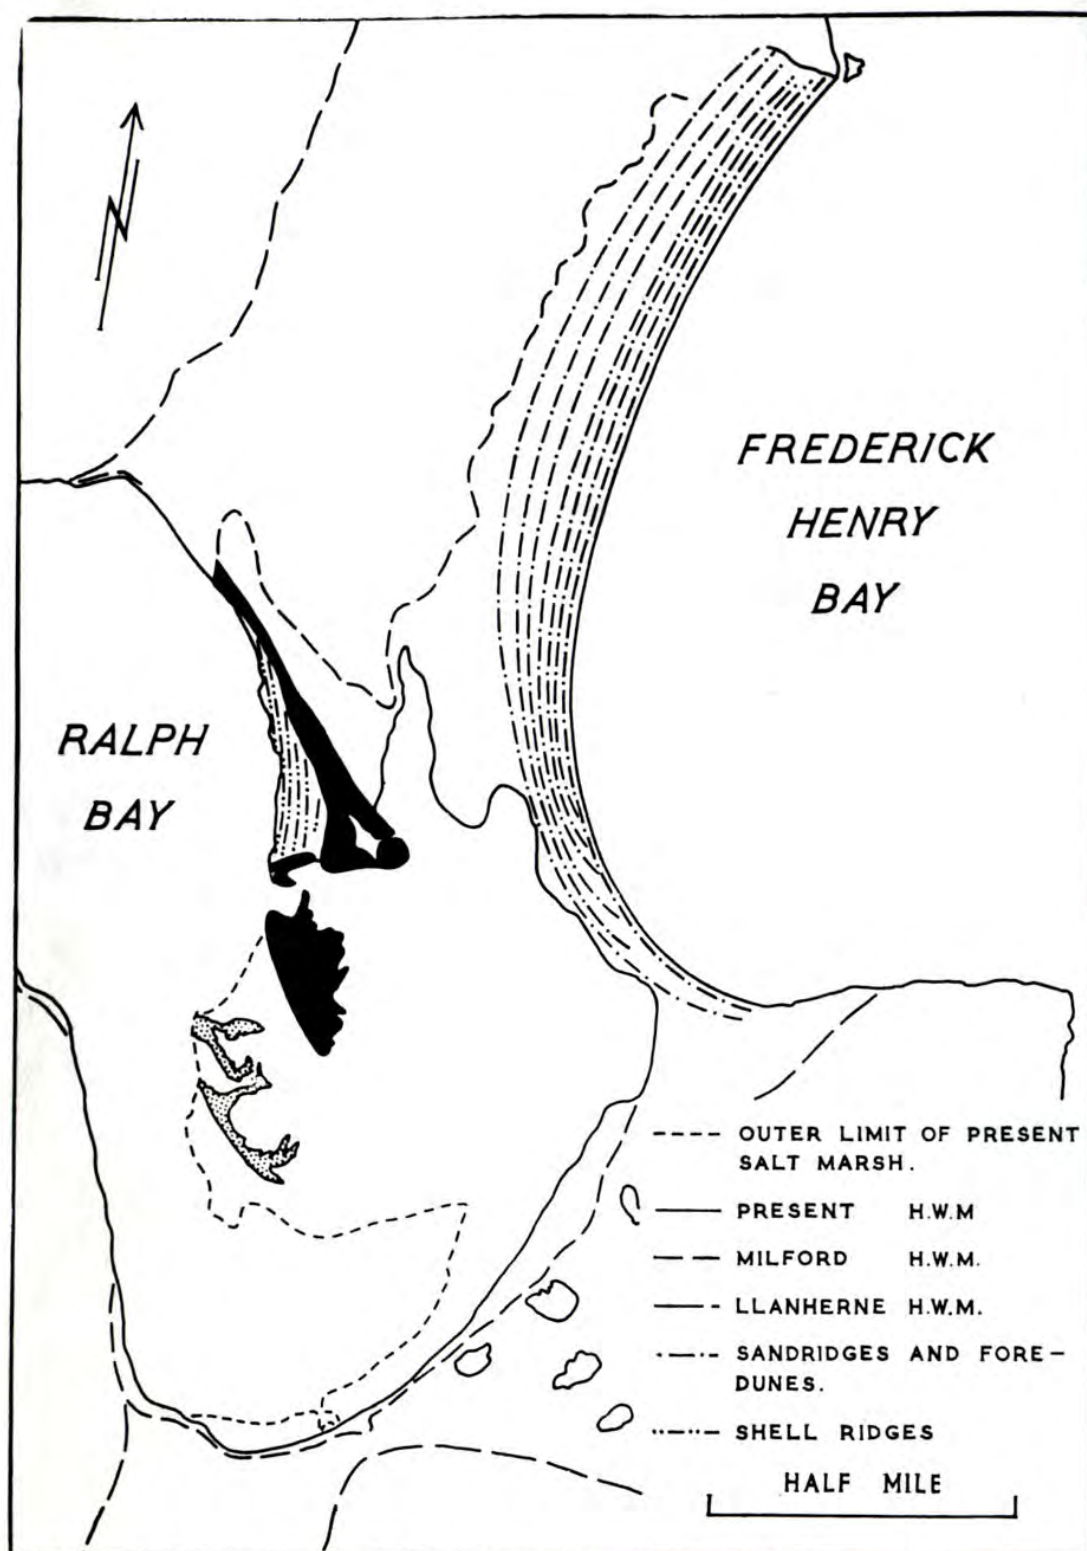
Figure 3: Geomorphic features identified at Roches Beach – Lauderdale by Davies (1959). Shingle structures are shown in black, shell structures are stippled. “Sand ridges” behind Roches Beach comprise a single foredune backed by low beach ridges. Most of the low beach ridges behind the foredune have been disturbed by roading and housing construction subsequent to 1959, and are generally difficult to discern today (see also Figure 6 & Figure 4). Davies considered the Milford HWM to represent a shoreline formed during a slightly higher mid-Holocene sea-stand following the last post-glacial marine transgression. The Llanherne HWM is likely to be a Last Interglacial shoreline. (Reproduction of Fig. 3 of Davies 1959).

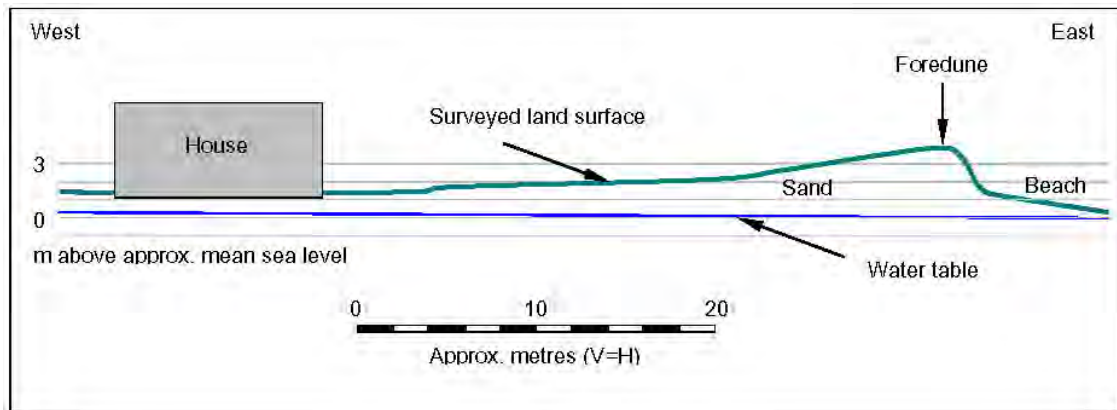
Figure 4: Surveyed profile of the foredune at the end of Aragoon Street, Roches Beach, reproduced from Cromer (2006, Fig. 2). A single foredune with a scarp on its seaward face is evident, and similar profiles are typical for much of Roches Beach. A series of low beach ridges mapped by Davies (1959) inland of the foredune (see Figure 3) are very subtle and virtually indiscernible today, probably largely due to ground disturbance associated with the building of the roads and houses of Lauderdale on the beach ridge area subsequent to 1959. As noted by Cromer (2006), this profile highlights the fact that many houses behind the foredune at Lauderdale are only about 1 metre above mean sea level, even though the foredune crest itself rises up to 3 metres above mean sea level. This location is at MGA (Zone 55) 540 369mE 5249 152mN (GDA94), about 200 metres north of the canal.

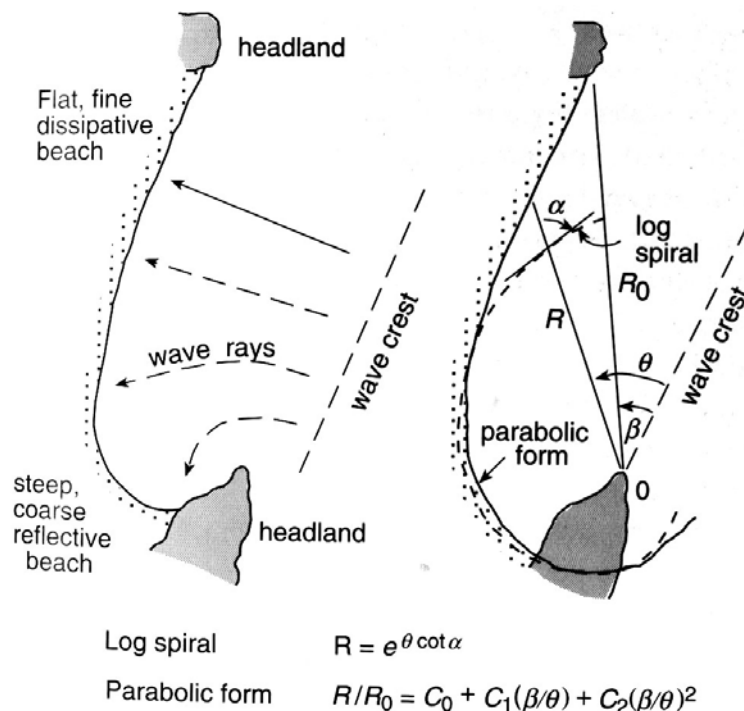
Figure 5: Diagram of a “Zeta-form” beach planform (Figure reproduced from Woodroffe 2003, after Hsu *et al.* 1989). Subsequent to Holocene progradation of the Lauderdale Neck and Roches Beach (Davies 1959), the main southern part of Roches Beach has settled into an equilibrium zeta-form plan controlled by the generally northwards – directed swell in Frederick Henry Bay (see Figure 9), the southern rocky headland of Mays Point, and the rocky point of Bambra Reef at the northern end of the main beach (compare also Figure 8).

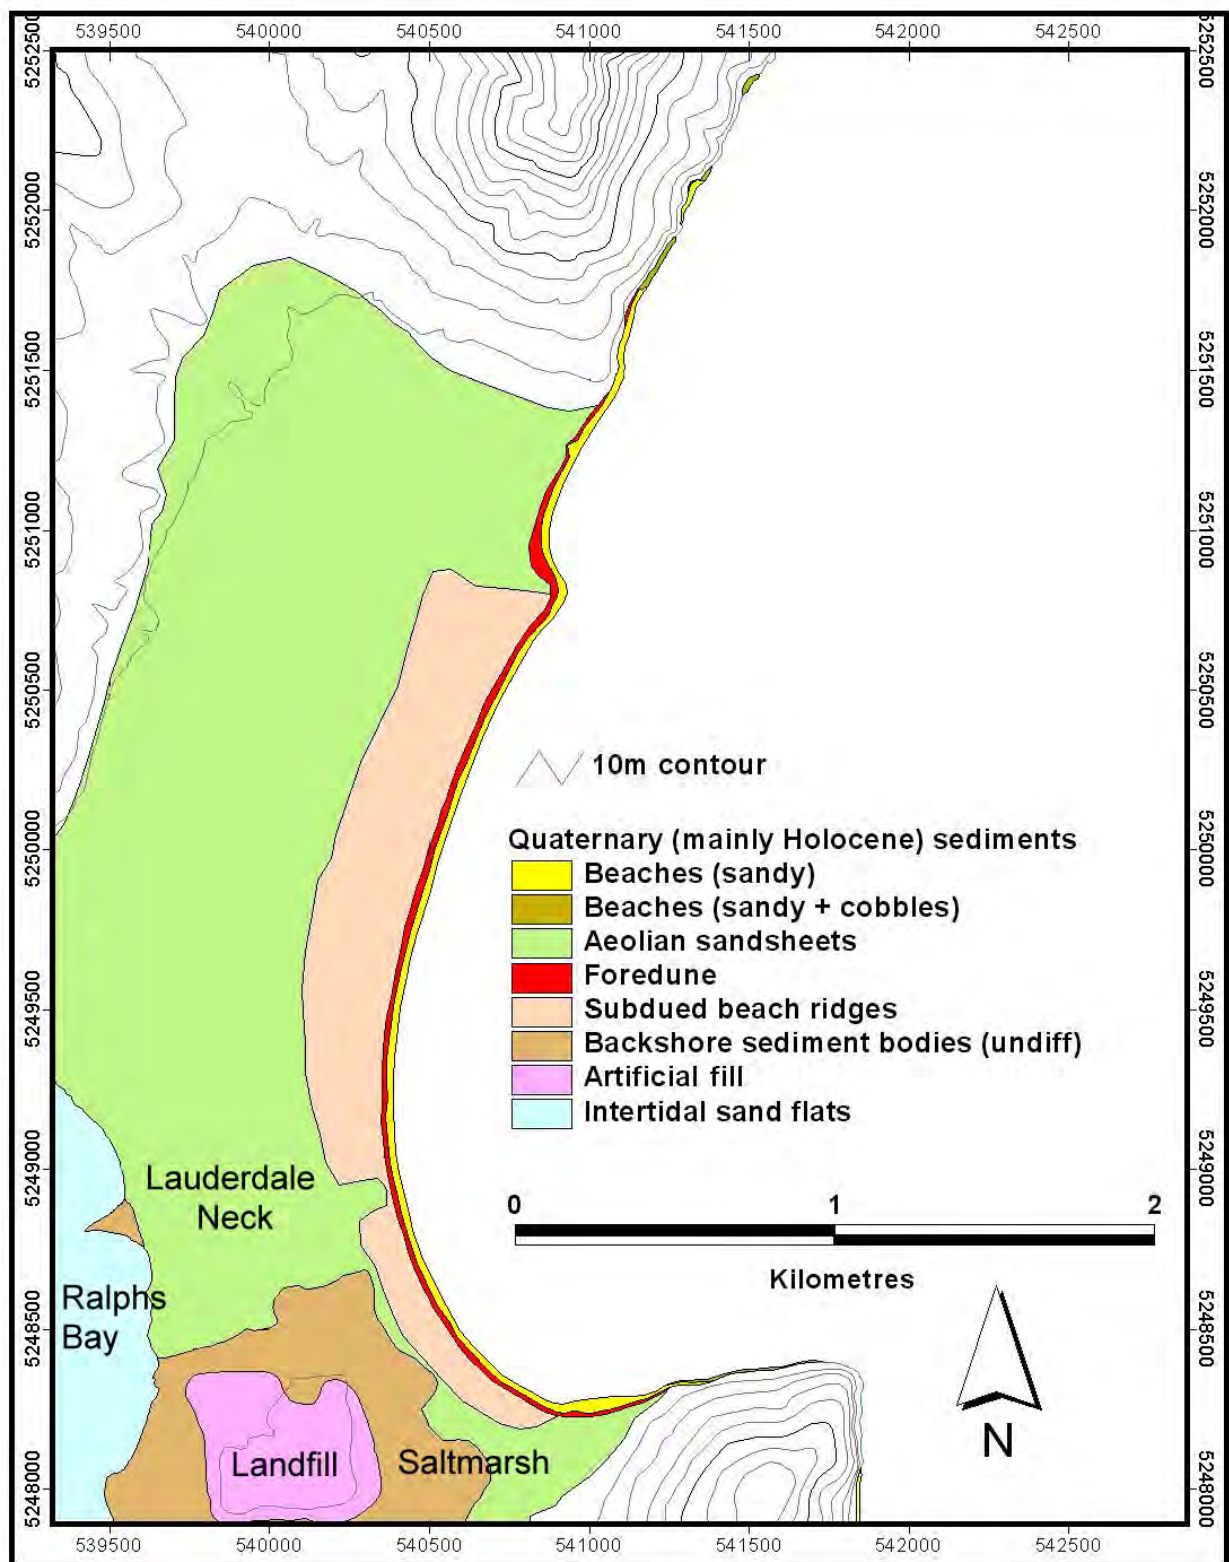
Figure 6: Onshore Quaternary (mainly Holocene) coastal soft sediment deposits and landforms at Roches Beach. This map is reproduced from a portion of the *tascoasted_v4gda* Tasmanian Quaternary Coastal Sediments map held by DPIW (Sharples 2006c), and is based on information from Davies (1959), Leaman (1972) and field observations by C. Sharples. Map grid is Map Grid of Australia (MGA) Zone 55, based on the GDA94 datum.

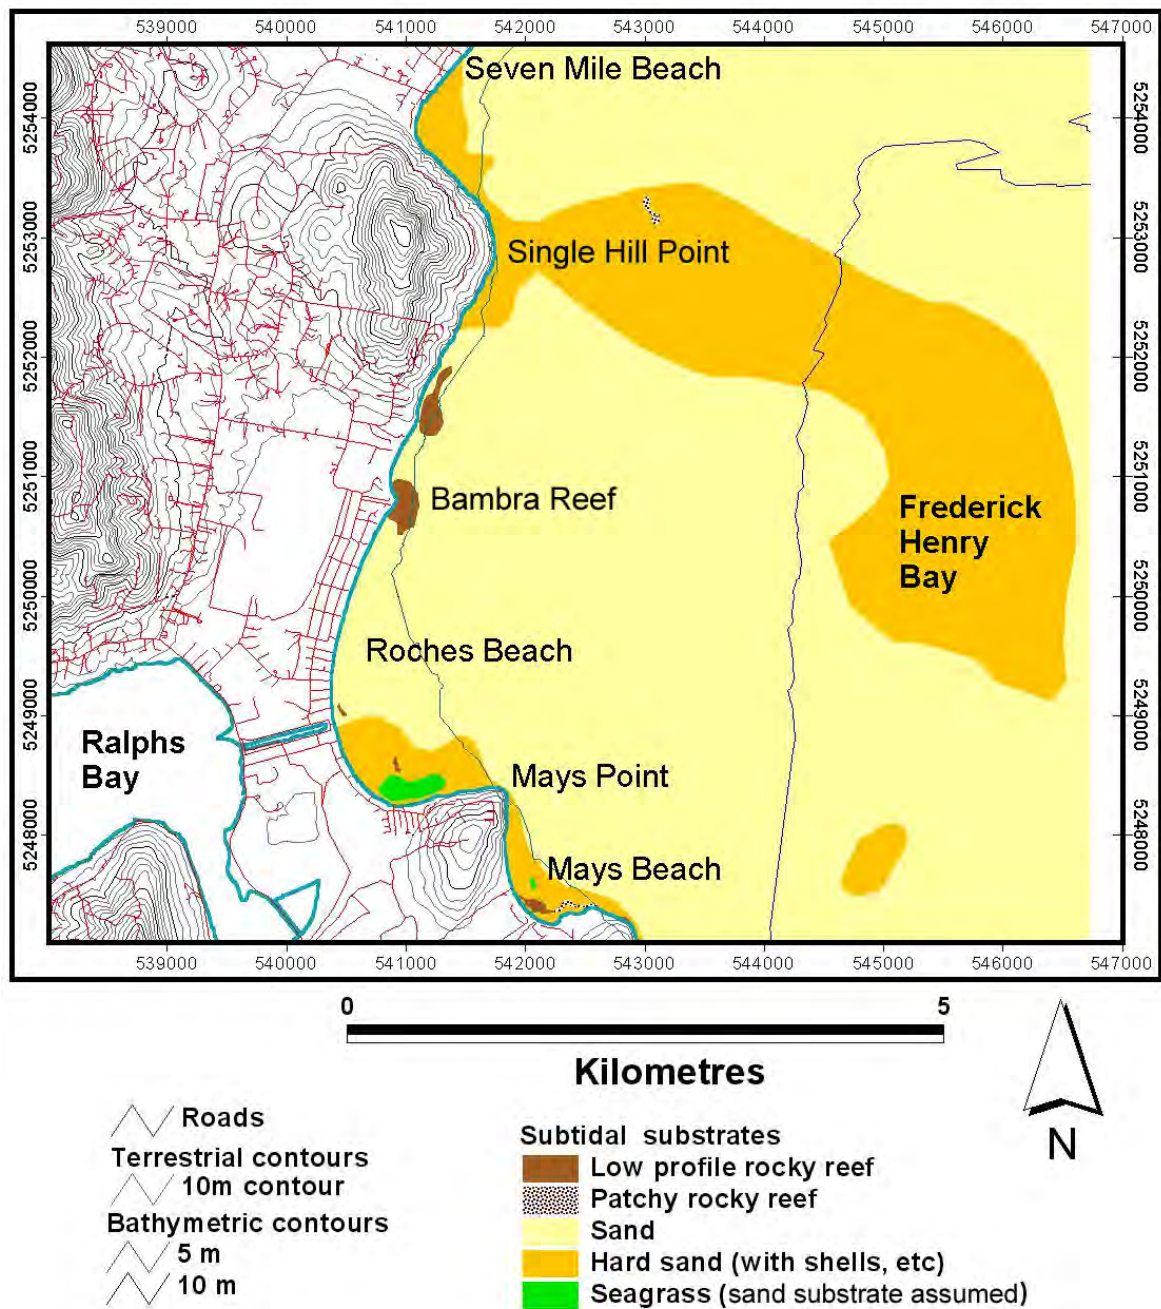
Figure 7: Offshore (subtidal) sediments and bathymetry in the Roches Beach – Seven Mile Beach – Frederick Henry Bay area. The subtidal bathymetry and substrate data shown is copyright © the SEAMAP Tasmania Project (Tasmanian Aquaculture and Fisheries Institute, University of Tasmania), and is reproduced here with permission. Map grid is Map Grid of Australia (MGA) Zone 55, based on the GDA94 datum.

Directly offshore from Roches Beach, Frederick Henry Bay has a broad shallow low-gradient seabed reaching 5 metres depth directly off Mays and Single Hill Points, but only reaching 10 metres depth several kilometres offshore (see Figure 7). Carley *et al.* (2008, Fig. 13.5) measured transverse profiles (dune to subtidal) for a range of beaches in Clarence Municipality and found

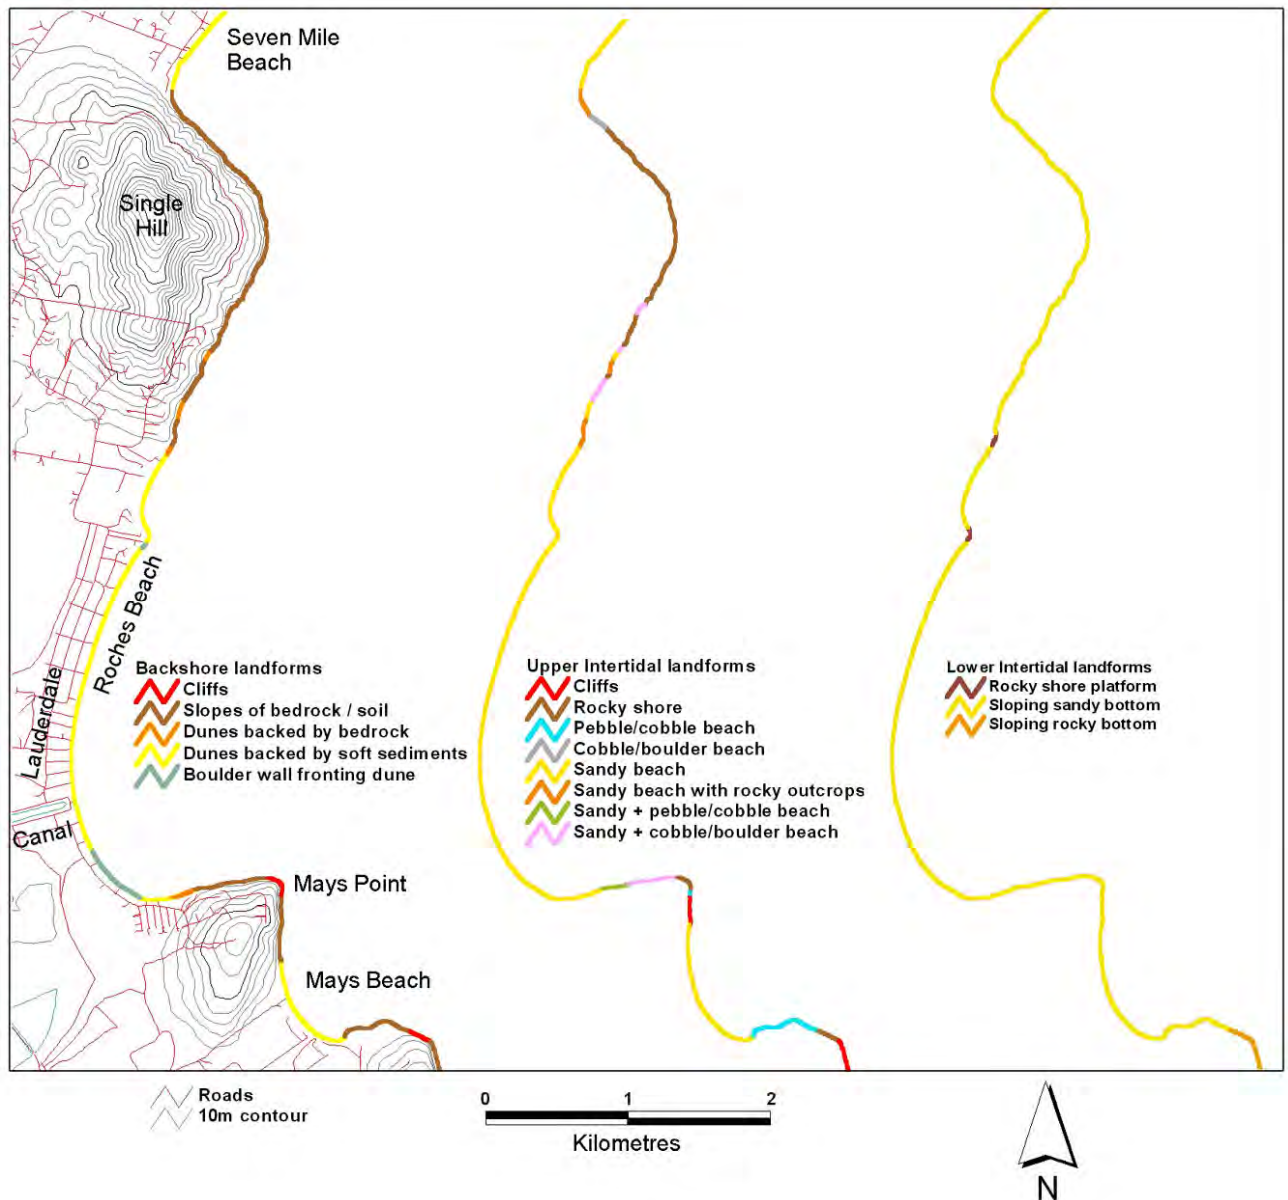
Figure 8: Coastal landform types at Roches Beach and adjacent areas. This map is reproduced from a portion of the *tascoastgeo_v4gda* Tasmanian Shoreline Geomorphic Types line map held by DPIWPE (Sharples 2006b), and is based on field observations by C. Sharples. Note that the information depicted here has now been incorporated into a similar but reclassified national coastal geomorphic map known as the ‘Smartline’, which is held by Geoscience Australia and is described in full by Sharples *et al.* (2009).

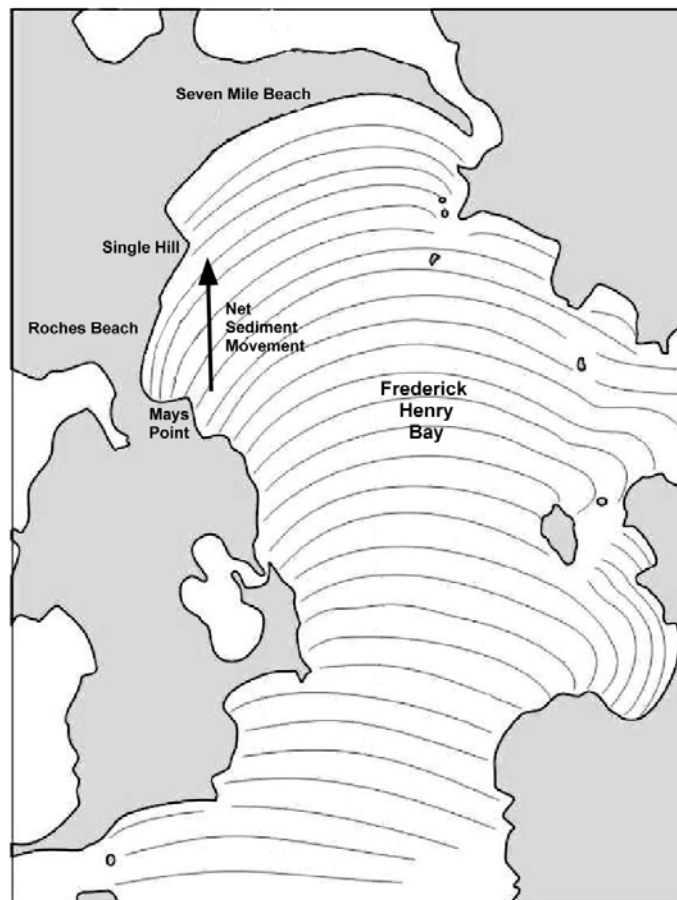
Figure 9: Swell wave refraction diagram for Frederick Henry Bay, showing how the predominating south-westerly swells produce a dominantly northwards longshore drift along the western side of Frederick Henry Bay (figure adapted from Byrne 2006). Although the southern end of the zeta-form Roches Beach embayment (in the lee of Mays Point) is relatively sheltered and may act as a sediment trap under normal swell conditions, the shallow bathymetry of the western side of Frederick Henry Bay and the presence of continuous shallow subtidal sands from south of Mays Point to Seven Mile Beach (see Figure 7), implies that this normal swell wave action is capable of driving a net northwards littoral drift of sand from south of Mays Point, through the Roches Beach embayment, and onwards around Single Hill Point to Seven Mile Beach.

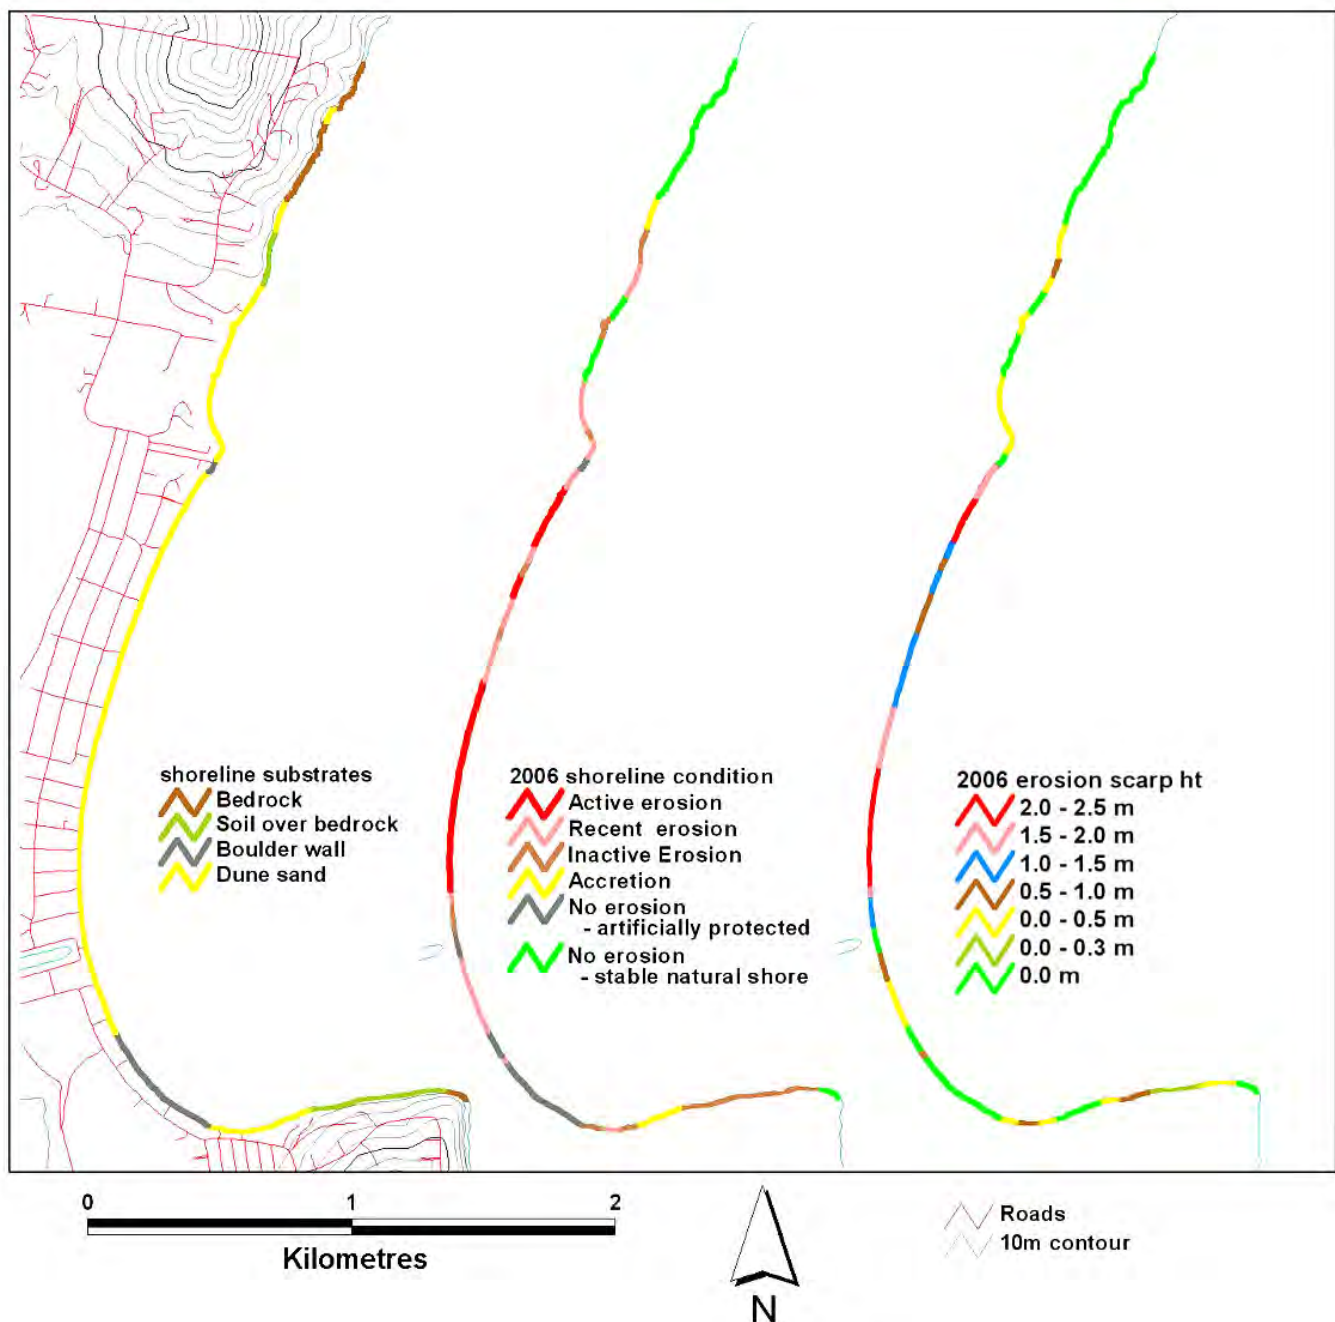
Figure 10: Shoreline condition (i.e., erosion status) at Roches Beach as at August 2006. This map shows the erosional status of all shoreline types in the study area, including sandy shores, artificial shores and bedrock shores. Shoreline “substrate” (LHS) refers to the substrate at the seawards vegetation boundary, which is taken as “the shoreline” for the purposes of this study. “Erosion” refers to recent (last few decades) or accelerated erosion (i.e., the “stable” bedrock shores are also eroding, but at a rate which is negligible for the purposes of this study). The information provided on these maps is encoded in the shapefile *2006_rochescondition_gda.shp*. See also Figure 8 which indicates the distribution of the different (geomorphic) shoreline types at Roches Beach.

The results of the 2006 condition assessment are graphically represented on Figure 10. An active or recent erosion scarp was present along most of the main part of the beach, from a few hundred metres south of the canal to Bambra Reef several kilometres north of the canal (encompassing recession zones RZ1 to RZ5 as depicted on Figure 19). No incipient foredune growth was observed along this stretch, and the present writer’s repeated field observations since 2001 are that this long part of the beach has been in a similar actively erosional state, with minor scarp slumping but no incipient or ‘embryo’ dune growth, from at least 2001, through 2006 and up to 2010 (See Figure 11). The findings of this project (Section 5.1) are that this long stretch of Roches Beach experienced significant net recession between 1957 and 2005 (apparently commencing circa 1975-1977), and the field evidence indicates this is ongoing at present (2010). Most of the boulder revetment (wall) south of the canal showed no sign of active erosion in 2006, although it is noteworthy that a small recent erosion scarp was evident on the foredune above and behind the revetment in at least one place (see Figure 30). This indicates that the revetment is not entirely halting shoreline erosion, and may require repair at some future time.

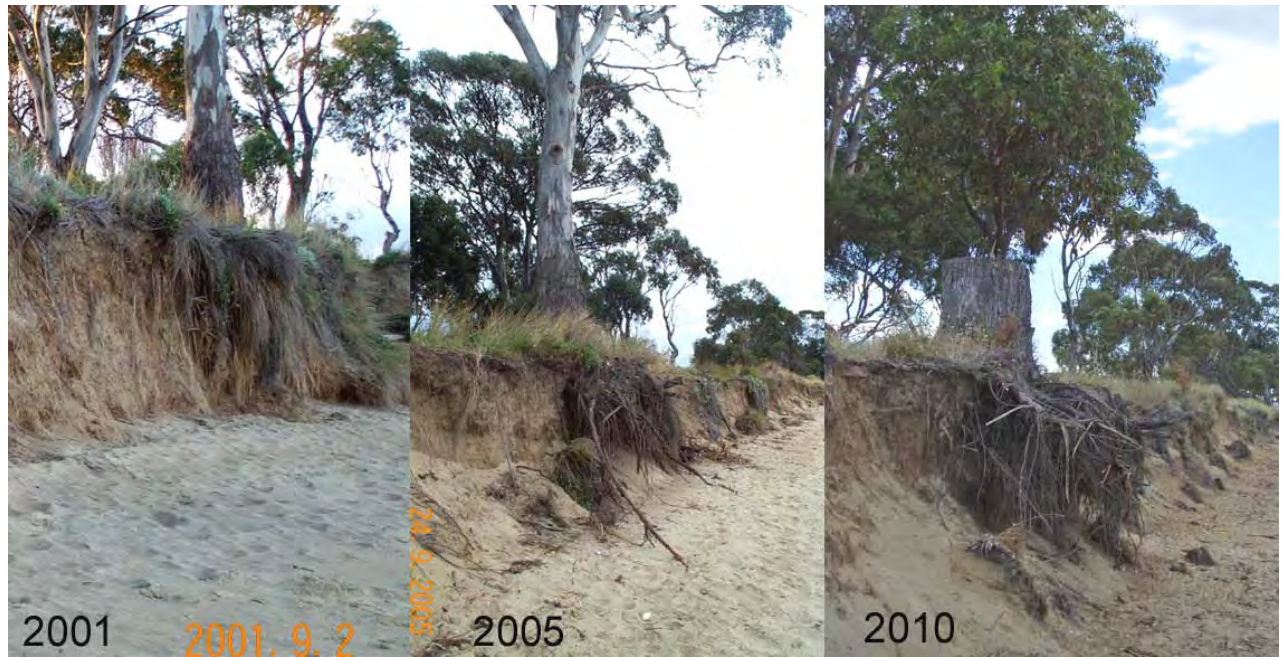
Figure 11: An example reference point on the Roches Beach dune front erosion scarp, photographed in 2001, 2005 and 2010. This is Viewpoint 26 (in Recession Zone RZ3: see Figure 19) as documented in Appendix Three (also depicted as a 2006 image in Figure 32). The crooked background tree on the RHS of the 2001 image provides a comparable reference feature in all three photos, which were taken from just slightly differing viewpoints. These photos illustrate that this location – in common with most of the main part of Roches Beach – has been in a continually erosive state from at least 2001 until the present (2010). Whilst some slumping of the erosion scarp has occurred between erosion events, there has been no incipient dune formation in front of the scarp, which has receded more than a metre over the period of these photos at this particular location, as indicated by progressive exposure of the roots of a large tree which was cut down in late 2005 (shortly after the photo shown here was taken) for safety reasons.

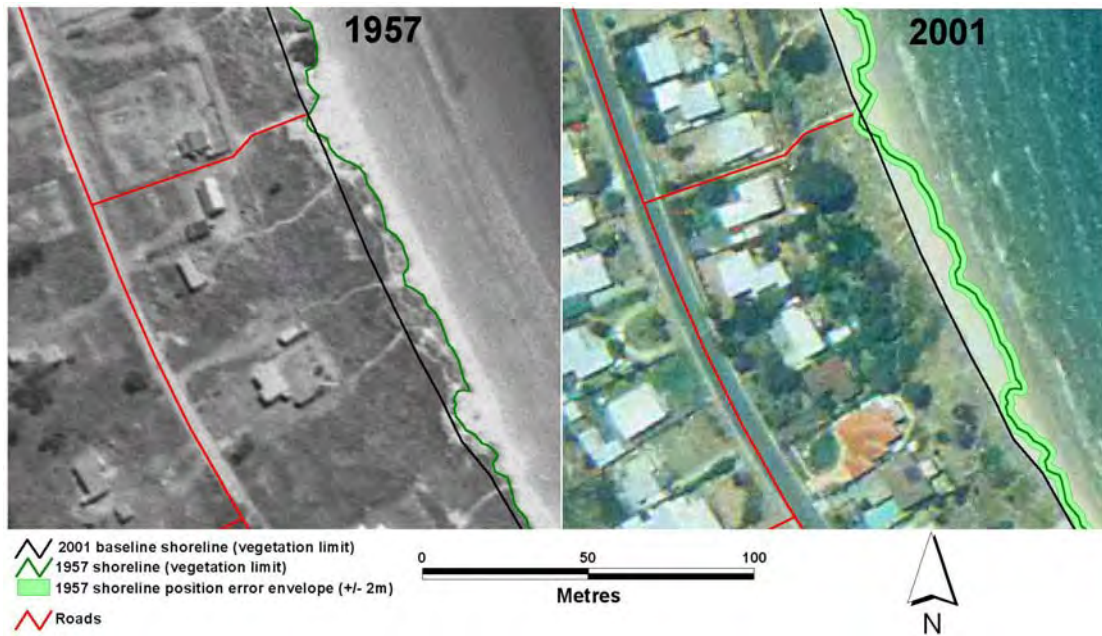
Figure 12: An example of detectable net shoreline recession at Roches Beach between 1957 and 2001 that can be demonstrated using the error envelope method described in this section (south of the canal). Both ortho-rectified air photo images (LHS: 1957, RHS: 2001) show the current LIST road lines for comparison, and the 1957 (green) and 2001 (black) shoreline positions (vegetation limits) that were mapped from these photos. The 2001 ortho-photo (RHS) also shows the $\pm 2\text{m}$ shoreline position error envelope around the mapped 1957 shoreline position. This error envelope is based on taking the 2001 image as the “correct” baseline, and allowing a $\pm 2\text{m}$ position error for the 1957 ortho-image relative to the 2001 ortho-image. On this basis the parts of the 2001 shoreline position line falling outside the 1957 shoreline position error envelope represent a real detectable movement of the shoreline position between 1957 and 2001, whilst those parts falling within the error envelope may or may not represent actual movement of the shoreline.

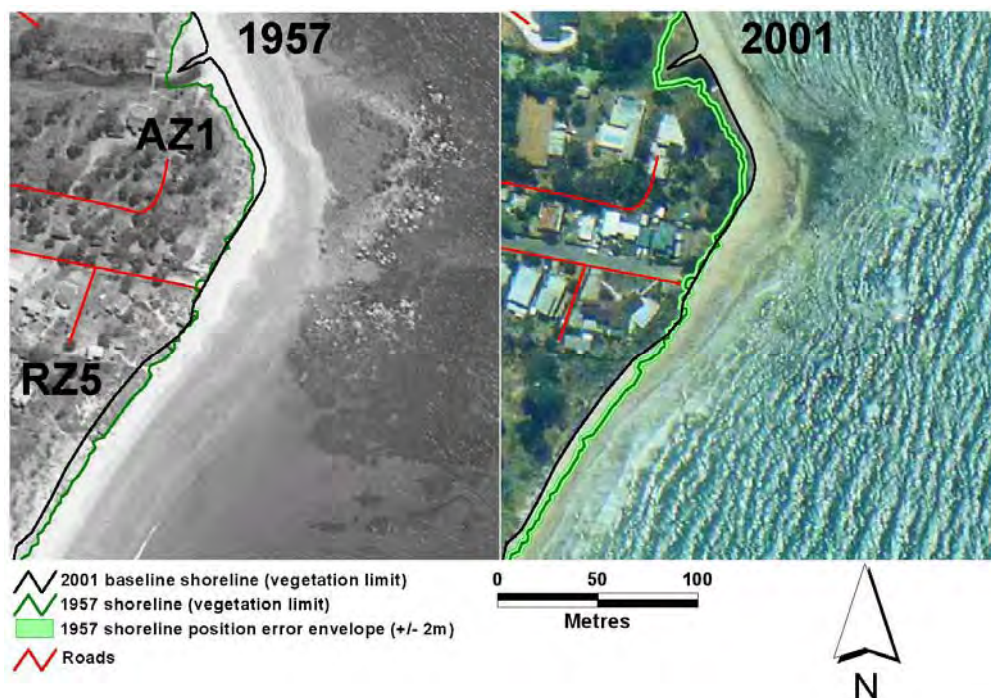
Figure 13: Net detectable shoreline recession and accretion between 1957 & 2001 that can be demonstrated using the error envelope method near Bambra Reef, a rocky point in the northern part of Roches Beach (see also Figure 18). Discussion as for Figure 12 above (zones AZ1 & RZ5 refer to Section 5.1 discussion).

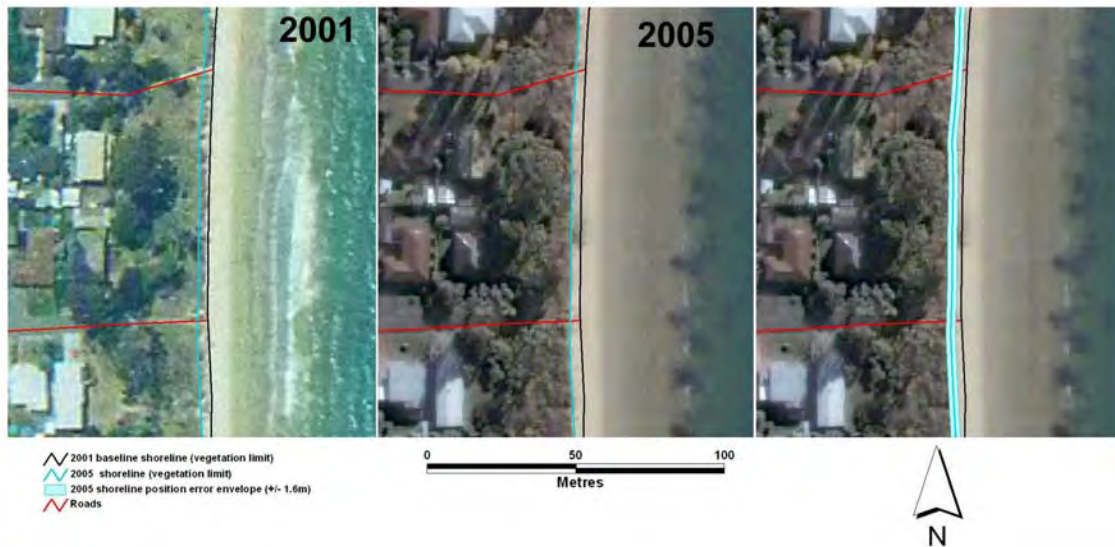
Figure 14: Detail of net recession zone RZ3 at Roches Beach (centred at MGA 540 370mE 5249 257mN GDA94 datum, 330 metres north of the canal; see also Figure 18). The left hand and centre images show the unbuffered mapped shoreline positions for 2001 and 2005 overlain on the ortho-rectified images from which they were mapped (2001 ortho-image 1342-48 and 2005 QuickBird satellite image). Current LIST road lines are shown for comparison. On the right hand image, the 2001 baseline shoreline position is plotted against the 2005 shoreline position with its $\pm 1.6\text{m}$ position error envelope. Measuring the separation of the 2005 error envelope's nearest edge from the baseline 2001 shoreline position, a minimum detectable shoreline recession of typically 1.5m (and conceivably up to 3.2m more) has occurred between 2001 and 2005 in this area. Compare Figure 18.

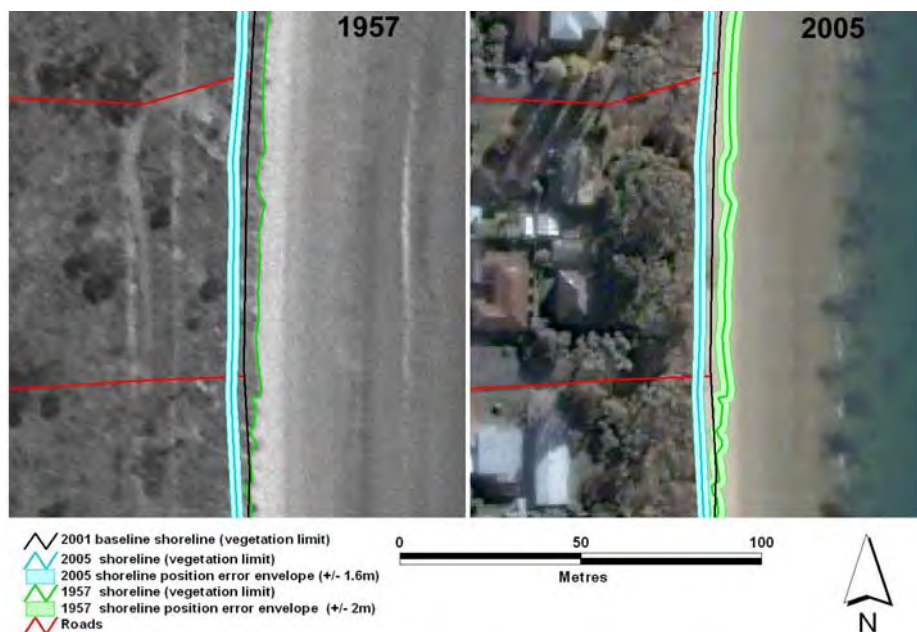
Figure 15: Detail of same portion of net recession zone RZ3 at Roches Beach that is depicted in Figure 14 above (centred at MGA 540 370mE 5249 257mN GDA94 datum, 330 metres north of the canal; see also Figure 18). These images show the mapped shoreline positions for 1957 and 2005 plotted over the ortho-rectified images from which they were mapped (1957 ortho-image 326-40 and 2005 QuickBird satellite image). The 1957 shoreline is shown with and without its position error envelope, which is slightly wider than the 2005 shoreline position error envelope (see text). Current LIST road lines are shown for comparison. Comparing the nearest edges of the 1957 and 2005 shoreline position error envelopes to the baseline 2001 shoreline, it is apparent that in this area a minimum net detectable shoreline recession of typically 3.3m (and conceivably up to $4.0 + 3.2 = 7.2\text{m}$ more) has occurred between 1957 and 2005. It is notable that about half of this recession has occurred subsequent to 2001 at this location. Compare Figure 18.

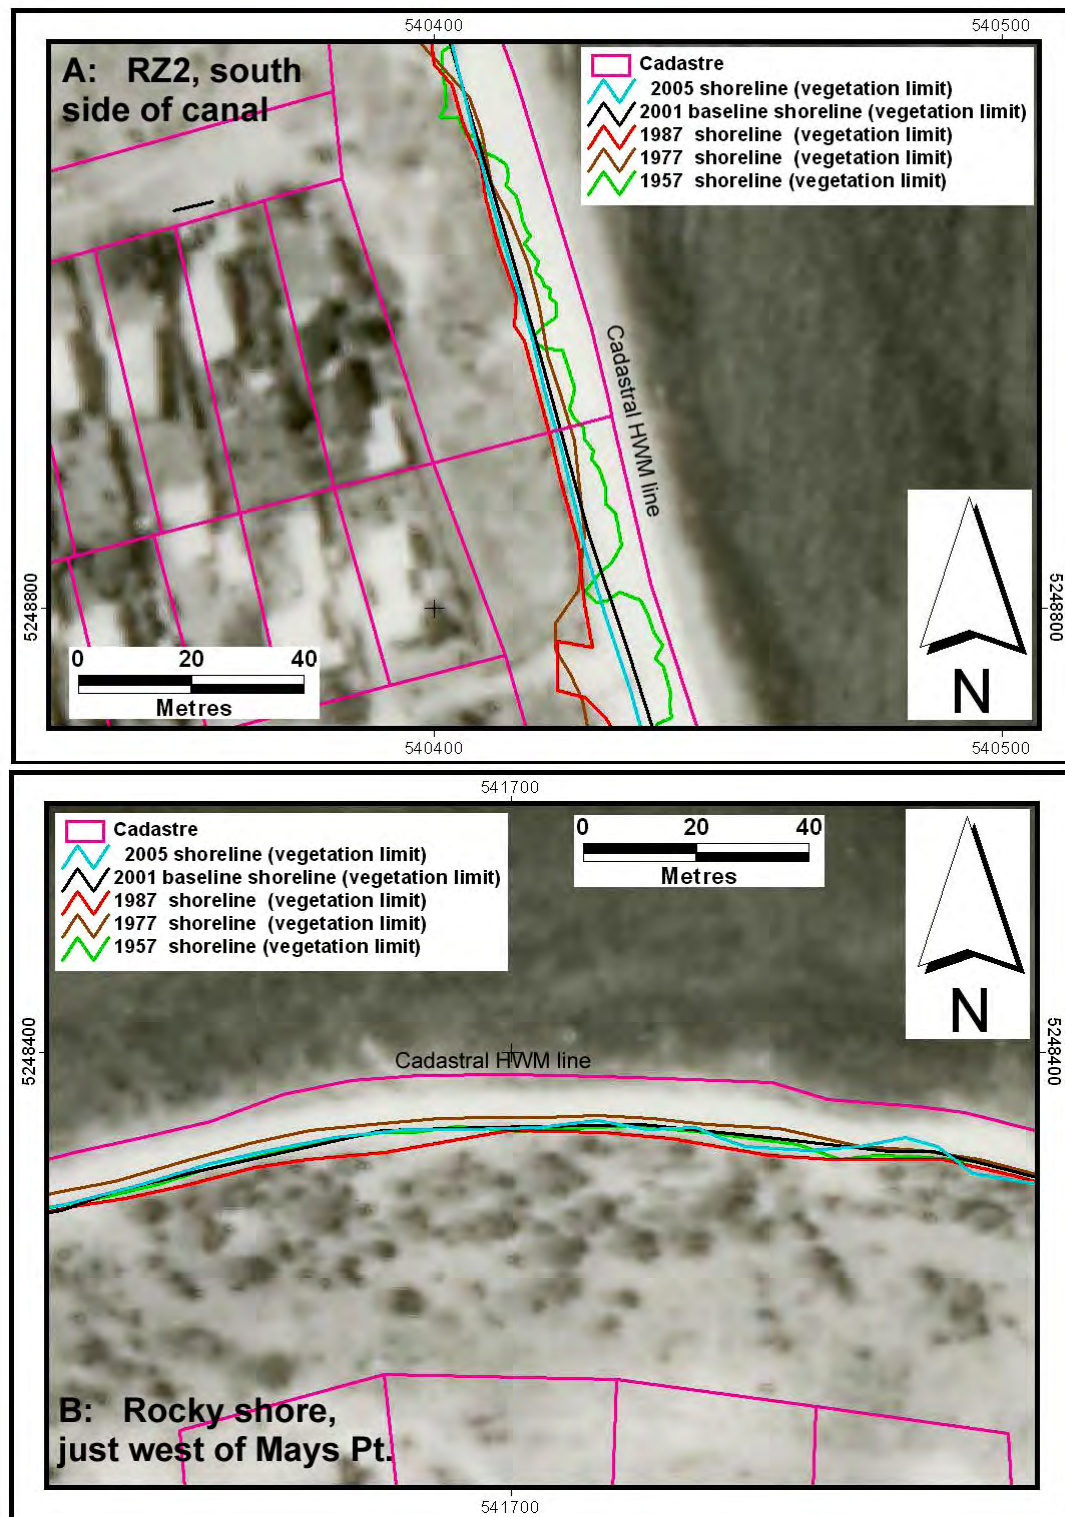
Figure 16: Comparison of the LIST cadastral HWM (High Water Mark) line with measured shoreline positions (seawards vegetation limits) at 1957, 1977, 1987, 2001 and 2005, at two locations at Roches Beach. Location A (top) shows a portion of the sandy beach immediately south of the canal, whilst B (bottom) shows a mainly rocky shoreline section immediately west of Mays Point. The background image is the 1987 ortho-image. The LIST cadastral HWM line is understood to have been drawn from a 1987 air photo. It is clear that the cadastral line is intended to be the High Water Mark (and not the vegetation limit, as used to define “shoreline position” for the present project), however note the difficulty of defining the HWM line precisely from photography such as this. Both images are same scale, map grid is MGA Zone 55 based on the GDA94 datum.

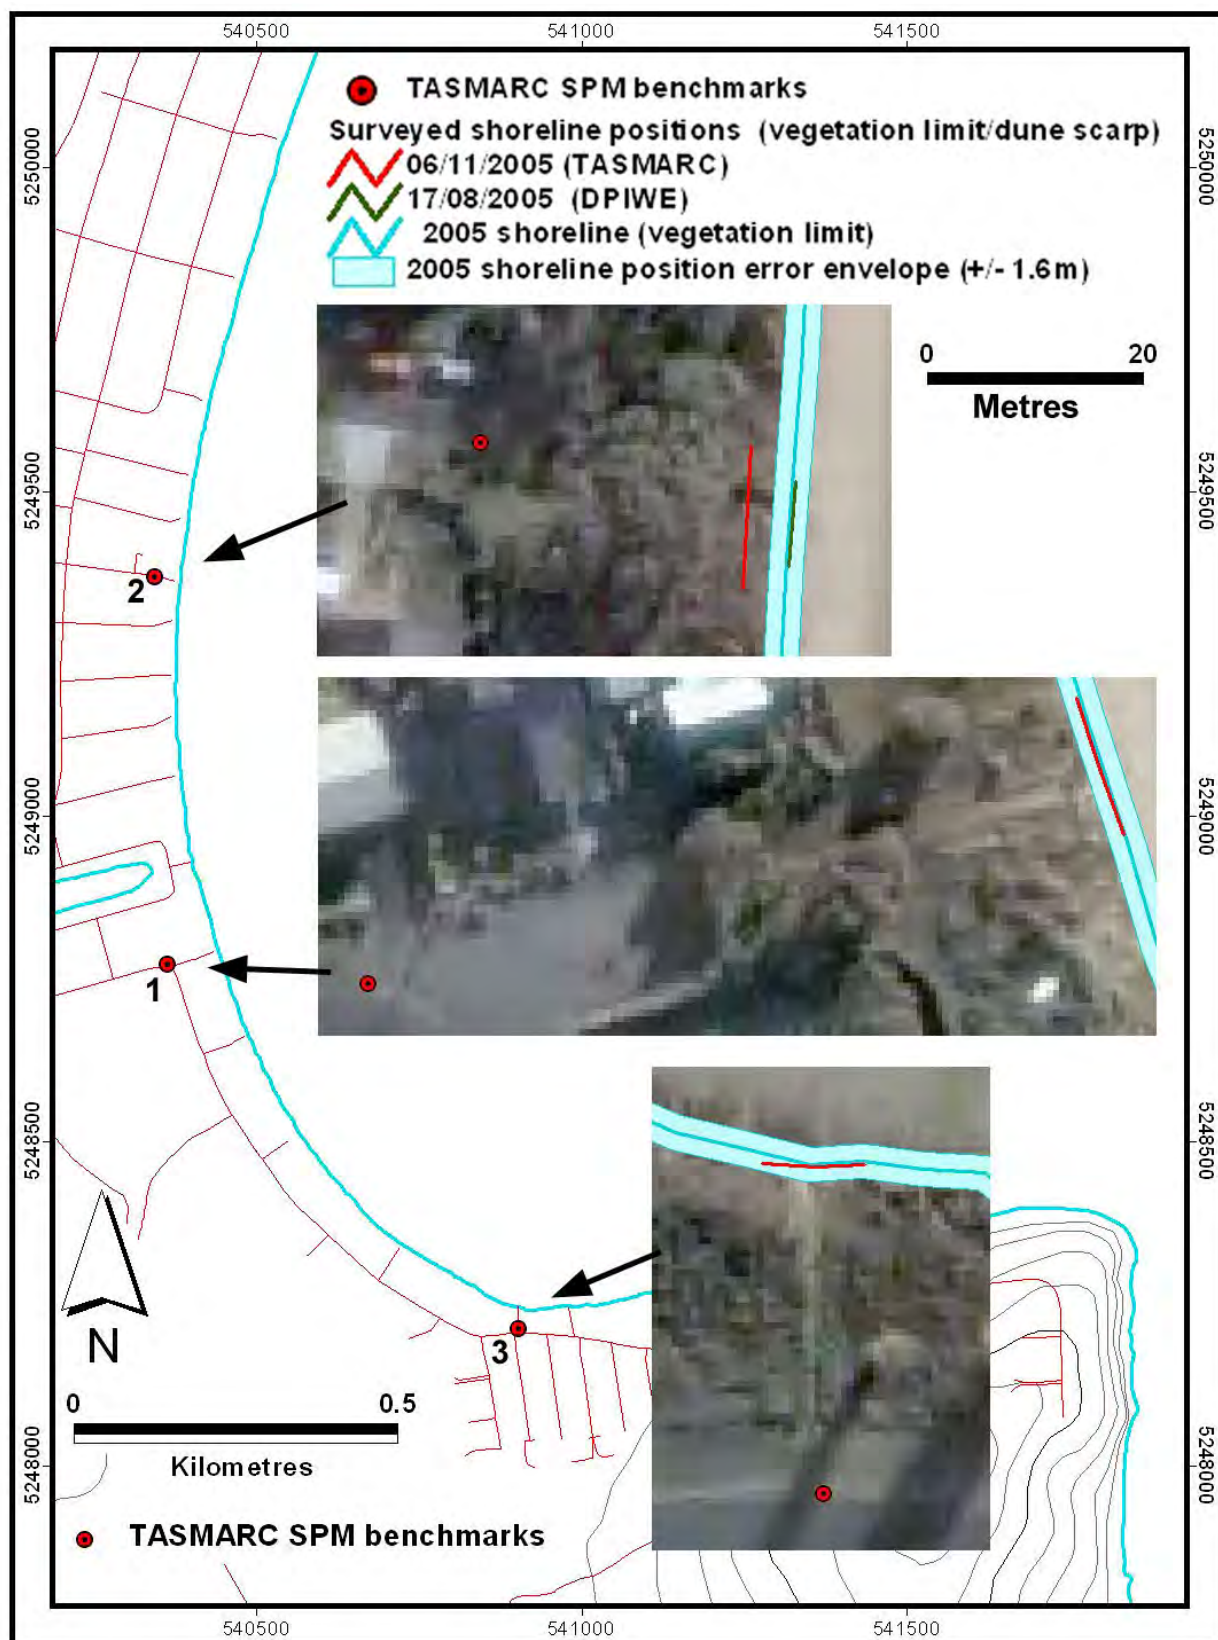
Figure 17: Comparison of the Roches Beach shoreline position for 2005 determined from ortho-rectified QuickBird satellite imagery with that measured from SPM benchmarks during late 2005 using tape and theodolite survey techniques. Upper right scale refers to inset images; lower left scale refers to base map. Survey data is provided in Appendix Four. Background images are the 2005 QuickBird image. Map grid is Map Grid of Australia (MGA) Zone 55, based on the GDA94 datum.
