Shoreline Change at Roches
Beach, South-Eastern Tasmania
1957-2010

Prepared by: Chris Sharples, School of Geography and Environmental
Studies, University of Tasmania August 2010

Shoreline Change at Roches Beach, South-Eastern Tasmania, 1957 - 2010

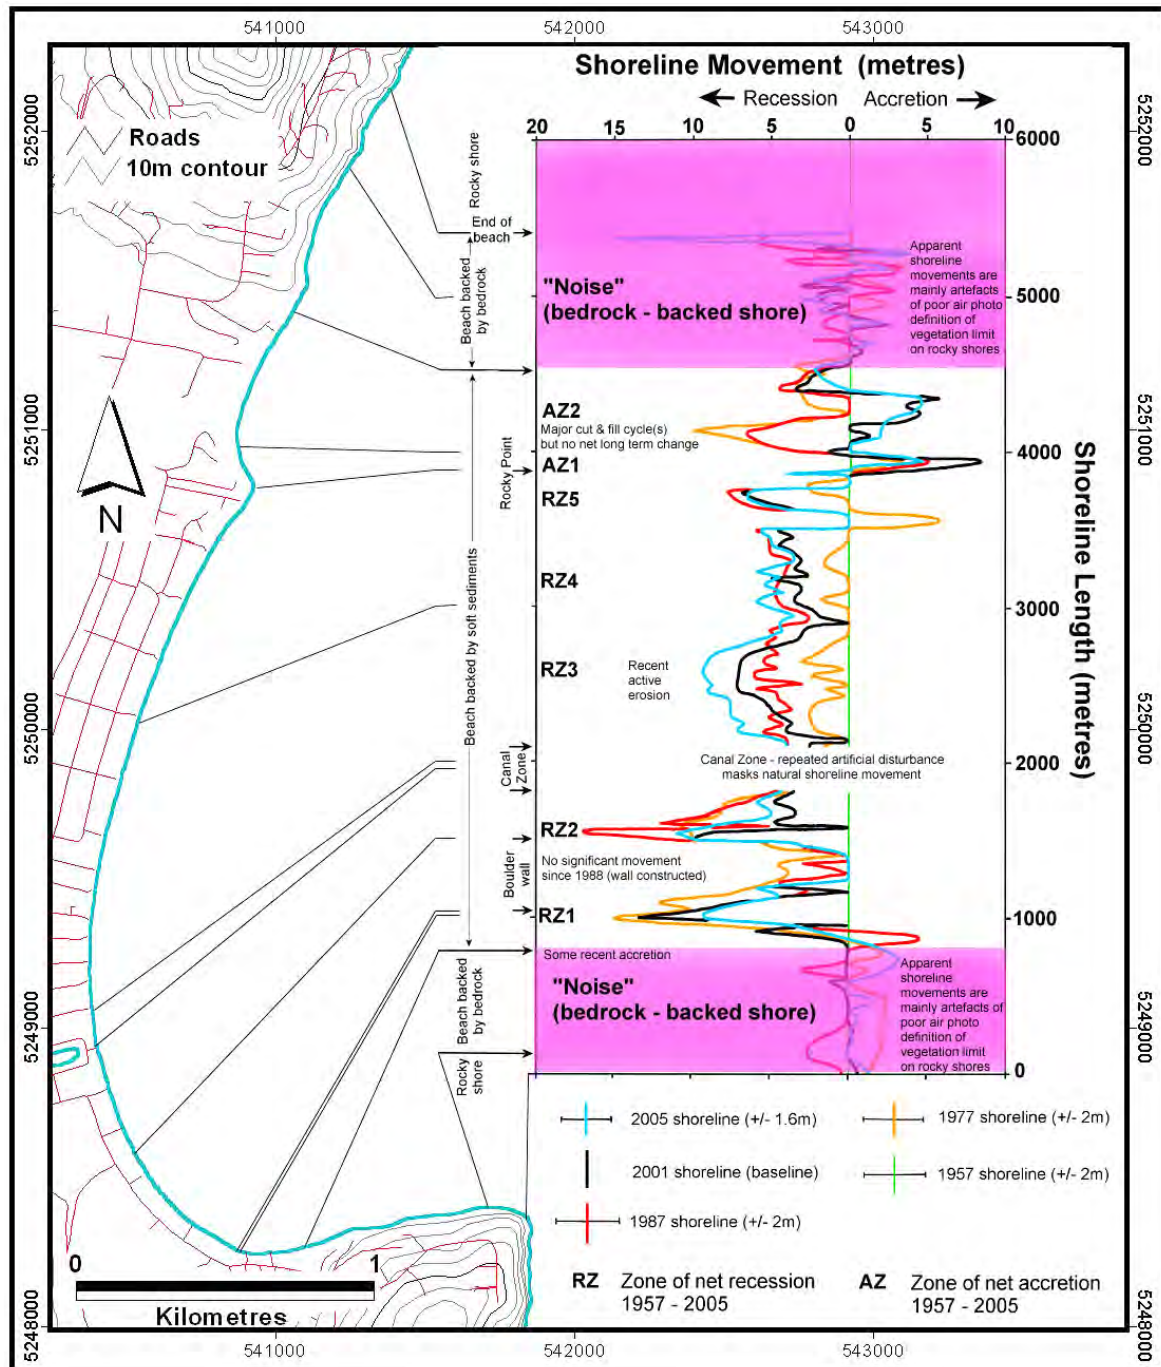
Figure 18: Apparent shoreline movement at Roches Beach, 1957 to 2005, as traced from ortho-rectified air photos from 1957, 1977, 1987 & 2001, and from a rectified 2005 QuickBird satellite image. For ease of comparison, the 1957 shoreline is depicted as a straight line, with later shoreline positions depicted relative to the 1957 position. The coloured lines represent the *apparent* shoreline positions at each epoch; however these are not the minimum *detectable* shoreline change positions, which would be represented by the separation between shoreline position error envelopes. See also Figure 19, which depicts the minimum detectable shoreline position changes based on the separation between the error envelopes. Error envelopes for each shoreline position are represented on this figure by bars on the figure key. Nonetheless, the *apparent* shoreline positions depicted here represent the centre of the position error envelopes, and therefore represent the most *likely* shoreline positions at each epoch. The shaded portions of the shoreline movement graph are those areas in which sandy beach is backed by bedrock; in those areas shoreline position could not be reliably determined by the method used in this project due to poor definition of the vegetation limit on air photos in areas of dark-toned bedrock and bedrock-derived soil backshores. The map grid is the MGA (Zone 55) grid (GDA94 datum). Note that the scale of the "Shoreline Length" axis on the graph is not the same scale as the map. An enlarged version of this figure is also provided in Appendix Five (Figure 37).

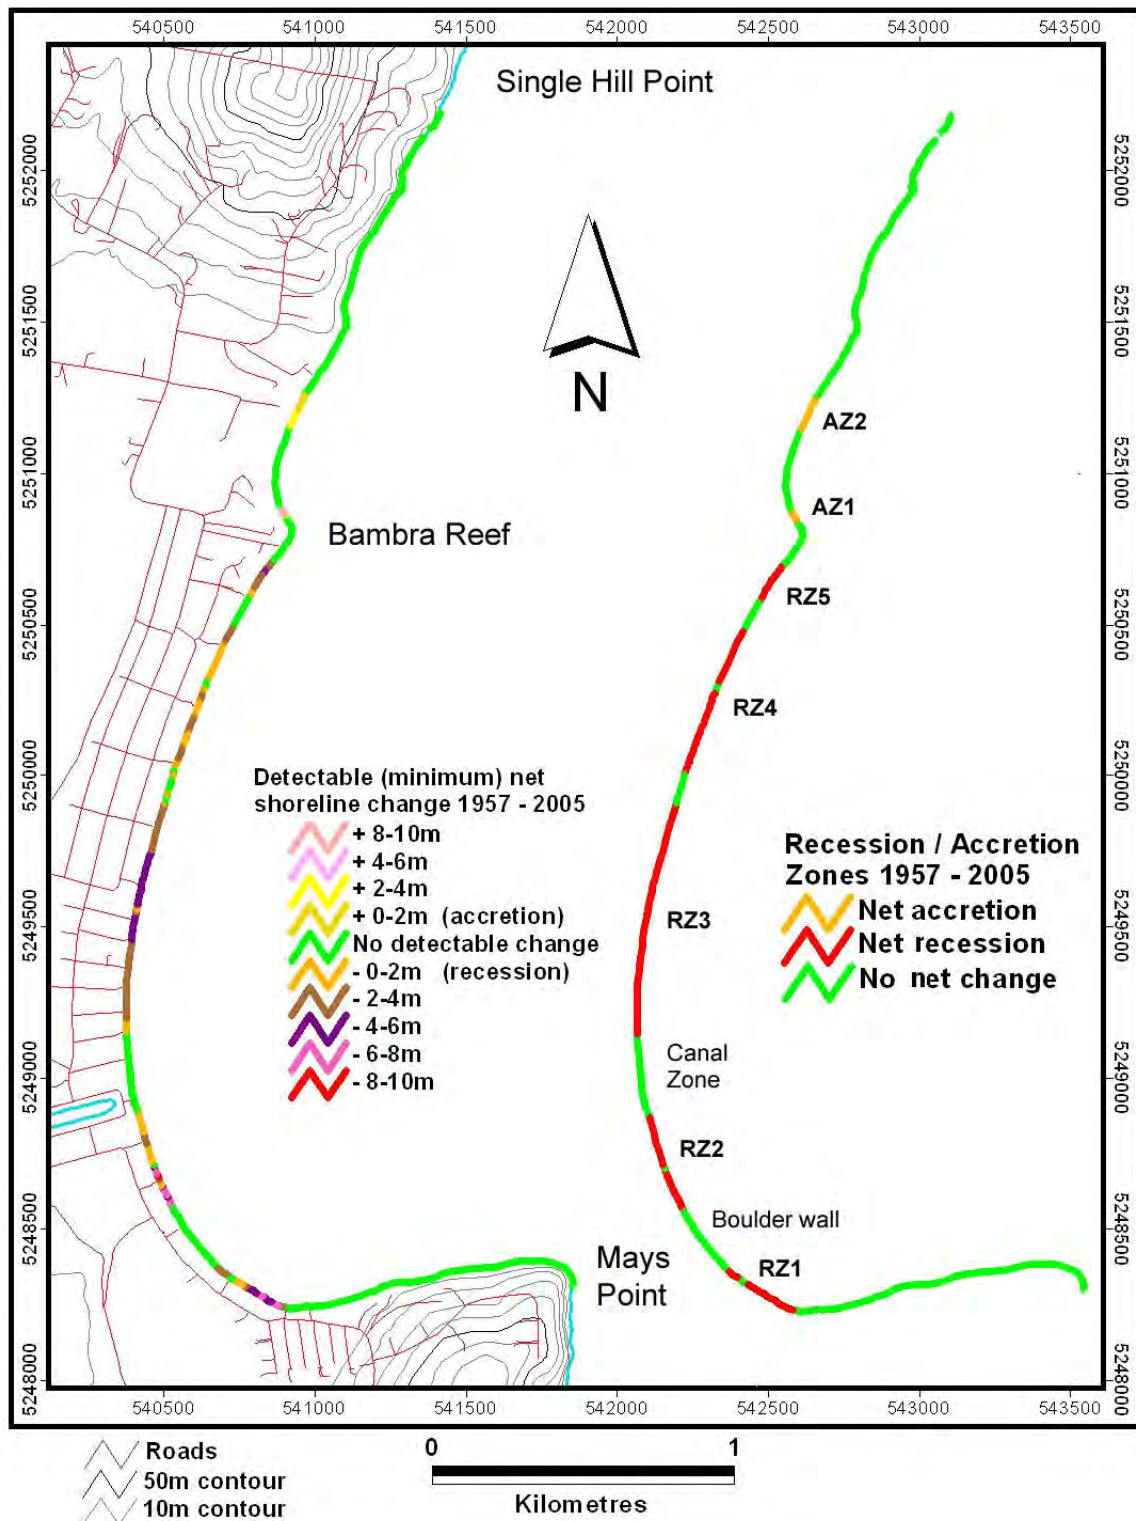
Figure 19: Detectable (minimum) net shoreline movement at Roches Beach between 1957 and 2005. This figure depicts the minimum net shoreline change that can be demonstrated to have occurred between 1957 and 2005, based on the separation between the edges of position error envelopes for the apparent 1957 and 2005 shoreline positions (as shown on Figure 18). Actual net shoreline change over that period is almost certainly greater than these minimum changes, but cannot be unequivocally demonstrated due to the position errors inherent in the ortho-rectified photos. However, the most likely actual shoreline changes are those depicted as apparent shoreline position changes in Figure 18, and are 3.6m greater than the minimum detectable changes depicted in this figure (1.6m 2005 error margin + 2m 1957 error margin). The map grid is the MGA (Zone 55) grid (GDA94 datum), and relates to the left-hand map.

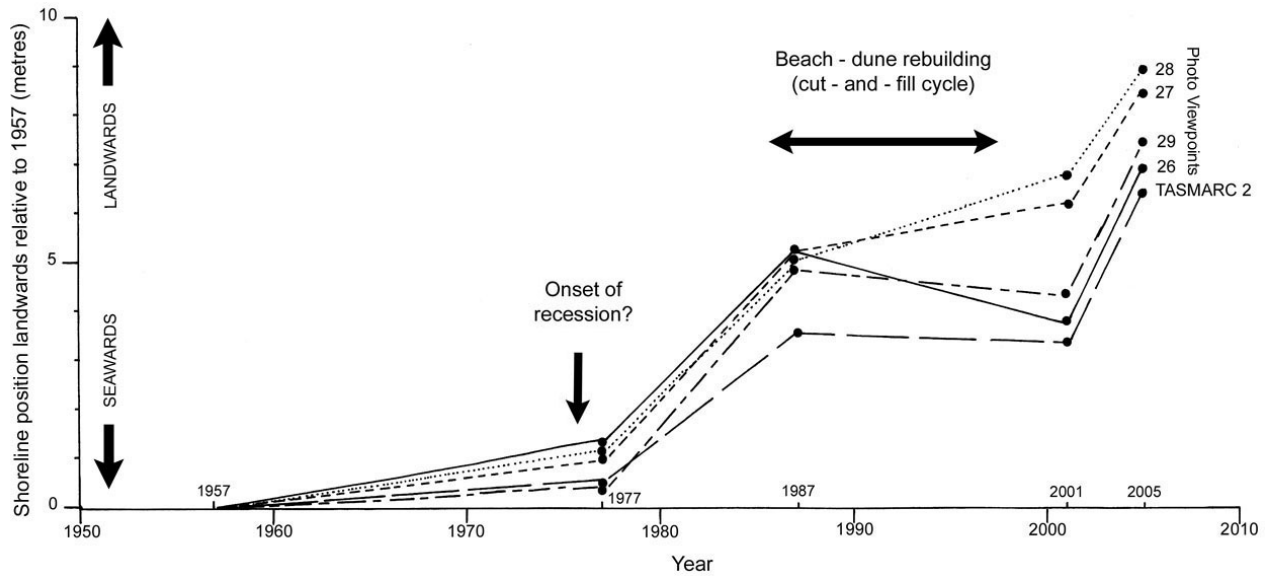
Figure 20: Shoreline recession plotted against time for the central part of Roches Beach (recession zone RZ3). This part of the beach shows the least effect of cut-and-fill cycles (compare Figure 18), although at least one such cycle is evident. Apparent (most likely) shoreline positions (vegetation limits) in metres landwards relative to the 1957 shoreline position were manually measured in Arcview from the ortho-rectified imagery time series (1957, 1977, 1987, 2001 & 2005) at four numbered photo viewpoints as specified on the RHS of the figure (see Appendix 3) and at the position of the TASMARC 2 monitoring profile (see Appendix 4). Although more data points are desirable (particularly in the 1960s, 1970s and 1990s intervals), this figure clearly indicates a substantial shoreline recession trend beginning with a marked change in shoreline behaviour that probably commenced in the mid - 1970s.

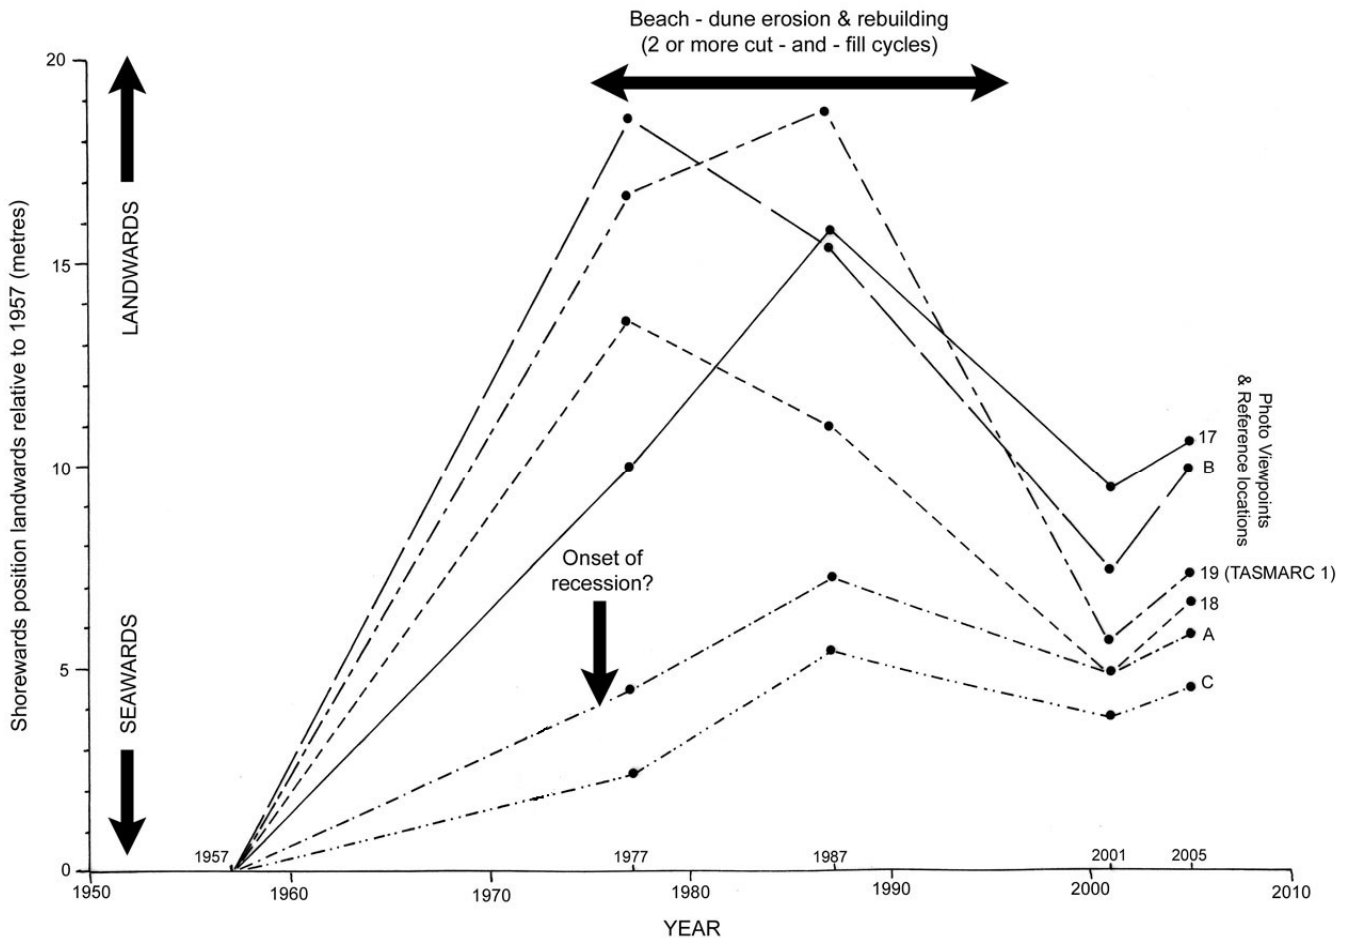
Figure 21: Shoreline recession plotted against time for Roches Beach south of the canal and north of the boulder wall (recession zone RZ2). This part of the beach shows several large cut-and-fill cycles superimposed on an overall recession trend comparable to that at recession zone RZ3. At least two cut-and-fill cycles are evident – erosion occurred at all sites before 1977, with several areas then showing significant rebuilding prior to 1987, however some sites show further erosion between 1977 and 1987. All sites show rebuilding after 1987 & prior to 2001, and all sites then show only progressive erosion without rebuilding after 2001. This figure was derived by measuring apparent (most likely) shoreline positions (vegetation limits) in metres landwards relative to the 1957 shoreline position in Arcview from the ortho-rectified imagery time series (1957, 1977, 1987, 2001 & 2005) at six locations spread along recession zone RZ2, as specified on the RHS of the figure. These locations comprised three of the numbered photo viewpoints (17, 18 & 19) as listed in Appendix 3 (one of which is also the TASMARC 1 monitoring profile as described in Appendix 4), and three new reference locations whose positions are as follows: A = 540 430mE 5248 821mN; B = 540 476mE 5248 691mN; C = 540 418mE 5248 871mN (all MGA, GDA94 datum). Although more data points are desirable (particularly in the 1960s, 1970s and 1990s intervals), this figure clearly indicates a substantial shoreline recession trend beginning with a marked change in shoreline behaviour that probably commenced in the mid - 1970s.

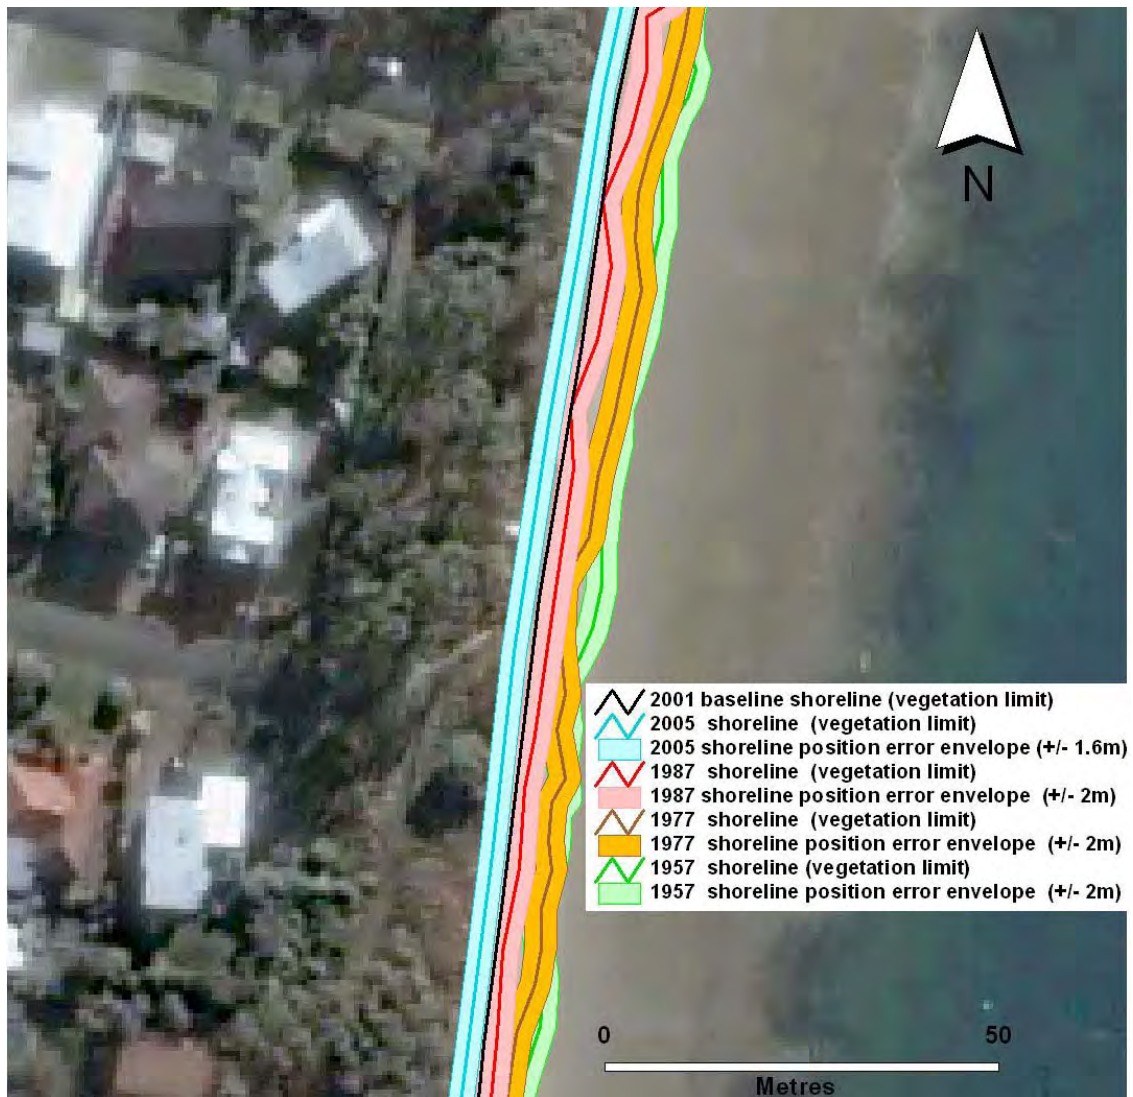
Figure 22: Shoreline change between 1957 and 2005 for a central portion of recession zone RZ3 (area shown is centred at 540 390mE 5249 480mN (MGA co-ordinates, GDA94 datum), about 550 metres north of the Lauderdale Canal). Background image is the 2005 QuickBird satellite image. Shoreline position error envelopes around the mapped shoreline positions show a minimum detectable net shoreline recession between 1957 & 2005 typically of the order of 4 to 6 metres in this area. Although small scale cut-and-fill cycles are likely to have occurred, no large scale cut-and-fill cycles are detectable along this central part of Roches Beach; instead the general pattern here over the period 1957 to 2005 has been one of progressive net shoreline recession (compare Figure 18).

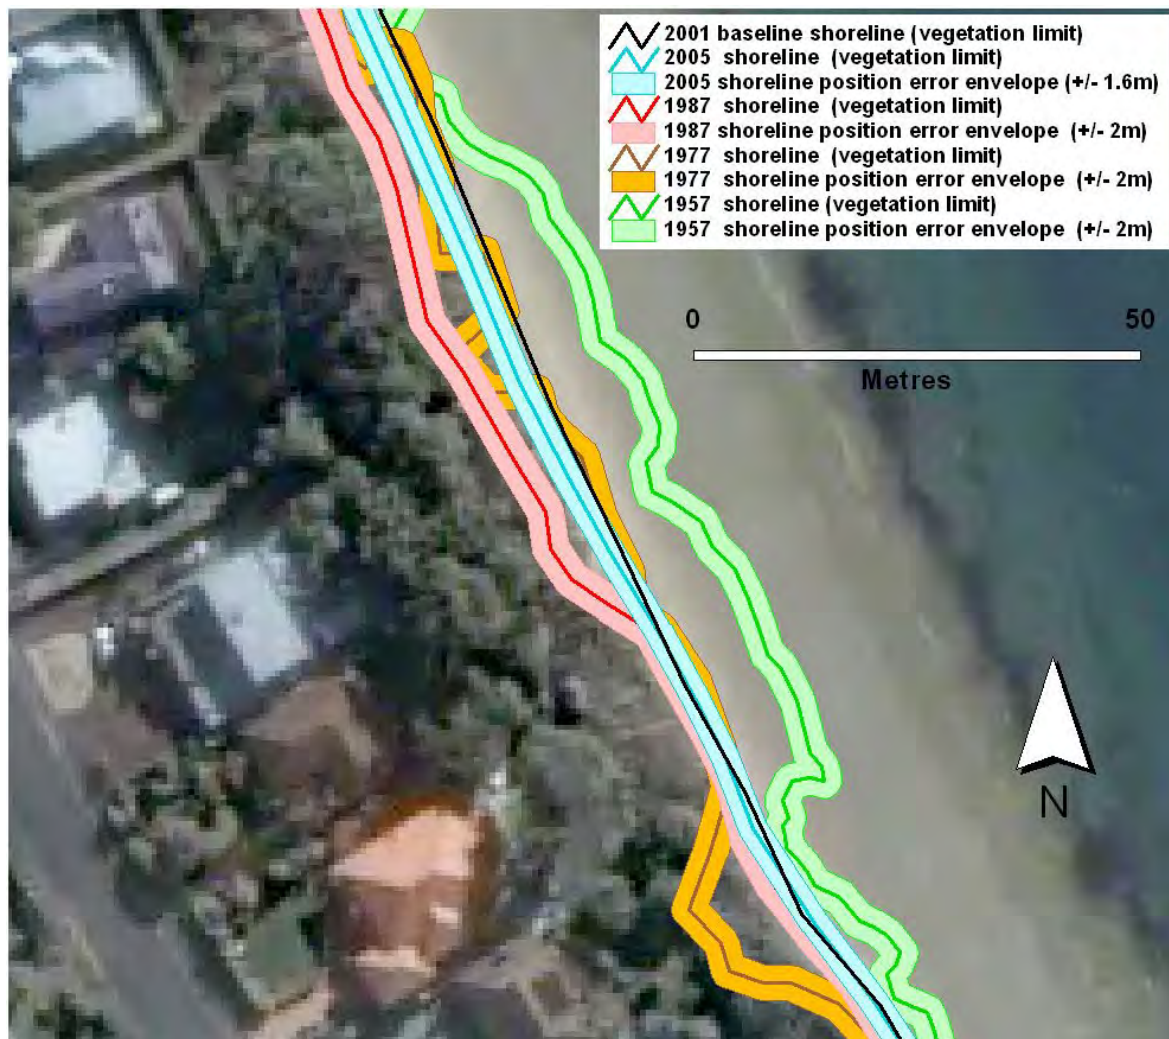
Figure 23: Shoreline change between 1957 and 2005 for a portion of recession zone RZ2 (area shown is centred at 540 505mE 5248 612mN (MGA co-ordinates, GDA94 datum), about 340m south of Lauderdale Canal). Background image is the 2005 QuickBird satellite image. Shoreline position error envelopes around the mapped shoreline positions show a minimum detectable net shoreline recession between 1957 & 2005 typically of the order of 6 to 7 metres in this area. In contrast to RZ3 (Figure 22 above) this area shows evidence of large cut and fill cycles, however these are also superimposed on a long term net recession trend as at RZ3. At least two very large erosion events (prior to 1977, and again between 1977 & 1987) have occurred at this site, however the shoreline has subsequently re-built (accreted seawards) prior to 2001, before again receding landwards between 2001 & 2005 and has remained in a continually erosive state with no incipient foredune growth up until the present (2010). Despite the cut and fill cycles, the beach has never rebuilt to its 1957 position, and the overall trend has been one of net erosional recession.

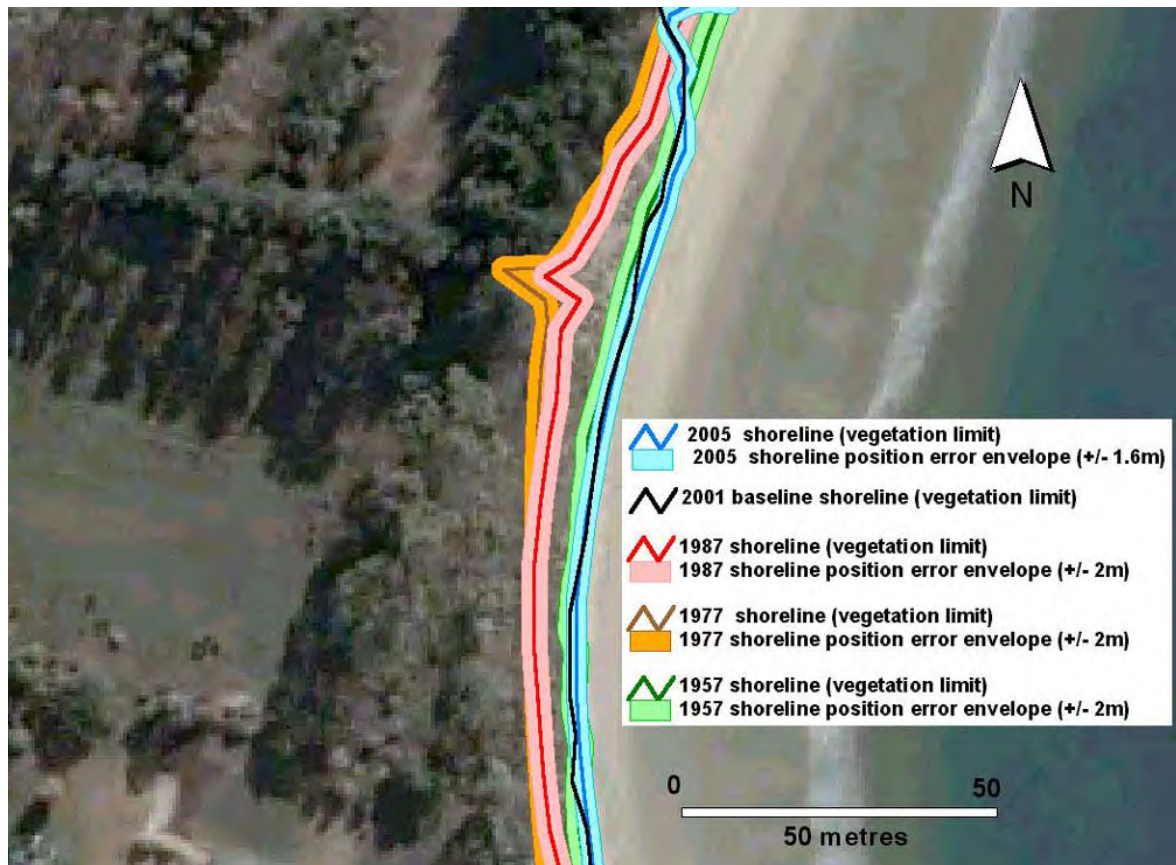
Figure 24: Shoreline change between 1957 and 2005 for an area between accretion zones AZ1 and AZ2 (area shown is centred at 540 863mE 5251 022mN (MGA co-ordinates, GDA94 datum), about 200 metres north of Bambra Reef at the north end of the main part of Roches Beach. Background image is the 2005 QuickBird satellite image. Shoreline position error envelopes around the mapped shoreline positions show evidence of at least one major erosion and shoreline recession event (demonstrable recession up to 8m) prior to 1977 (similar to RZ2; see Figure 23 above), however the shoreline has subsequently rebuilt (accreted seawards) back to its 1957 position. Thus, whilst this part of Roches Beach shows evidence of at least one major cut-and-fill cycle – probably contemporaneous with that evident at RZ2 – no net shoreline recession is detectable between 1957 & 2005 and this part of the beach is behaving as an equilibrium shoreline subject only to short-term cut and fill cycles, but not as yet subject to long term net erosional recession.

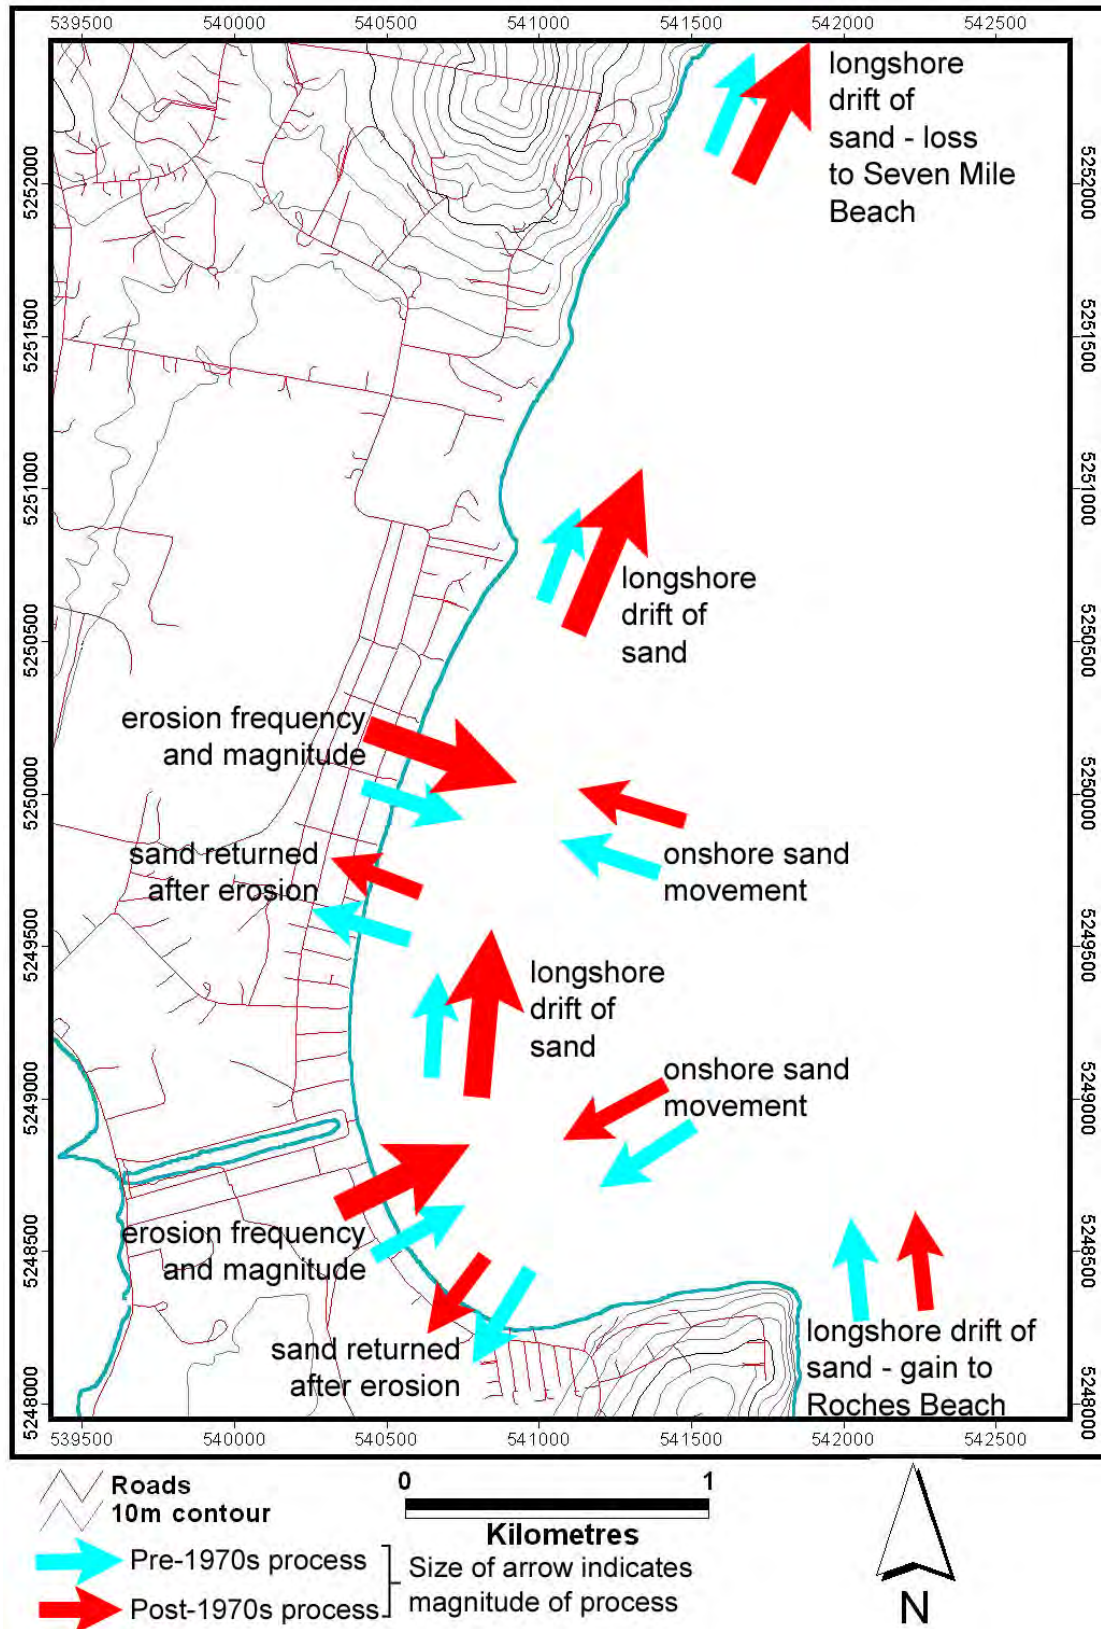
Figure 25: Diagrammatic summary of interpreted process changes at Roches Beach pre- and post-1970s. Increased erosion frequency and magnitude resulting from sea-level rise has from the 1970's onwards led to increased northwards longshore sand drift. Without counterbalancing increases in longshore sand gain from the south and onshore sand movement, the result has been a net progressive shoreline recession. The map grid is the MGA (Zone 55) grid (GDA94 datum).

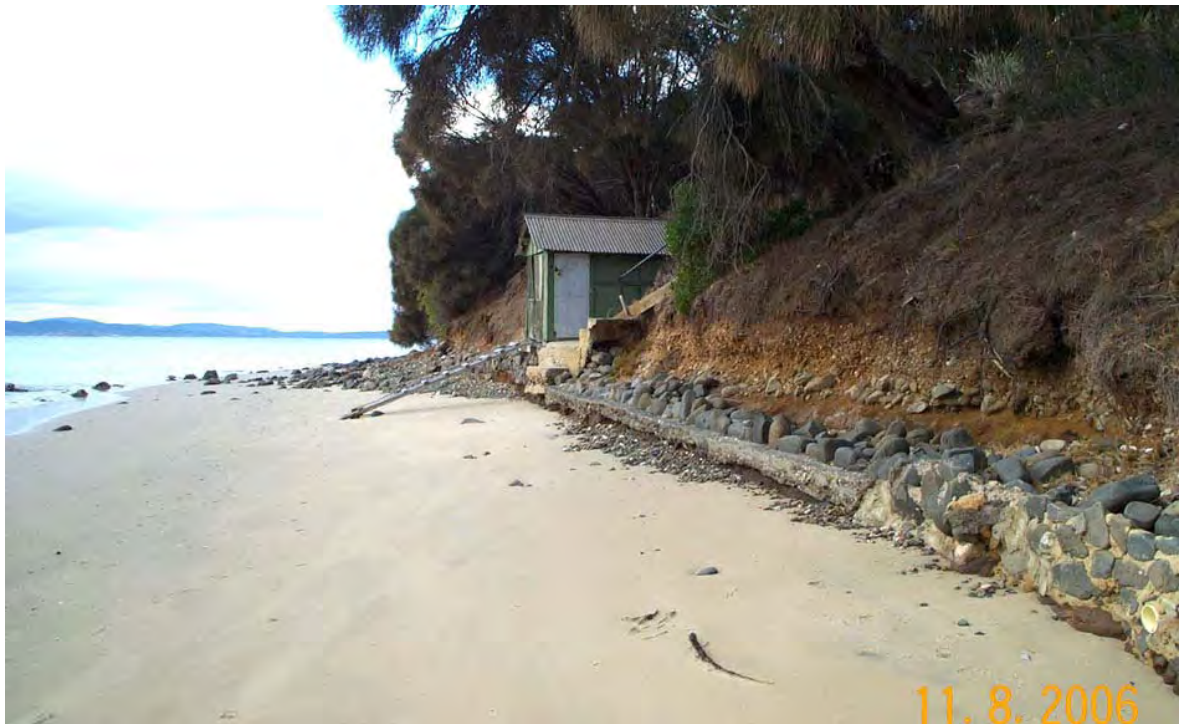
Figure 27: Photo RB2006_6 (Viewpoint 5). An old erosion scarp is evident in places behind this southern part of Roches Beach, eroded into (partly) colluvial soil over weathered bedrock. The artificial wall seen here is evidently ineffective in stopping erosion, however only a small amount of net erosion has occurred here over the last 50 years, insufficient to be detectable as net recession on air photos.

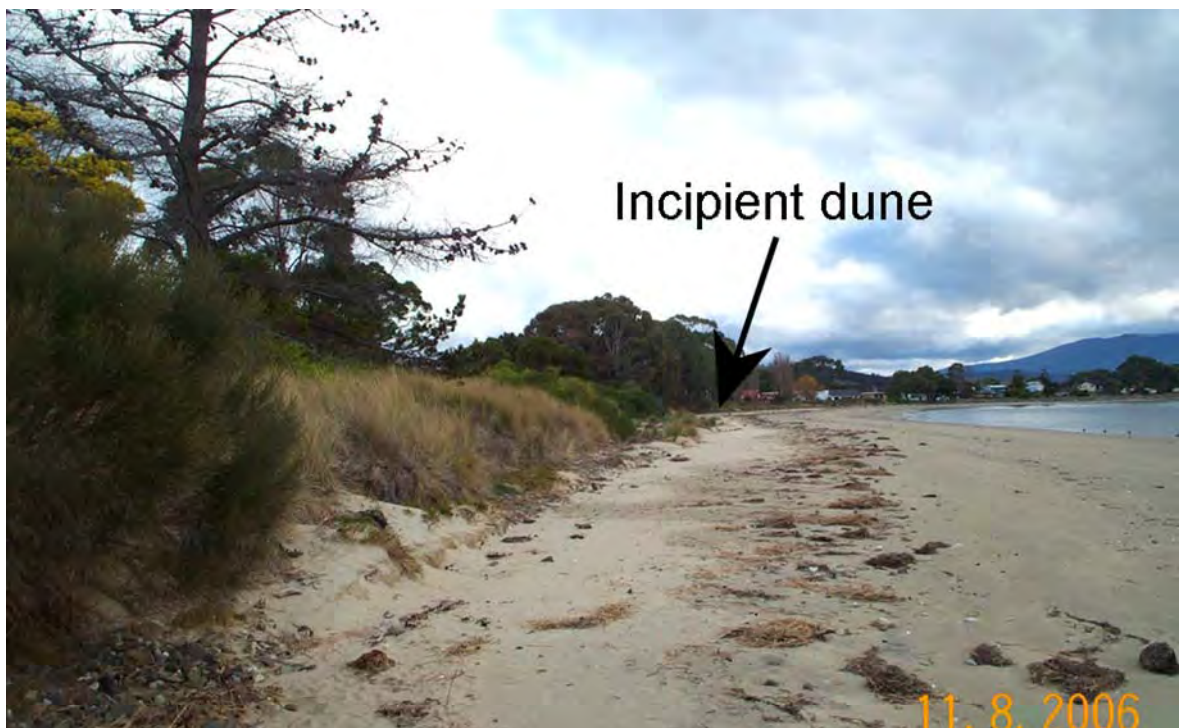
Figure 28: Photo RB2006_8 (Viewpoint 7). The shoreline in this short section of southern Roches Beach has accreted in recent times, as indicated by the small incipient dune present in front of the larger established foredune on this part of the beach; however this section of the shore has shown no detectable net change between 1957 and 2005. Only a few southern and northern sections of Roches Beach show evidence of sand accretion at the present.

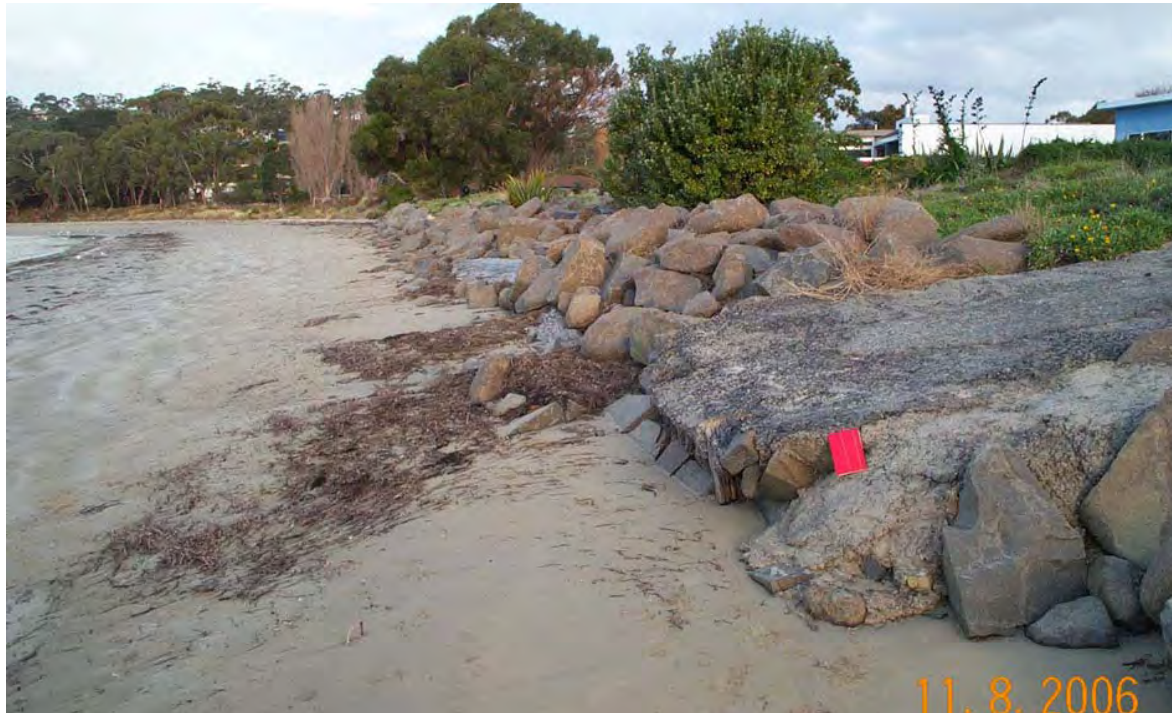
Figure 29: Photo RB2006_20 (Viewpoint 13). This view shows a concrete boat ramp in the boulder wall along part of the southern area of Roches Beach. Lowering of the beach surface below the lip of the ramp is probably a result of recent stormy conditions. The surface will probably grow (accrete) upwards during long calm weather periods, however it is likely that some degree of net lowering of the beach surface has occurred since the boulder wall was constructed in 1988, due to increased wave reflection off the hard wall. Red notebook is 180mm high.

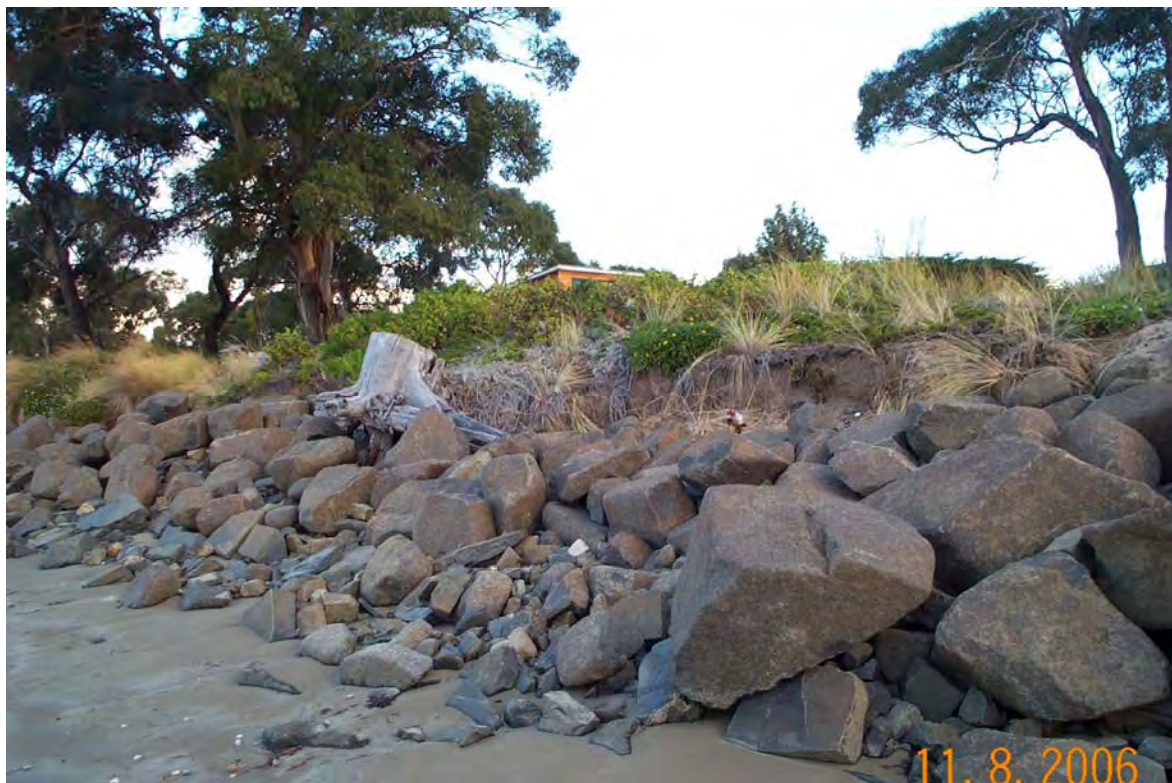
Figure 30: Photo RB2006_26 (Viewpoint 16). This view of the boulder wall (revetment) shows foredune erosion above and behind a section of the wall, indicating that storm waves have begun to overtop and erode behind the boulder wall in this area.

coastal erosion damage. This wall has largely prevented erosion of the foredune front since 1988, however the unprotected dune front adjacent the northern end of the boulder walls had by 2006 receded about 5 metres inland of the boulder wall (see Figure 31), and some wave erosion of the dune front behind other parts of the boulder wall was by then evident, as a result of storm wave run-up over-topping the boulders (Figure 30).

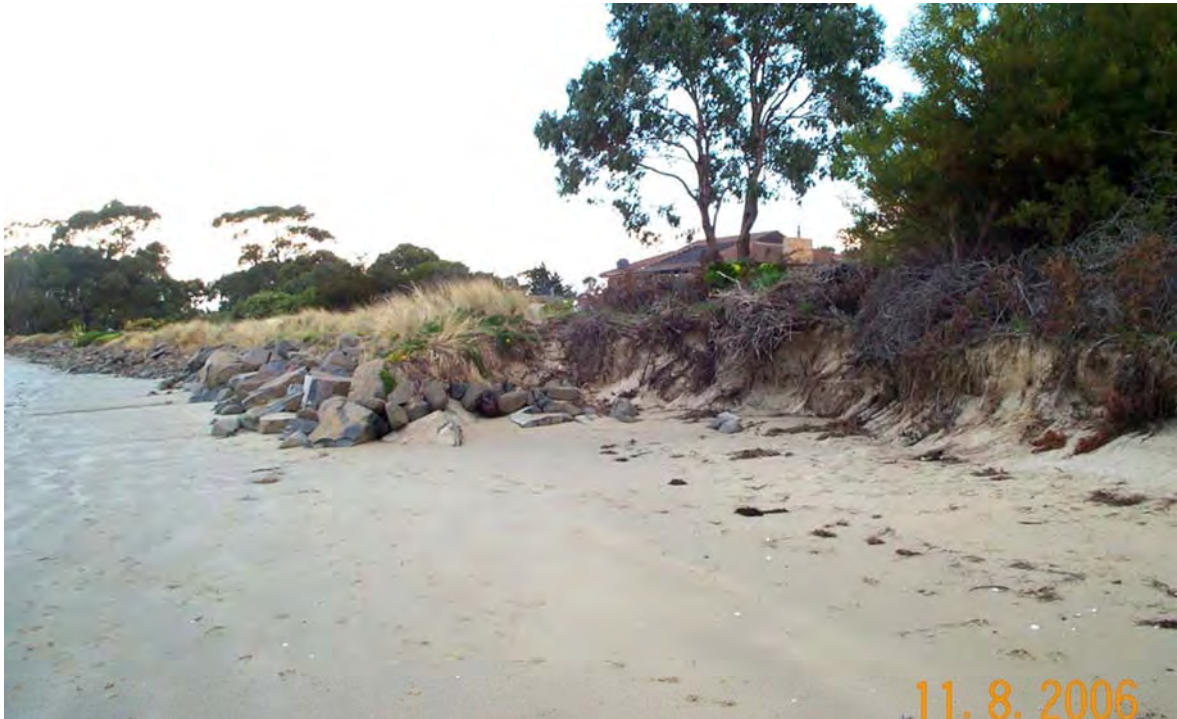
Figure 31: Photo RB2006_28 (Viewpoint 17). View southwards from the northern end of the boulder wall along part of the southern area of Roches Beach. This photo shows a shoreline (dune – front) net recession of about 5 metres at this point since the boulder wall was constructed during 1988.

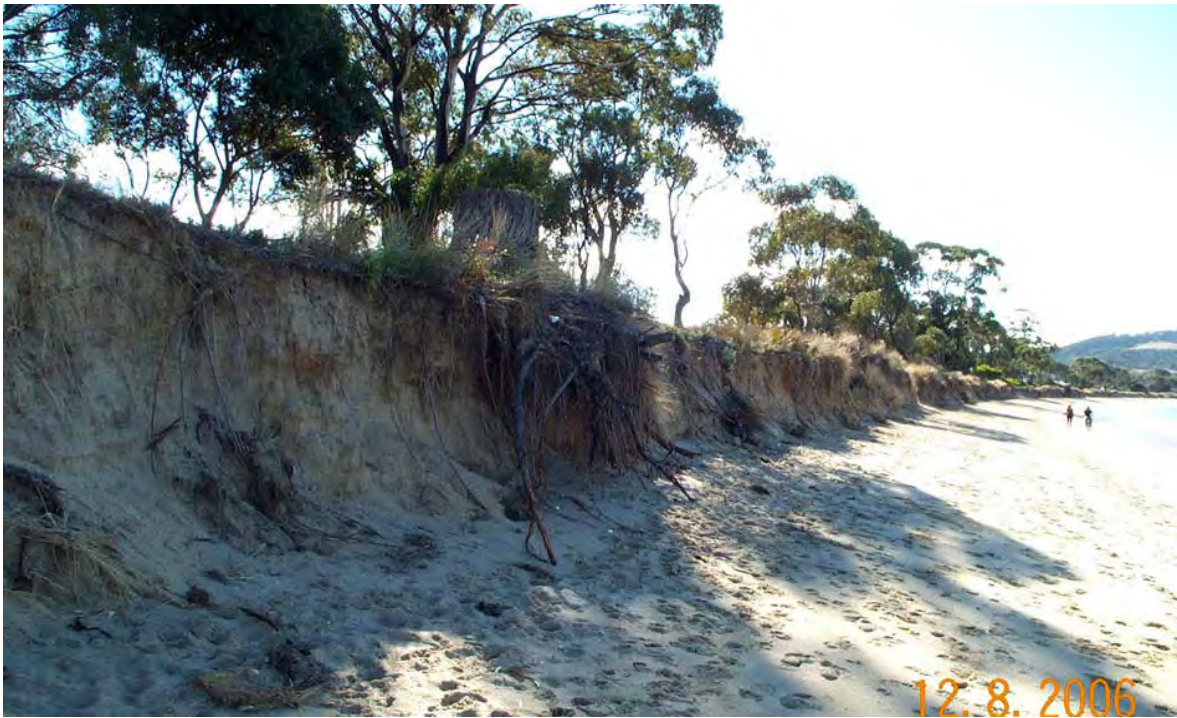
Figure 32: Photo RB2006_49 (Viewpoint 26). View north along Roches Beach erosion scarp, several hundred metres north of the canal. The sawn stump of a large eucalypt tree whose roots became exposed by erosion in the period 2001 – 2006 is visible. This view is in the area referred to as recession zone RZ3 in this report.

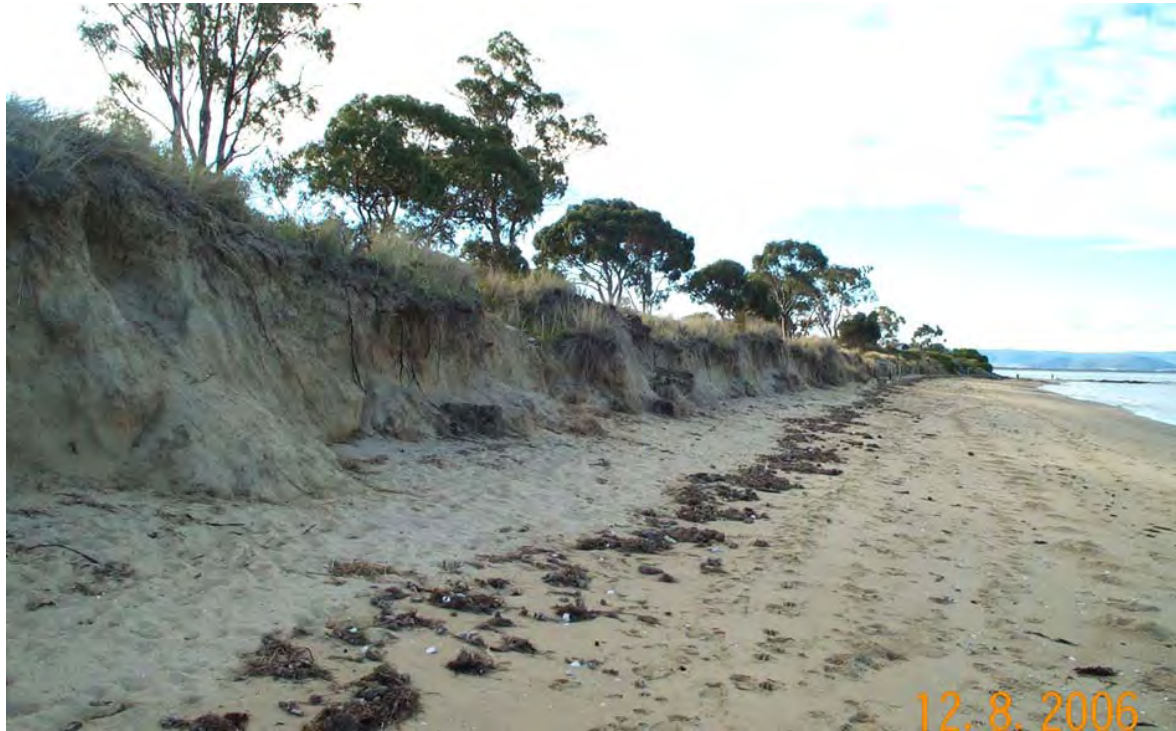
Figure 33: Photo RB2006_71 (viewpoint 37). View north along the large active erosion scarp in the northerly part of Roches beach. This view looks along the area referred to as recession zone RZ5 in this report.

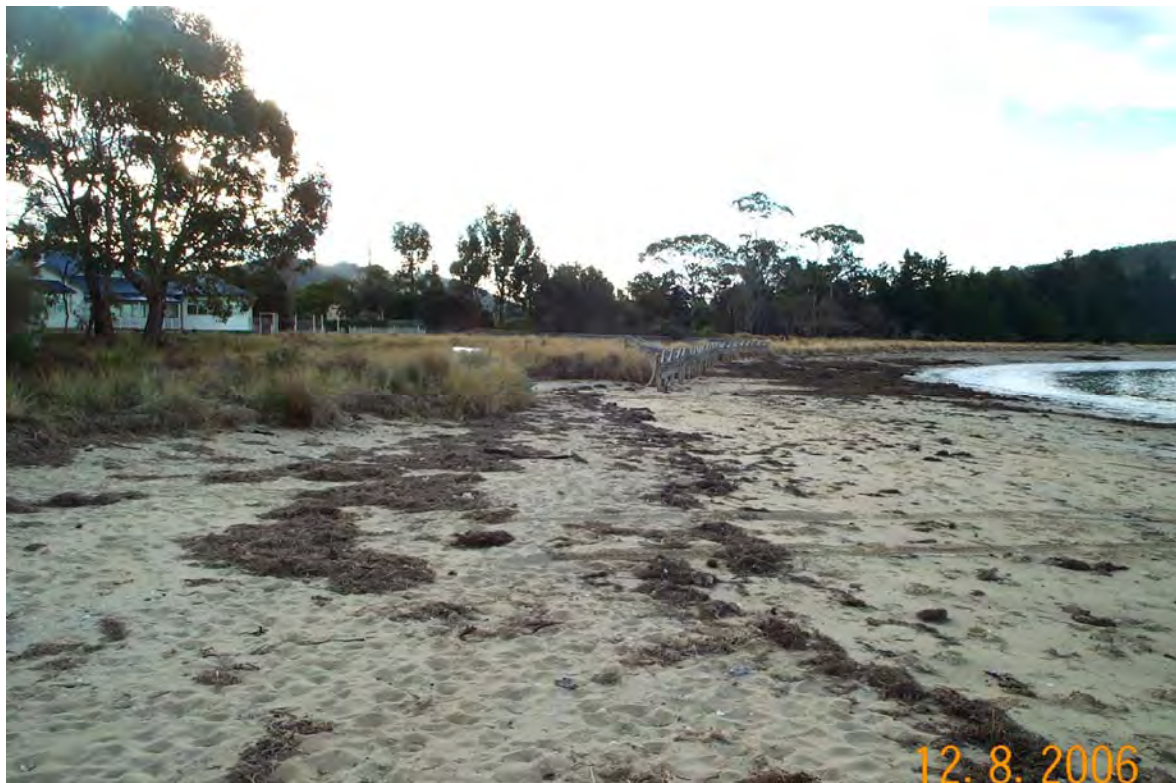
Figure 34: Photo RB2006_81 (viewpoint 42). View north showing Accretion Zone AZ1, immediately north of the small rocky point (Bambra Reef) at the north end of the main part of Roches Beach. This is one area where net detectable shoreline accretion has occurred at Roches Beach between 1957 and 2005. It is unlikely that the visible fence has been a major factor in the accretion, which is probably due to the location of this area on the down-drift (north) side of Bambra Reef.

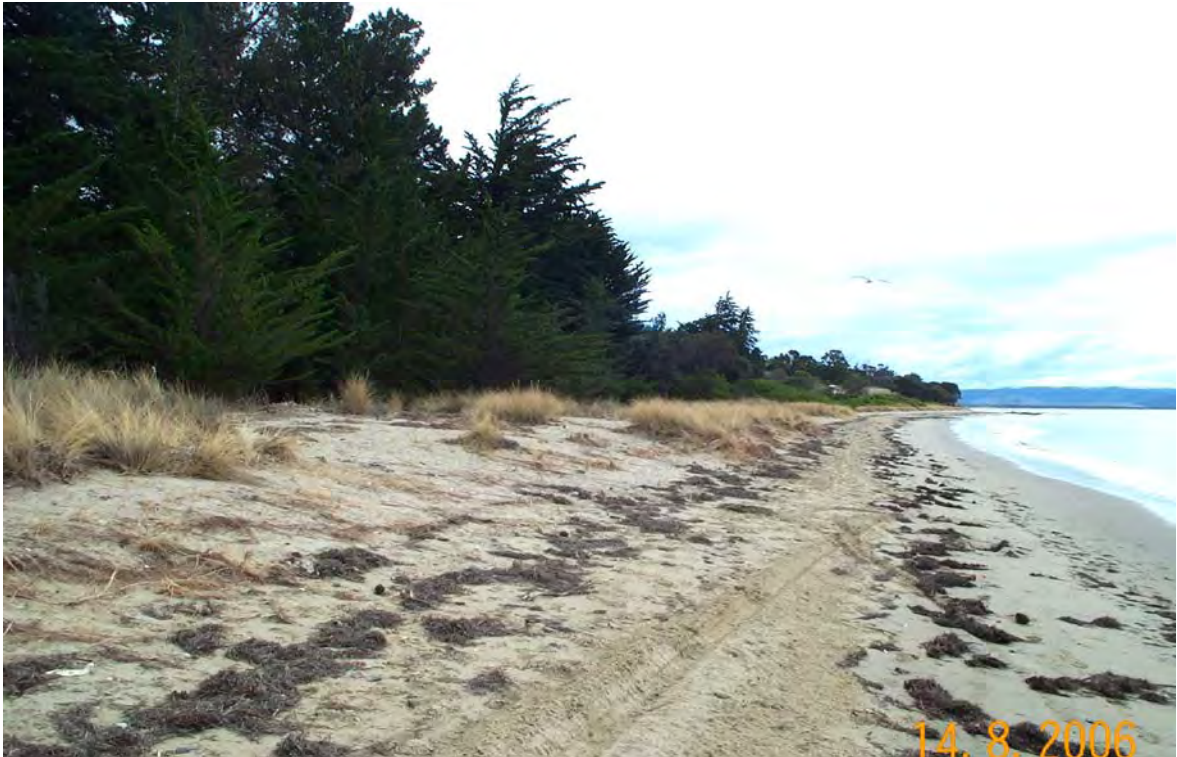
Figure 35: Photo RB2006_86 (viewpoint 44). View north showing part of Accretion Zone AZ2 with low incipient foredune development. This is an area where net detectable shoreline accretion has occurred at Roches Beach between 1957 and 2005.
