Shoreline Change at Roches
Beach, South-Eastern Tasmania
1957-2010

Prepared by: Chris Sharples, School of Geography and Environmental
Studies, University of Tasmania August 2010

Shoreline Change at Roches Beach, South-Eastern Tasmania, 1957 - 2010

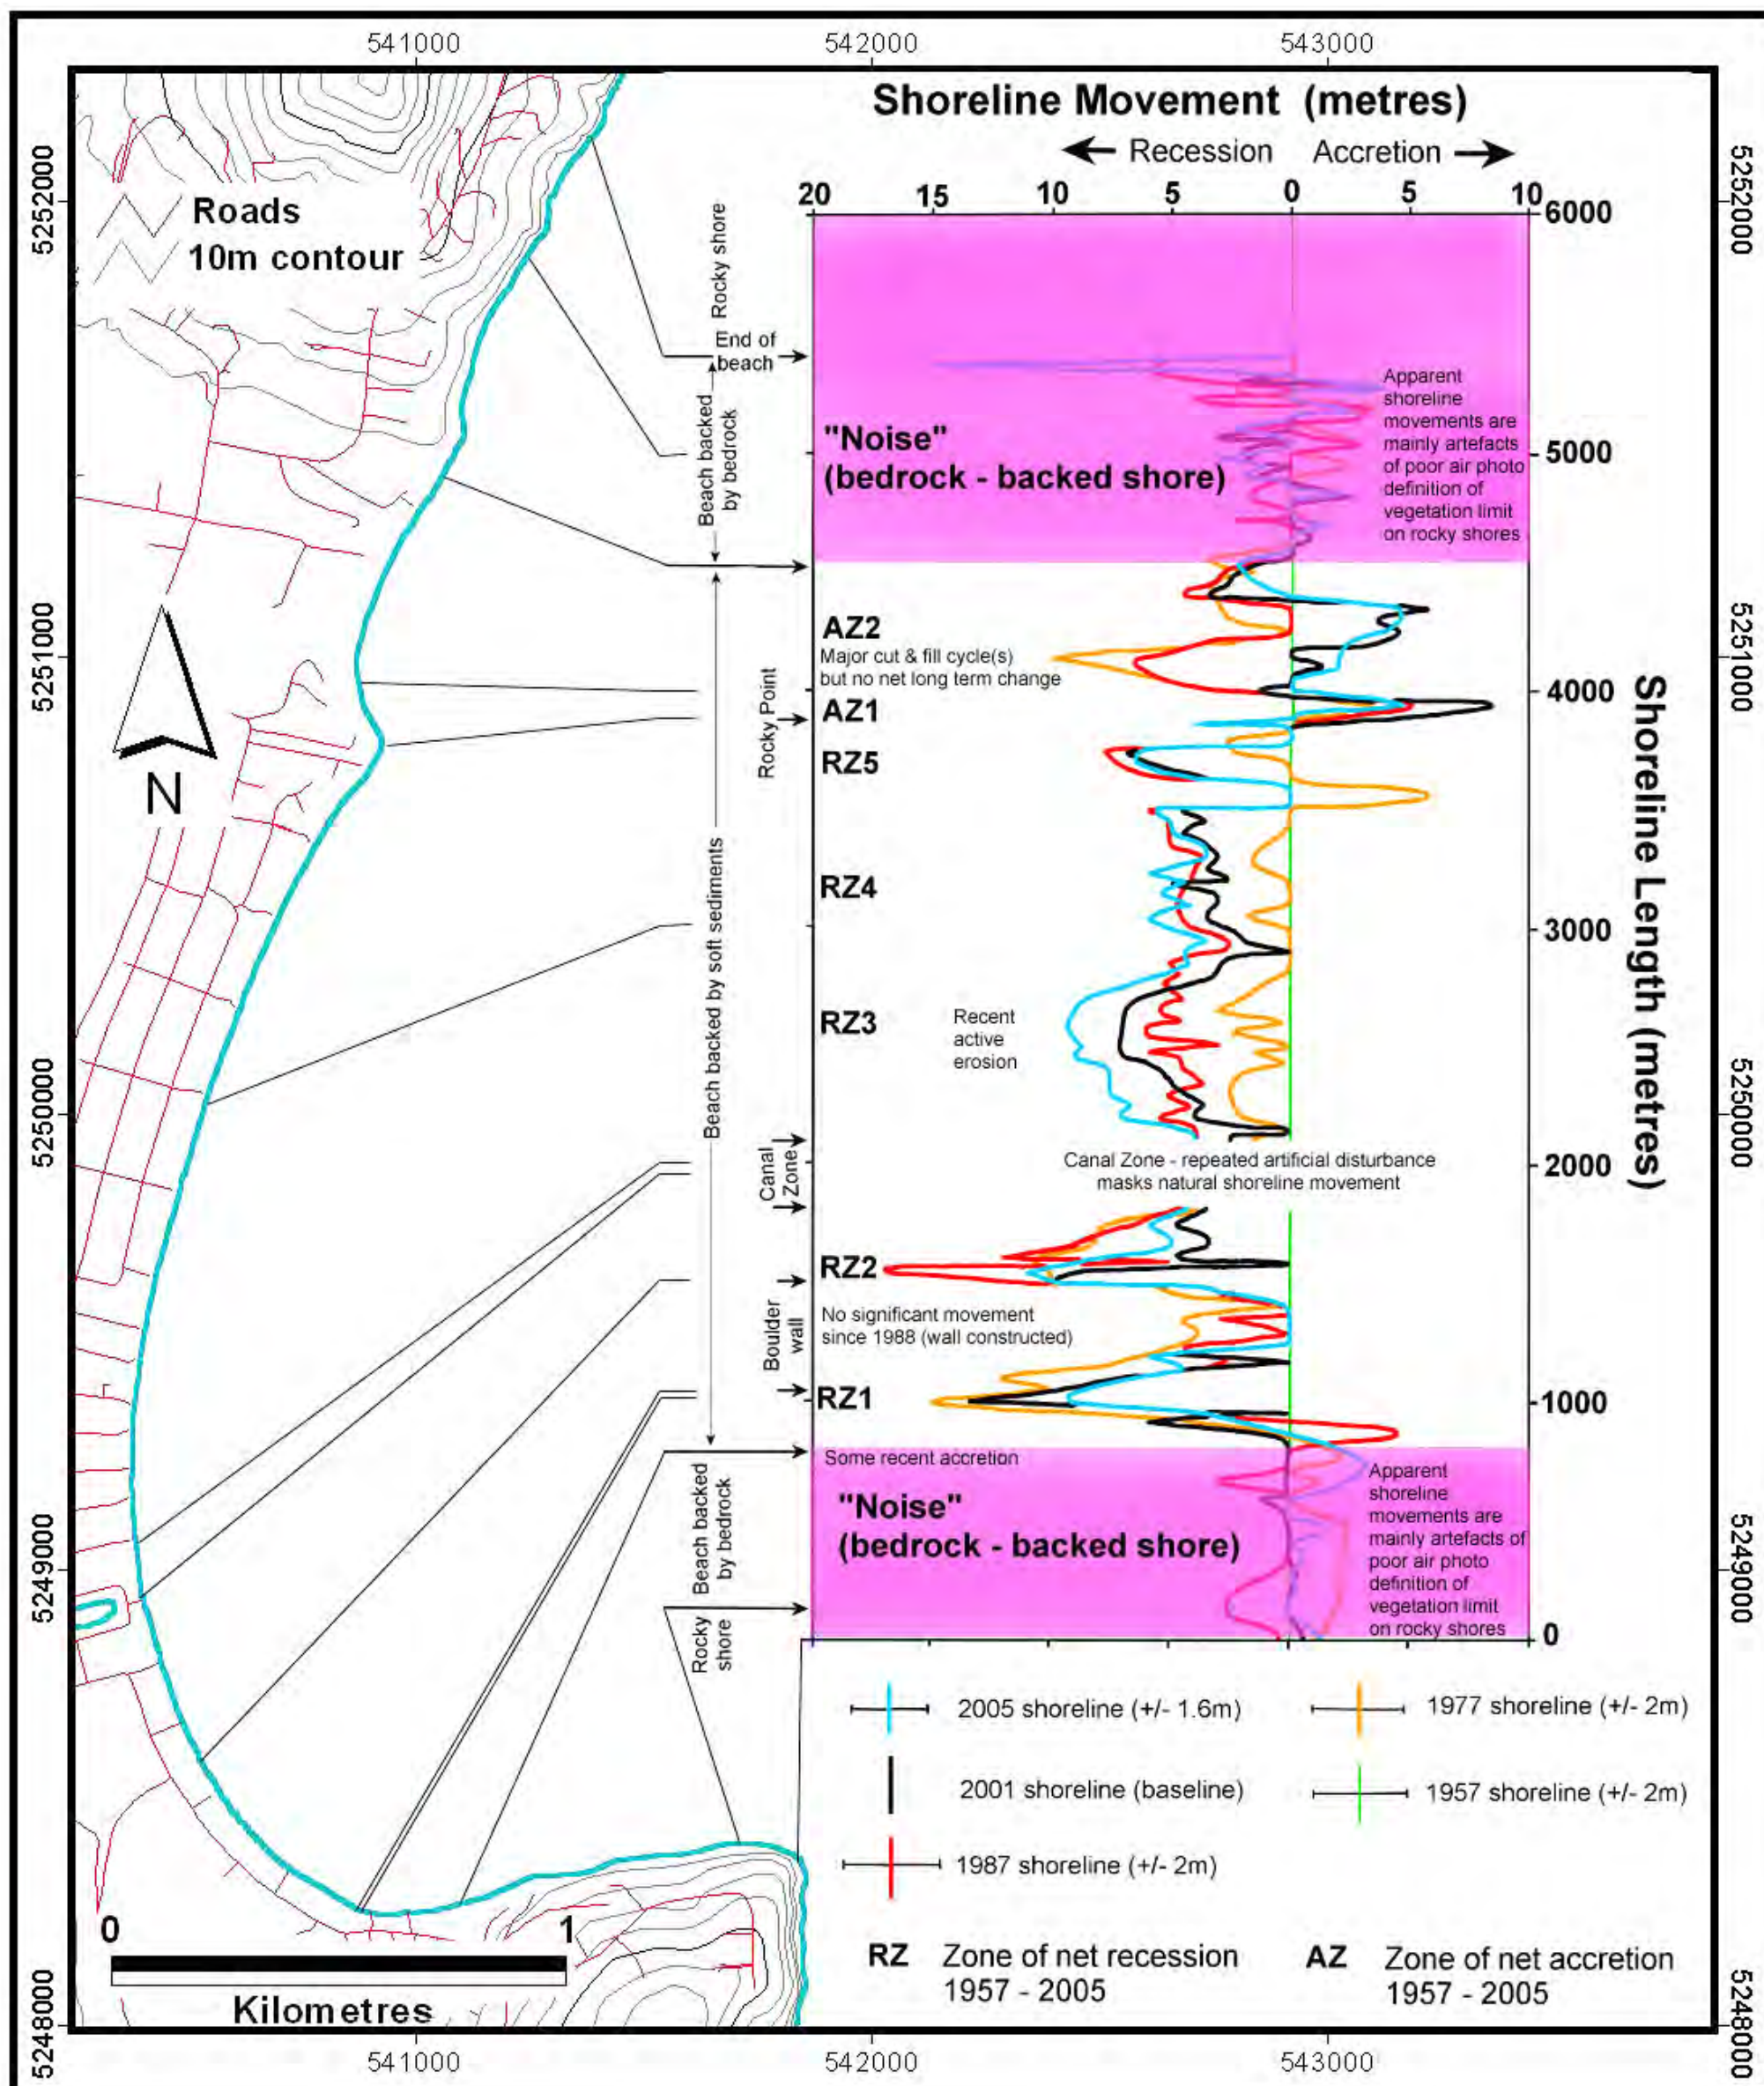
Figure 37: Shoreline Movement at Roches Beach from 1957 – 2005: Summary Chart. This chart depicts *apparent* shoreline positions along Roches Beach at 5 epochs from 1957 to 2005, which have been determined as described in report Section (4.0). For ease of comparison, the 1957 shoreline is depicted as a straight line, with later shoreline positions measured relative to the 1957 position. The coloured lines represent the *apparent* shoreline positions at each epoch; however these are not the minimum *detectable* shoreline change positions, which would be represented by the separation between shoreline position error envelopes. See also Figure 19, which depicts the minimum detectable shoreline position changes along Roches Beach between 1957 – 2005, and which is based on the separation between the error envelopes. Error envelopes for each shoreline position are represented on this figure by bars on the figure key. Nonetheless, the *apparent* shoreline positions depicted here represent the centre of the position error envelopes, and therefore represent the most *likely* shoreline positions at each epoch. The shaded portions of the shoreline movement graph are those areas in which sandy beach is backed by bedrock; in those areas shoreline position could not be reliably determined by the method used in this project due to poor definition of the vegetation limit on air photos in areas of dark-toned bedrock and bedrock-derived soil backshores. The map grid is the MGA (Zone 55) grid (GDA94 datum). Note that the scale of the "Shoreline Length" axis on the graph is not the same scale as the map. This is an enlarged version of text Figure 18.
