Sea ice reports for the season 2013-2014

Prepared by: Dr Jan L Lieser (Jan.Lieser@acecrc.org.au), Dr Robert A Massom (Rob.Massom@acecrc.org.au), Dr Petra Heil (Petra.Heil@acecrc.org.au), Antarctic Climate and Ecosystems Cooperative Research Centre, April 2014

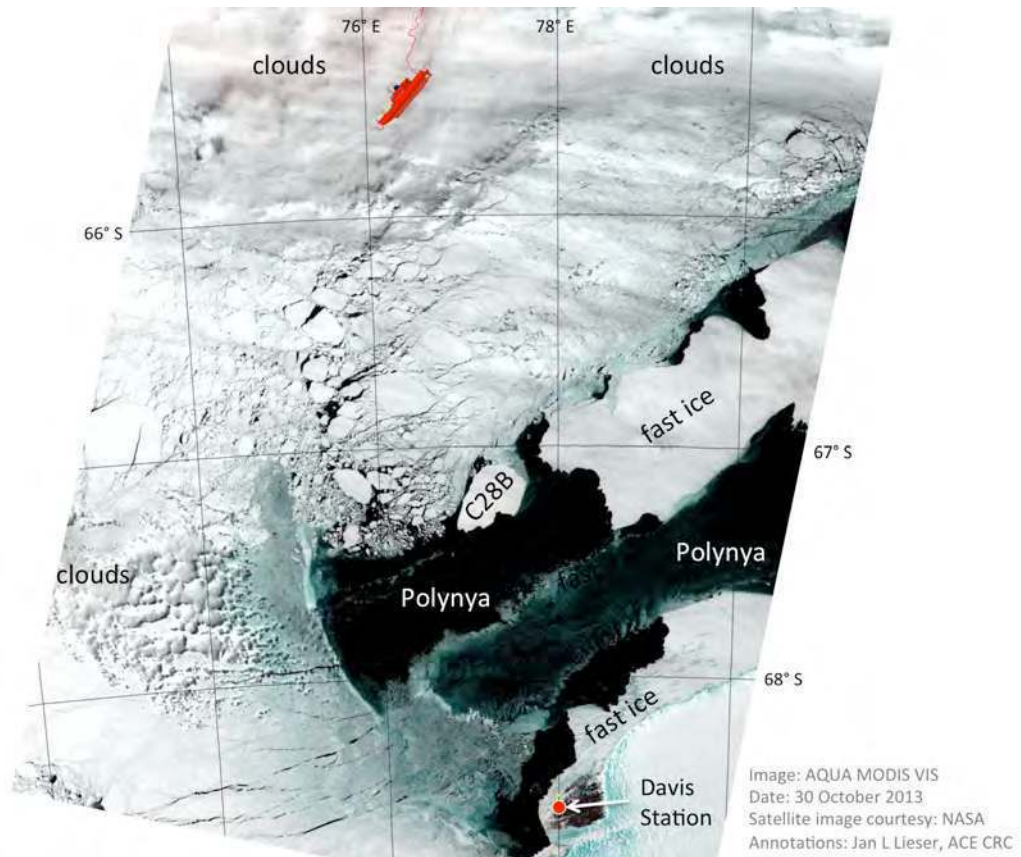
Figure 1: MODIS image, acquired 30/10/2013 and provided by NASA.

To the north of Davis Station between 74° E and 80° E, and 65° S and 68° S (Figure 1), sea ice conditions show an easing trend over the last two days. The general drift rate of the pack ice is about 5-6 nautical miles per day in westerly directions, with cracks and leads widening, notably around 76° E. But large floes appear still to be touching at pinch points. The polynya, as marked in Figure 1, is currently back-filling with new ice under calm conditions. Iceberg C28B, a former piece of the Mertz Glacier Tongue, is at the northern edge of the polynya almost due north of Davis Station, at the moment.

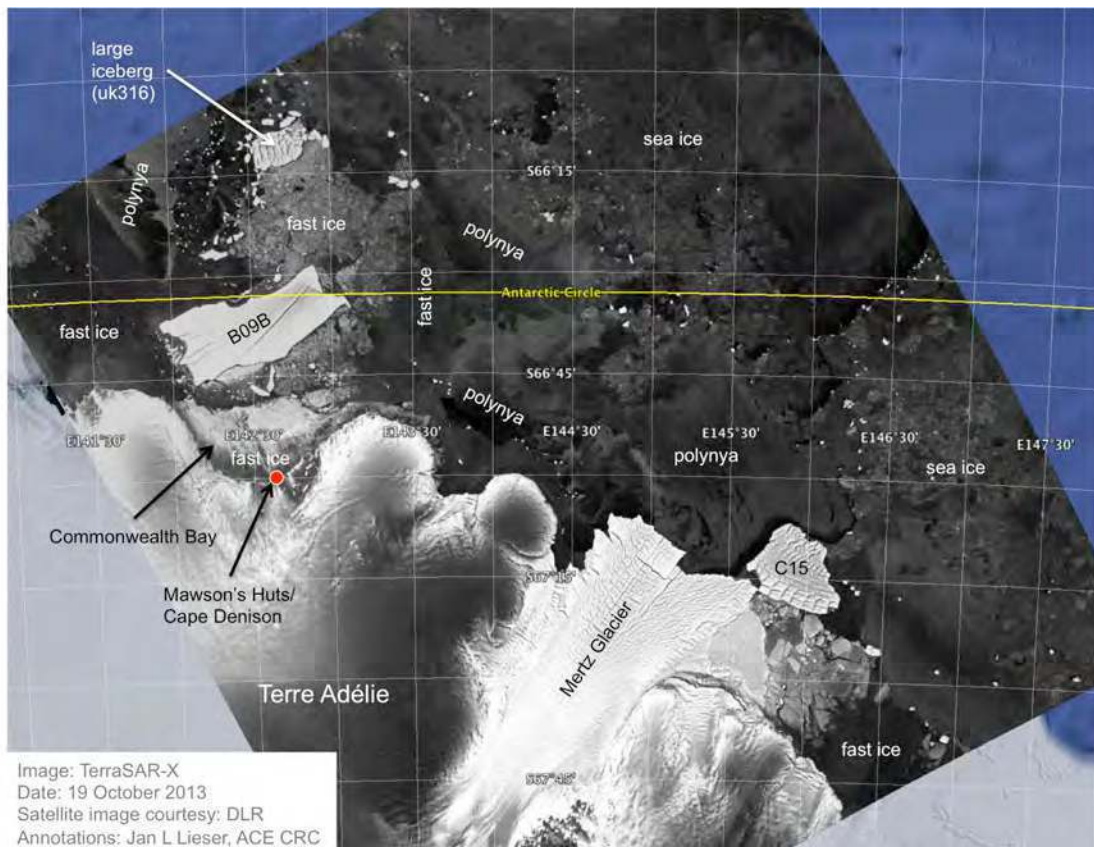
Figure 2: TerraSAR-X image, acquired 19/10/2013 and provided by DLR.

Figure 2 shows a synthetic aperture radar image of the Commonwealth Bay/Mertz Glacier region. This detailed, high resolution image provides an excellent impression of the sea ice surface conditions in the area. The bay is clearly filled with multi-year fast ice, where the near-coastal part is polished by offshore winds in preferential south to north direction, and the outer part exhibits more roughness with a medium-sized iceberg trapped in the central part of the bay.

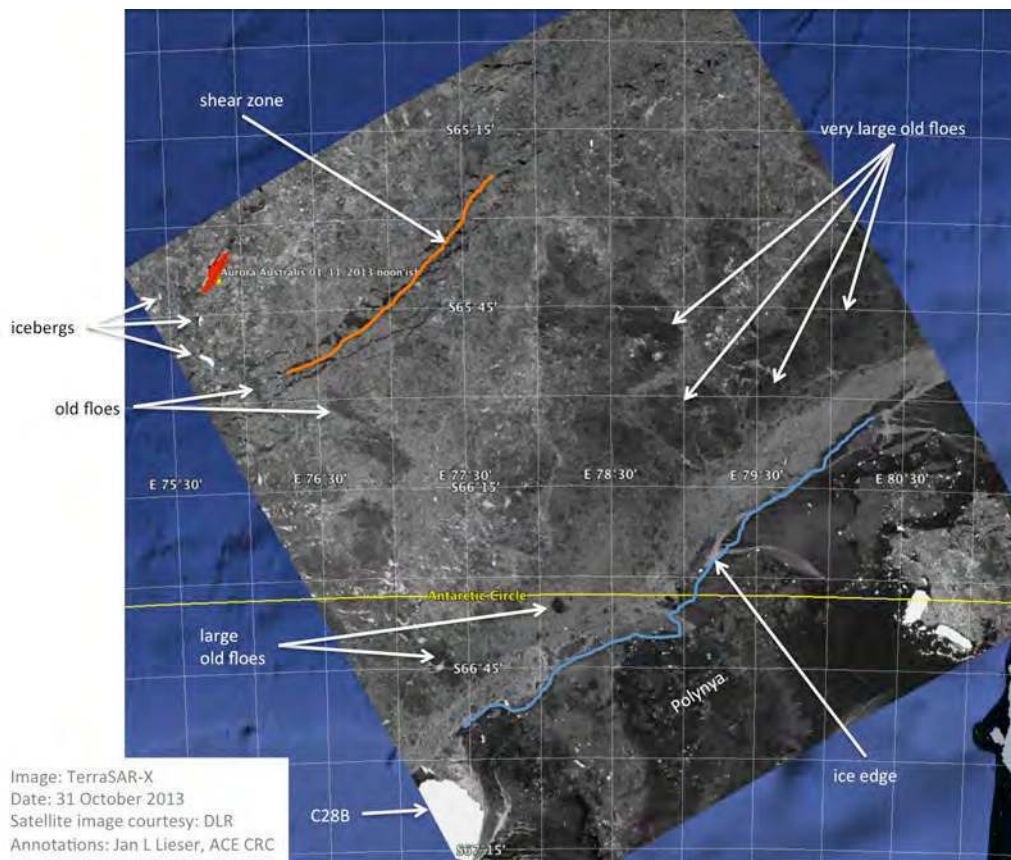
Figure 1: TerraSAR-X image, acquired 31/10/2013 and provided by DLR.

Overall, the region is covered by high concentration sea ice of various types, but the presence of cracks and leads (dark, string-like features showing up in the RADAR scene) indicates divergent drift conditions.

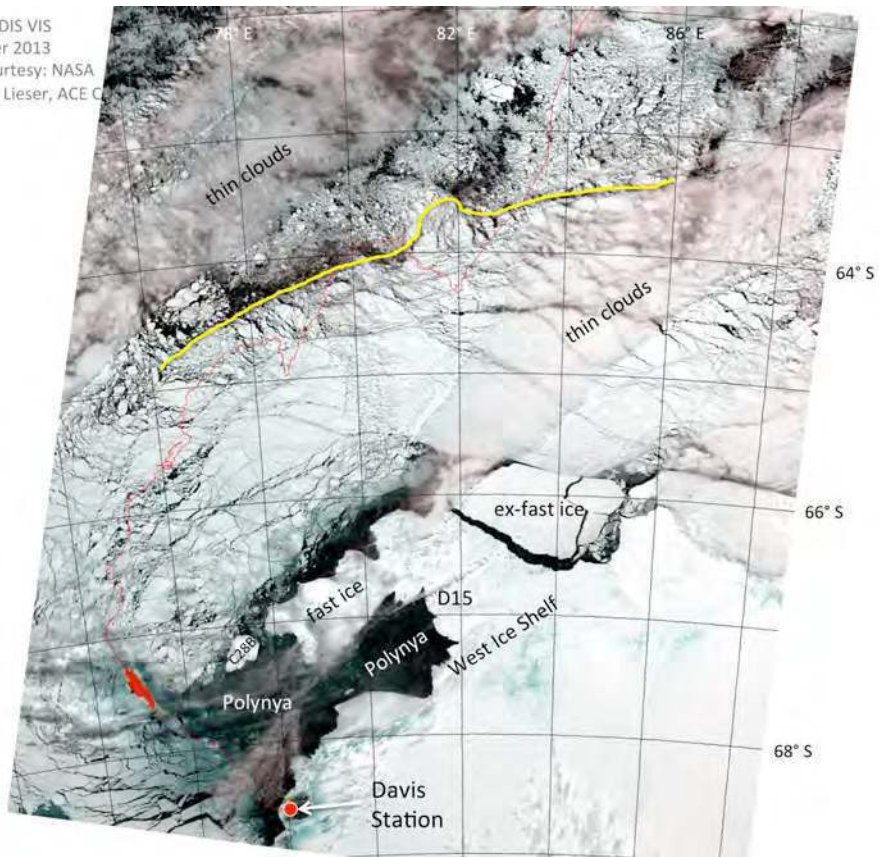
Figure 1: MODIS image, acquired 06/11/2013 and provided by NASA.

During the past few days, the general drift of the pack ice was in northerly directions, in the region. The current easing of conditions has opened further cracks and leads with various orientations, but some very large and potentially strong floes still survive in the band of high concentration sea ice mentioned above.

The area marked as 'ex-fast ice' in Figure 1 refers to the same region as marked in Figure 1 of Sea Ice Report #13/2013. The maximum gap between this slab of ex-land fast sea ice and the West Ice Shelf was about 8 nm on 08/11/2013. Fortyeight hours later, this gap had closed and the slab of had moved back into the place where it was land fast before. At the same time it appears to have shattered into many small floes, likely due to mechanical failure. This reflects the potential force driving this drift in the region.

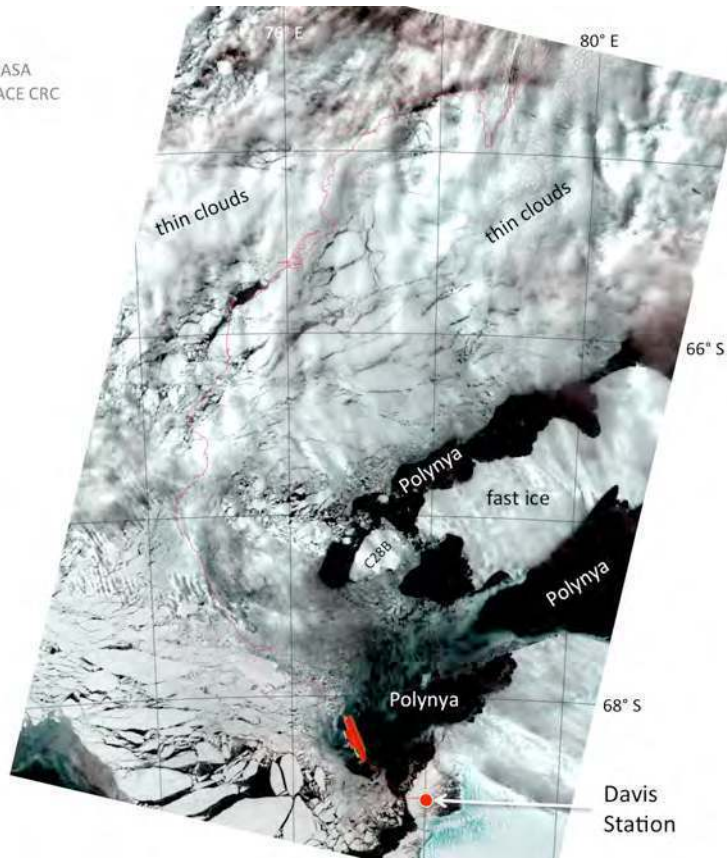
Figure 1: MODIS image, acquired 10/11/2013 and provided by NASA.

Between the station and iceberg C28B, the polynya is slowly back filling with new sea ice. Northwest of the berg, the sea ice appears loose with widening gaps at about 67° S and 76° 30' E. To the north and west from this location are still some very large sea ice floes with only narrow leads, even though those are widening slightly as well. The general sea ice drift in the region is about 6 nm per day in westerly directions for those very large floes. Further north beyond 66° S, leads are very wide but between some floes there appear pinch points around some edges. North of about 64° 30' S, the sea ice is quite broken up and floes are scattered.

Beyond the northeastern corner of the polynya to the north of the fast ice as marked in Figure 1 and iceberg D15 (not marked in the figure; see Sea Ice Report #13/2013 for reference), sea ice is densely packed for about 1.5 degrees of latitude with only very narrow cracks and openings. Also, a massive piece of fast ice that has broken away from the eastern side of iceberg D15, recently, and is currently centred at about 66° S and 83° 20' E (outside of the attached figure) and moving northward.

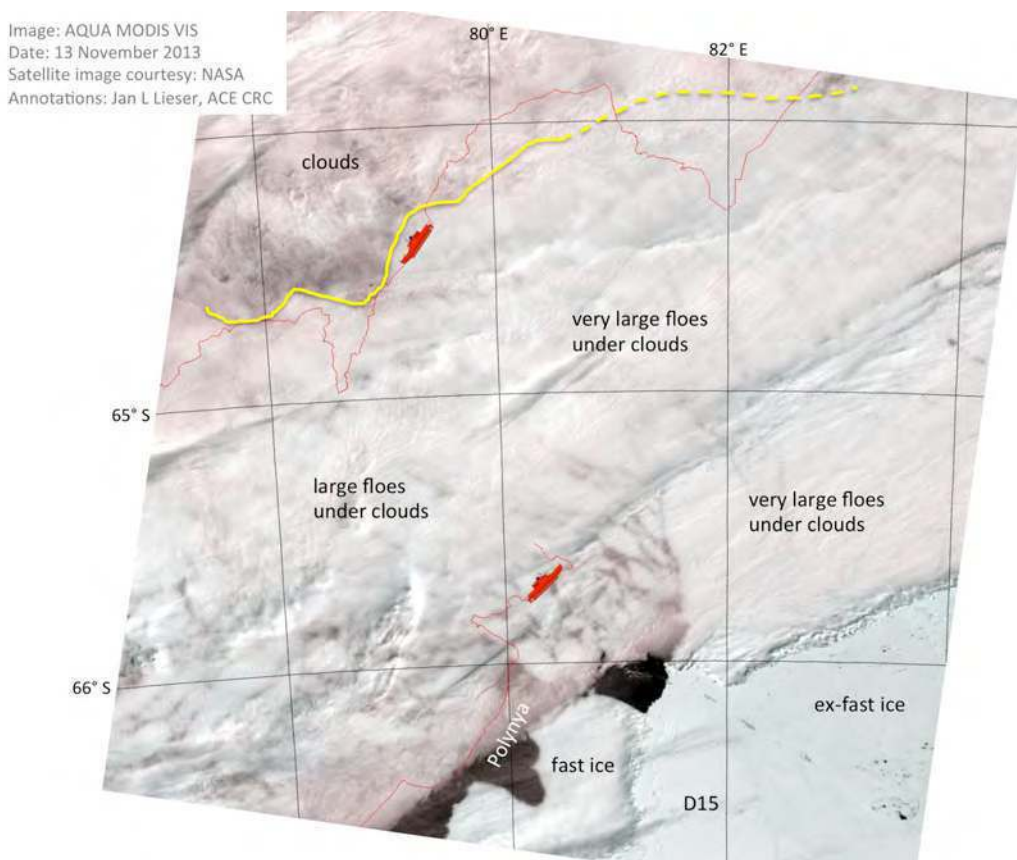
Figure 1: MODIS image, acquired 13/11/2013 and provided by NASA.

The sea ice drift in the vicinity of *Aurora Australis*' current position was about 8 nm in a southwesterly direction per day over the last three days. That part of the polynya has now filled with large floes. At the same time, a few cracks and leads opened in northwest-southeast direction. Further north at about 65° S and 81° E, and further east of the ship's current position, some very large floes can be detected through the cloud cover. There are also a few cracks shining through the clouds, however pinch points likely occur at floe edges.

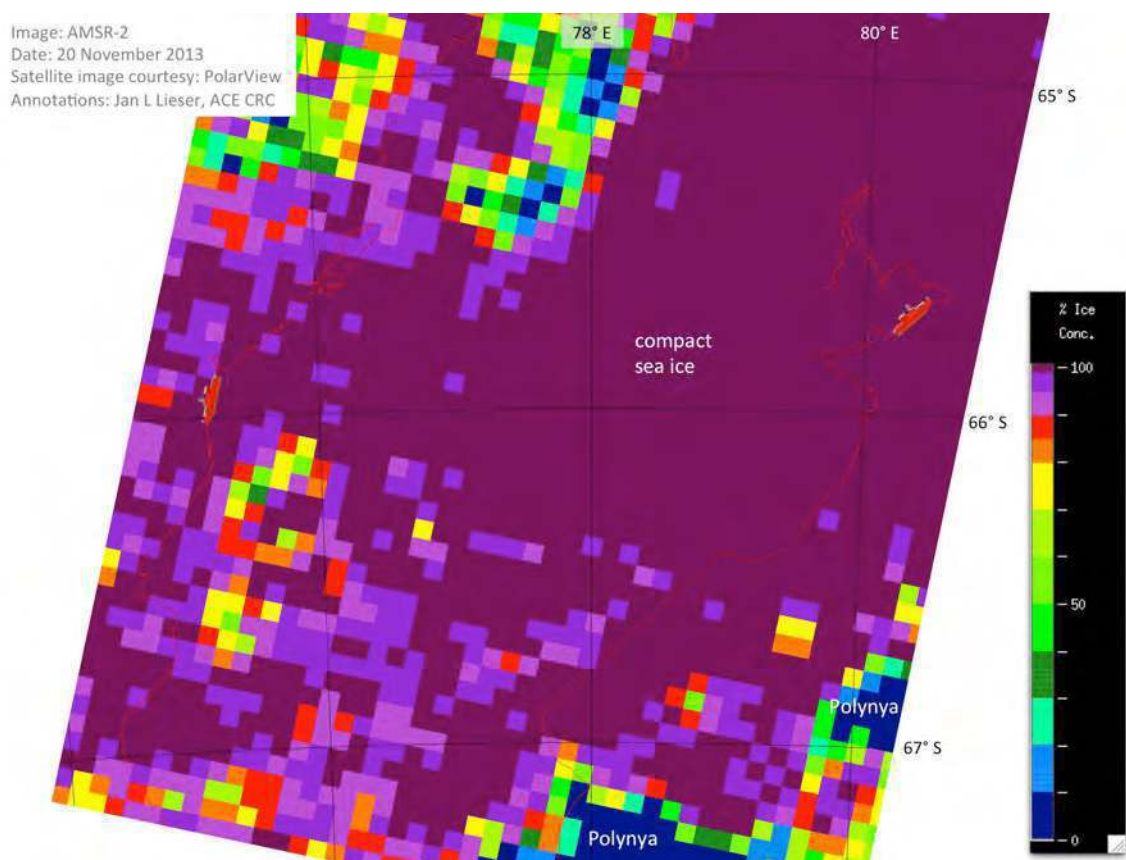
Figure 1: AMSR-2 image, acquired 20/11/2013 and provided by PolarView.

Over the past few days, sea ice concentration maps show a growing area of 100% sea ice concentration north of Davis Station (see Figure 1 and Sea Ice Report #14a/2013). Even though winds have only been light from the north recently, it was still enough to close most of the gaps between sea ice floes on the relatively coarse scale of the microwave data. However, visual imagery from *Aurora Australis*' web-cams indicates that the pack ice is currently under low stress (horizontal pressure), with small cracks still open around the ship.

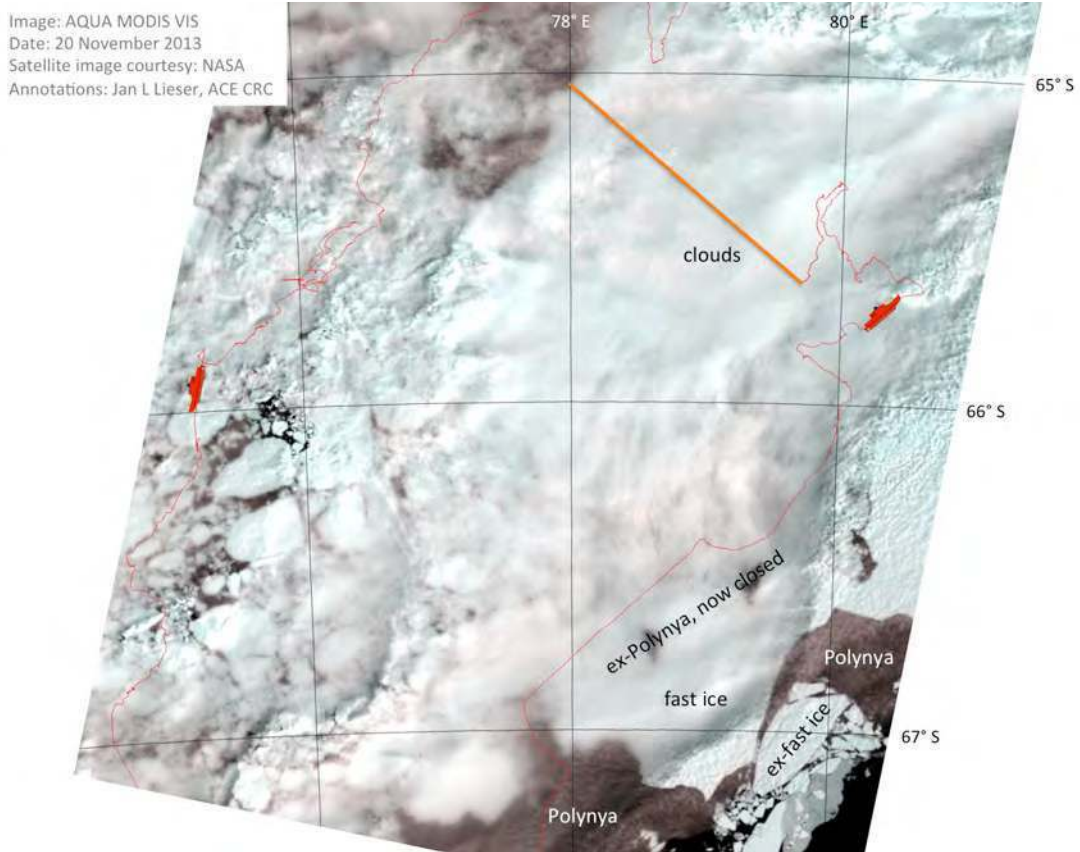
Figure 2: MODIS image, acquired 20/11/2013 and provided by NASA.

Between 76° E and 80° E (and beyond), the sea ice is much more consolidated and closed up. The polynya north of the fast ice northeast of Four Ladies Bank has closed almost completely, with only small pockets of thin ice remaining (this region is annotated 'ex-Polynya, now closed' in Figures 2 and 3). About two days ago, with the general southward drift and wind conditions, a large part of the above mentioned fast ice (which is still attached to the western side of iceberg D15) broke away and has changed the ice scape of the northeastern end of the polynya. It is annotated 'ex-fast ice' in Figures 2 and 3.

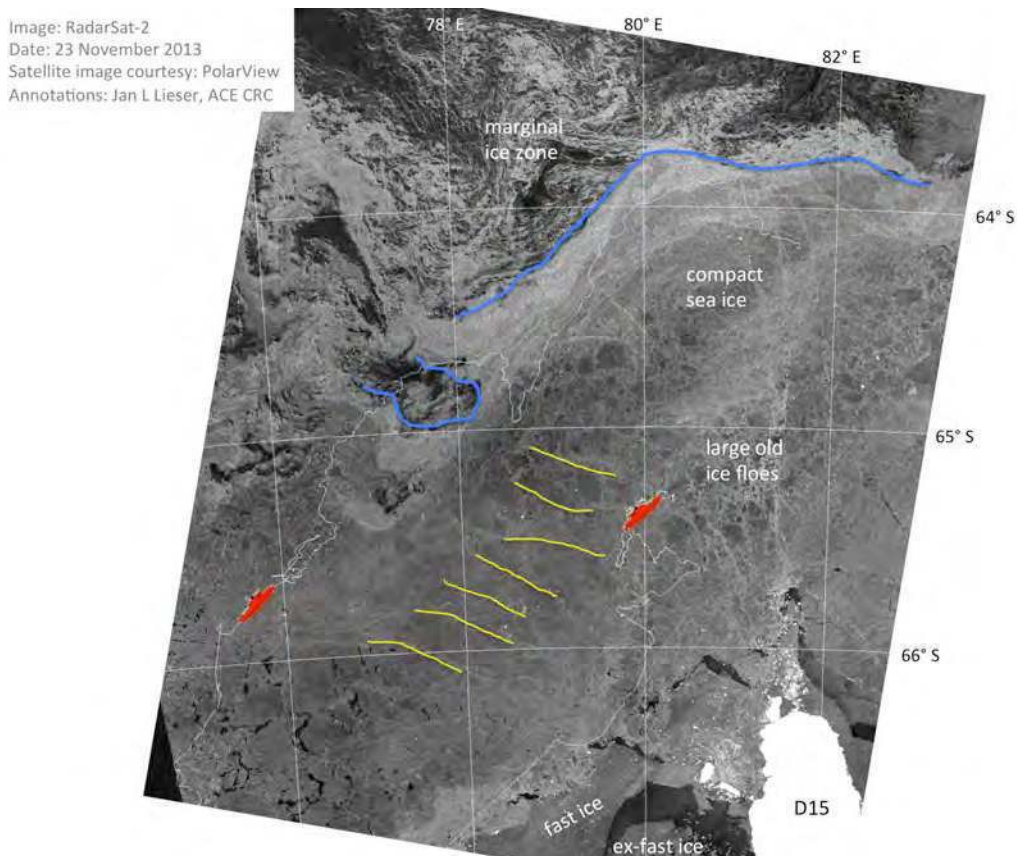
Figure 1: RadarSat-2 image, acquired 23/11/2013 and provided by PolarView.

Old cracks appear to the west of 80° E as long features of higher reflectivity (lighter grey), and are enhanced by yellow scribble lines in Figure 1.

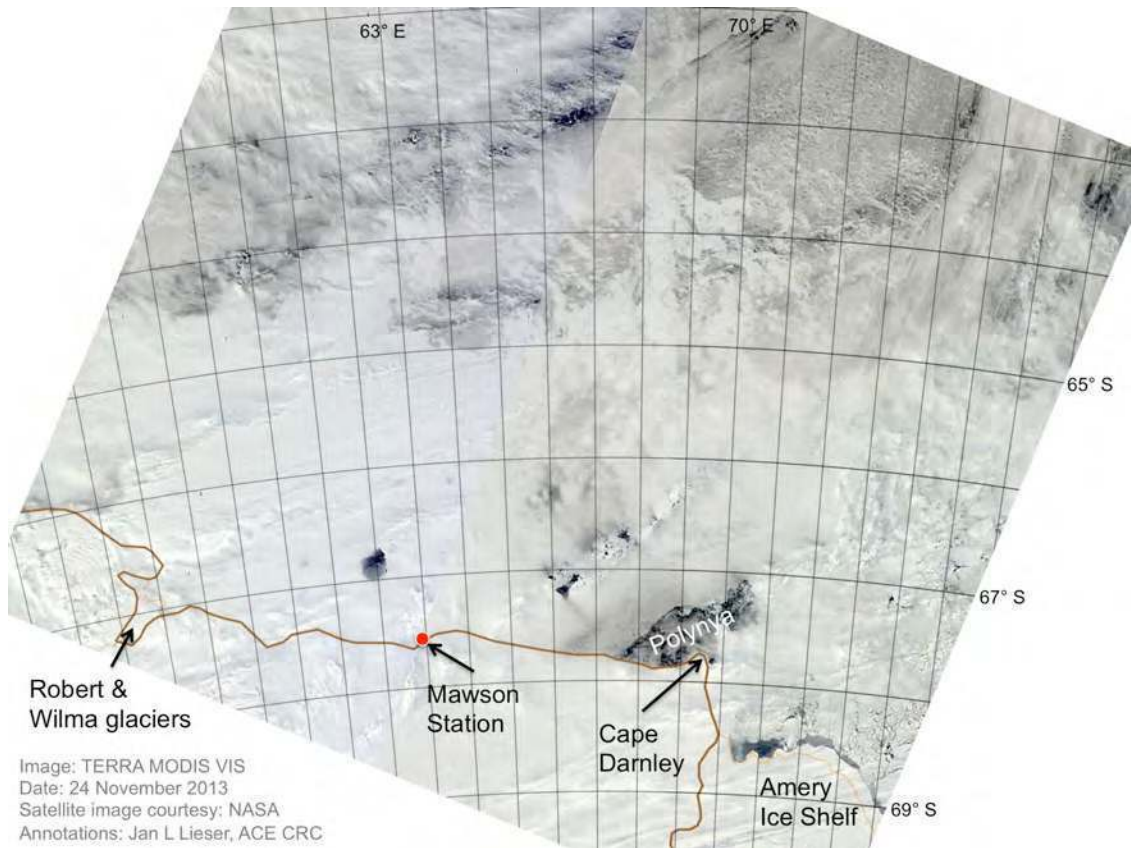
Figure 1: MODIS image, acquired 24/11/2013 and provided by NASA.

Figure 1 shows a moderate resolution (1 km pixel size) visible image of the sea ice zone off Mawson Station. It is the most recent image with only thin clouds, allowing a glimpse on the sea ice conditions. Since 24/11/2013, thicker cloud cover obscures the sea ice.

The sea ice edge is roughly located at about 62° S. Between two bands of slightly thicker clouds (marked in the figure), the sea ice appears loose with large patches of open water in between.

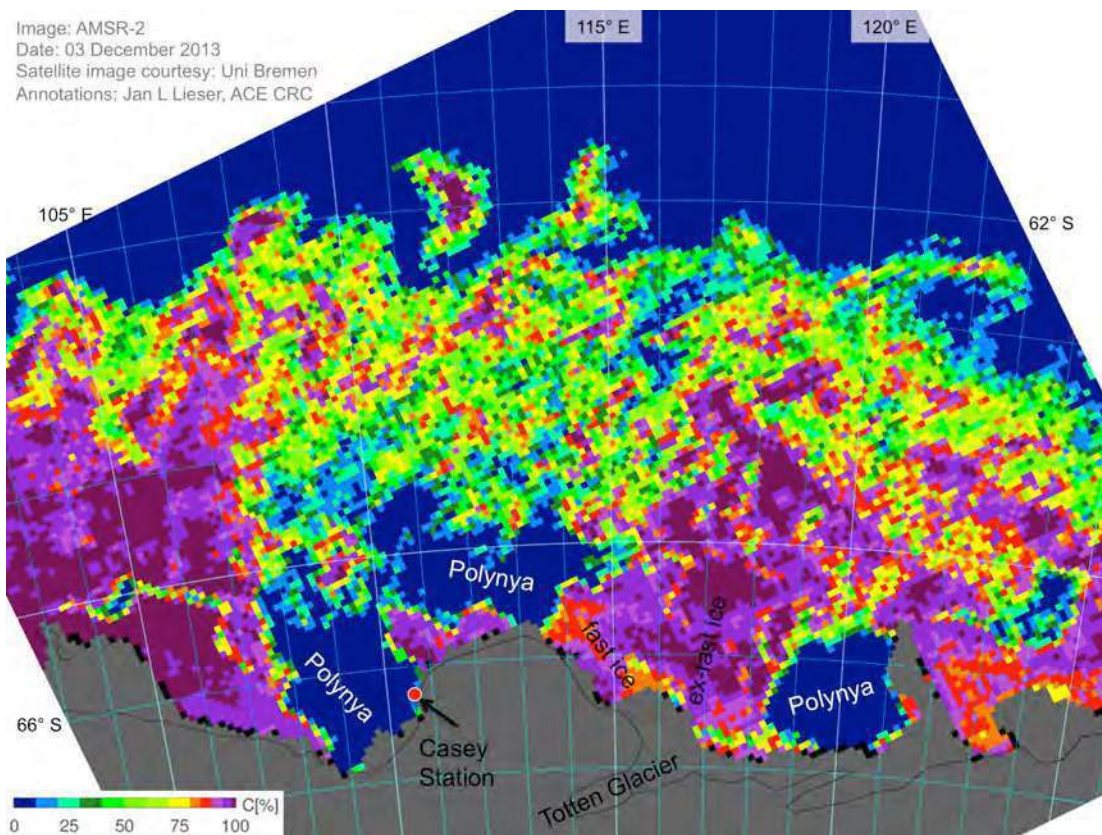
Figure 2: AMSR-2 image, acquired 03/12/2013 and provided by Universität Bremen.

Figures 1 and 2 show the same frame of sea ice conditions between approximately 105° E and 125° E, as seen by the high-resolution MODIS and the coarser resolution AMSR-2 instruments, respectively, on 03/12/2013.

Currently, fast ice remains largely intact between the coast and Petersen Bank (65° 47' S and 110° 47' E), and off the northeastern side of Law Dome (66° 44' S and 112° 50' E). At the face of Totten Glacier, a large area marked 'ex-fast ice' is broken into many pieces. This ex-fast ice had separated at some time between 18/10/13 and 20/10/13, and since then has been moved around inside the embayment, with only occasionally sea ice floes of various size escaping northward into the Antarctic coastal current.

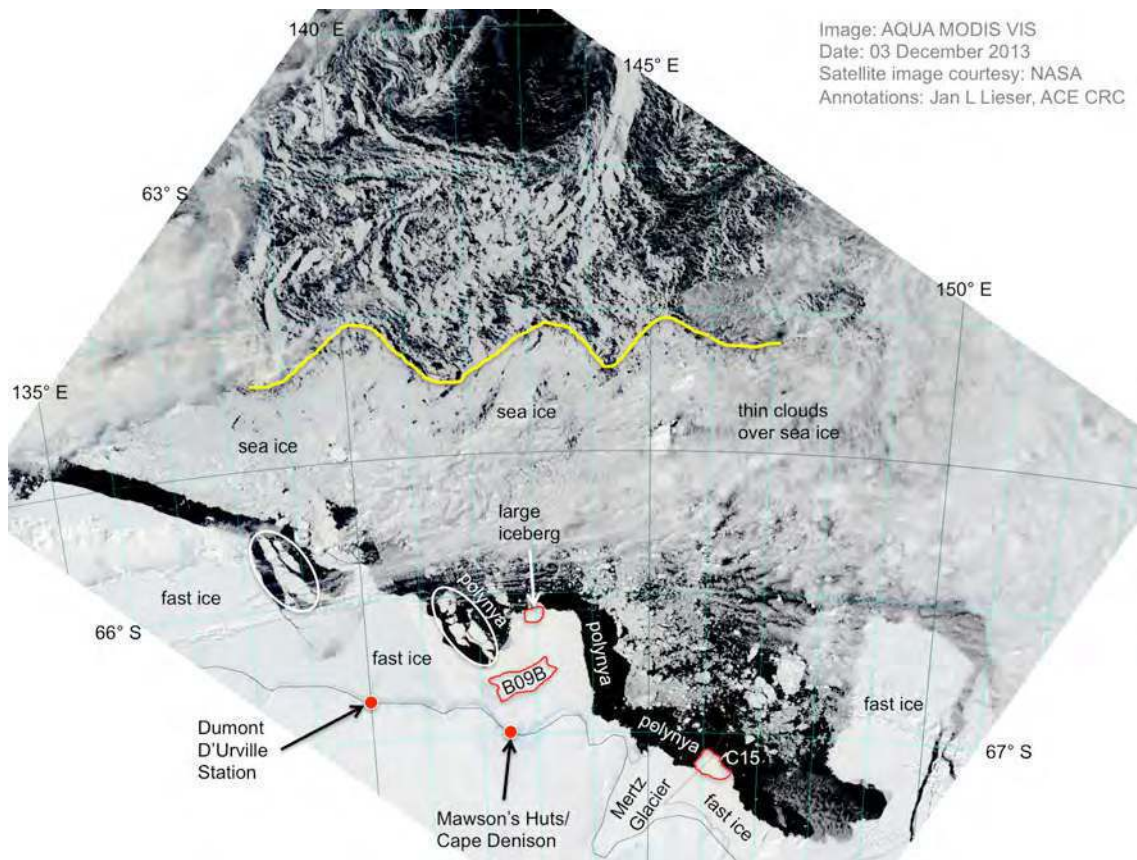
Figure 3: MODIS image, acquired 03/12/2013 and provided by NASA.

During the past week, overall sea ice conditions have not changed significantly in Commonwealth Bay (Figure 3). The yellow squiggle line in Figure 3 denotes the approximate location of the transition zone between the marginal sea ice zone and the pack ice. Sea ice can be seen north of 62° S in places.

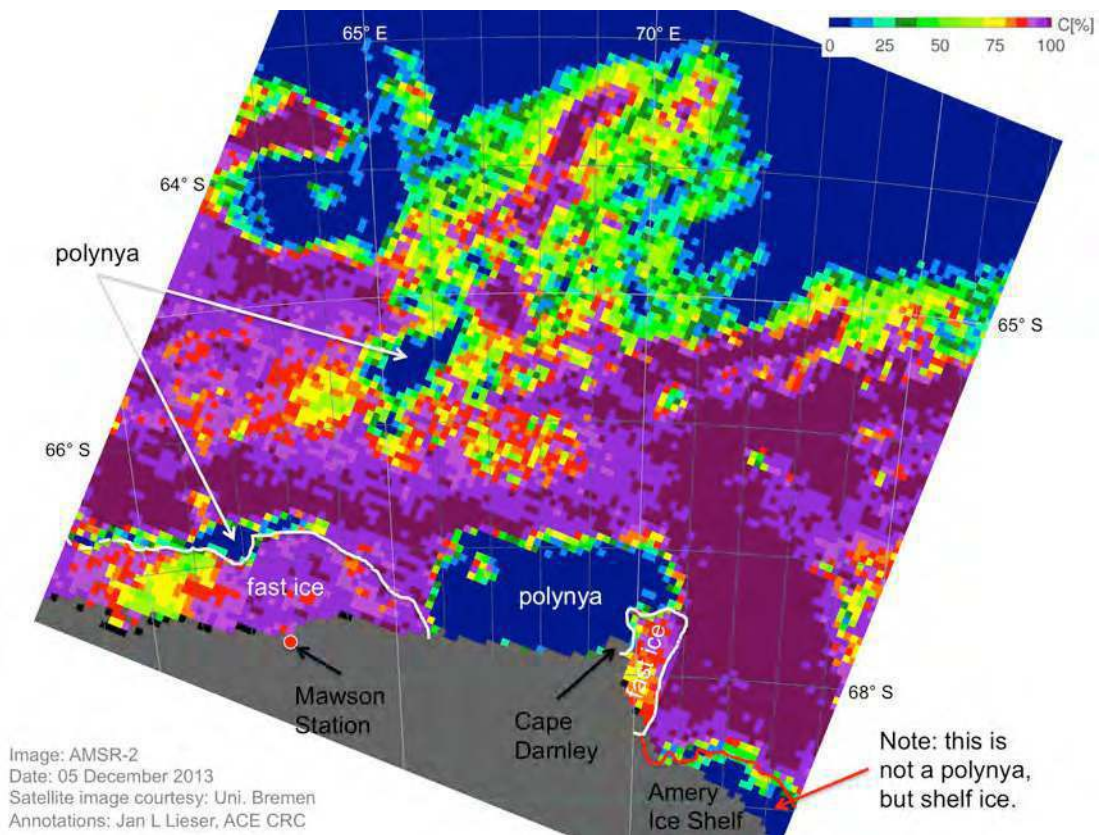
Figure 2: AMSR-2 image, acquired 05/12/2013 and provided by Universität Bremen.

Figures 1 and 2 show the same frame of sea ice conditions between Mawson Station and Cape Darnely, as seen by the high-resolution MODIS and the coarser resolution AMSR-2 instruments, respectively, yesterday.

Between 66° S and 67° S and 63° E and 68° E is a band of high sea ice concentration, which separates the fast ice (and polynya) north of Mawson Station in the west and the Cape Darnley polynya in the east from the more loose and patchy sea ice north of 66° S.

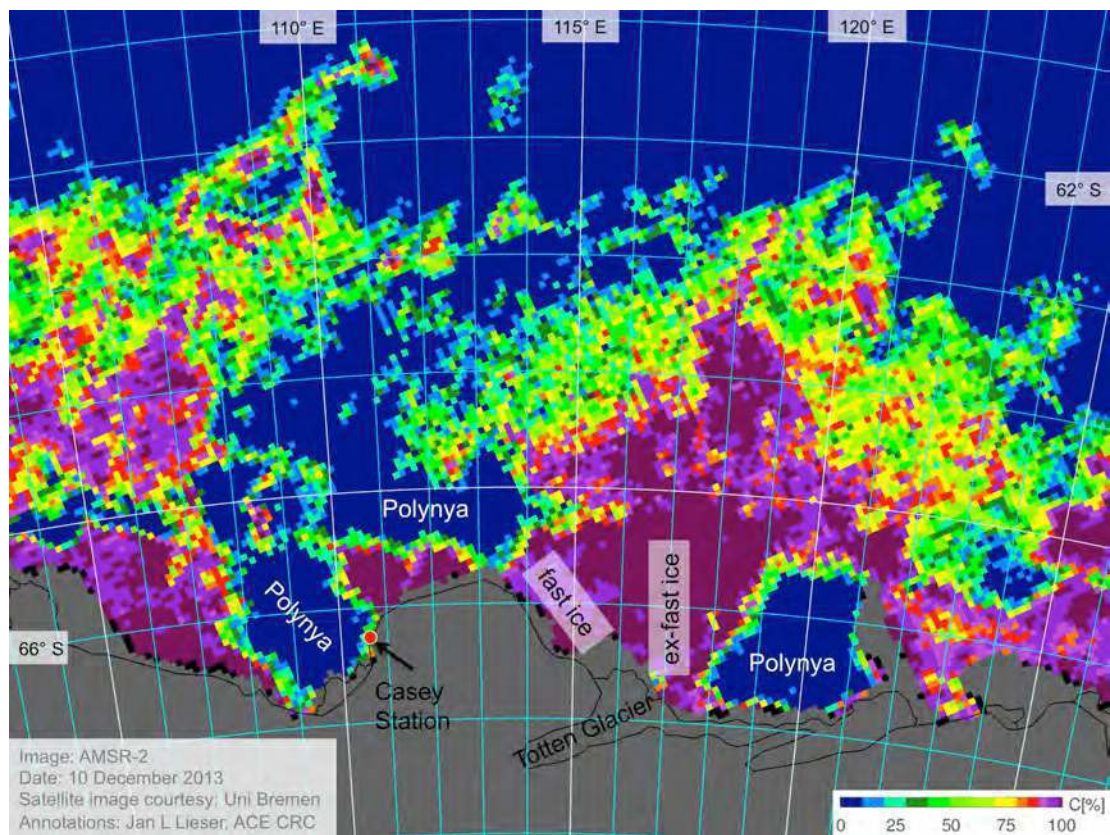
Figure 2: AMSR-2 image, acquired 10/12/2013 and provided by Universität Bremen.

Sea ice conditions in the vicinity of Casey Station can be seen in Figures 1 and 2. Two days ago, the visible image from MODIS sensor shows a corridor of very open sea ice conditions roughly between 110° E and 116° E. This corridor was widening during the past week, and has currently further reducing sea ice concentration.

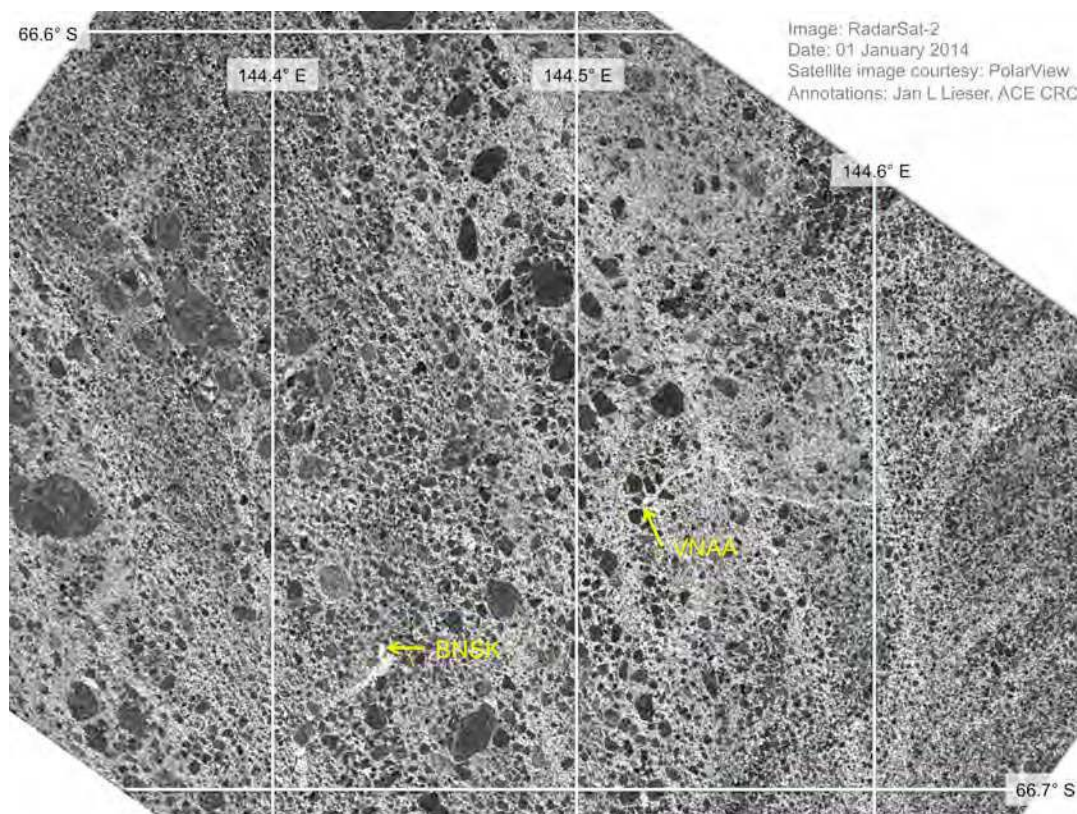
Figure 5: RADARSAT-2 image, acquired 01/01/2014 and provided by PolarView.

The yellow rectangle in Figure 4 denotes roughly the frame of Figure 5, which is a zoom of Figure 4 and gives an indication of the level of detail provided by this imagery. MV *Xue Long* and RSV *Aurora Australis* can be seen as highly reflective targets (bright white spots) at the time of acquisition. The track of RSV *Aurora Australis* heading towards MV *Xue Long* can also be seen as a white trail coming from the east, showing the high deformation (roughness) of the broken sea ice after the ship's passage.

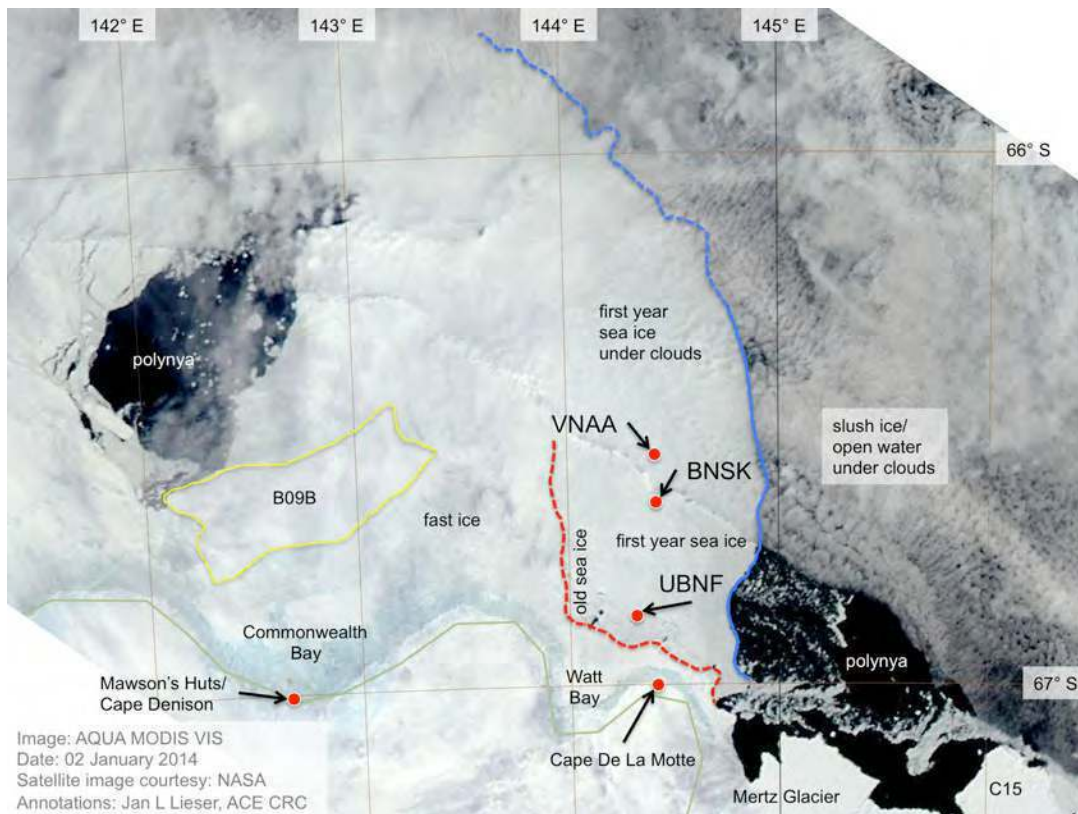
Figure 1: MODIS image, acquired 02/01/2014 and provided by NASA.

Under the influence of the recent persistent strong wind from the southeast some of the fast ice has broken off the western corner of iceberg B09B, exposing the iceberg cliff side to the open water of the polynya northwest of Commonwealth Bay. The broken sea ice and a very large piece of ex-fast ice can be seen drifting in the western side of this polynya now.

The pack ice edge (blue squiggle line) can be expected to be diffused and retreat westward if the wind direction changes to westerlies at adequate speeds and for a sufficiently long time. At the same time, this then free drifting pack ice is expected to move east across the Mertz Glacier polynya. Some of the large floes identified in previous Sea Ice Reports are expected to be released as well, but could remain as large floes until warmer conditions weaken them and further wave action might break them.

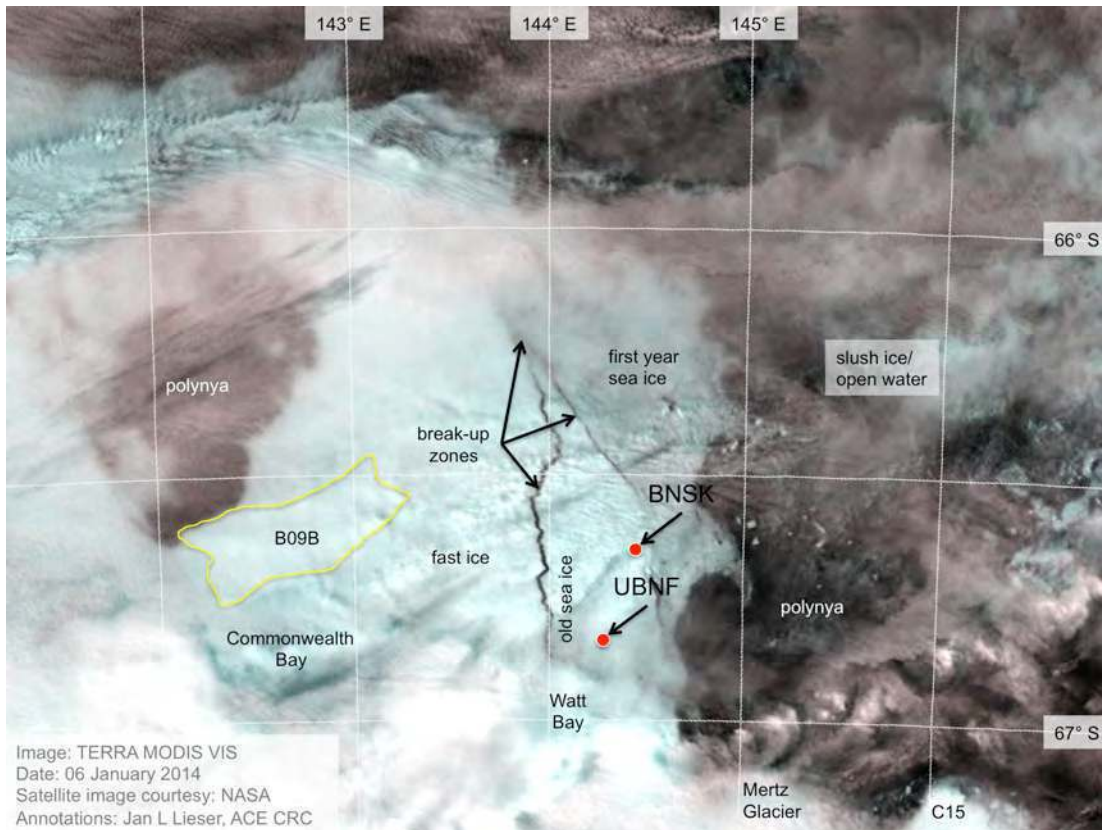
Figure 1: MODIS image, acquired 06/01/2014 and provided by NASA.

Over the past day or two, a substantial crack has appeared between the fast ice surrounding iceberg B09B, and the old and new sea ice that accumulated against it from the east. These break-up zones are clearly visible as dark serrated lines. At the moment, the accumulated old pack ice has separated from the fast ice as one large consolidated sheet of sea ice. The first year sea ice appears to have separated from the old sea ice along one of the (now former) major shear lines in the region.

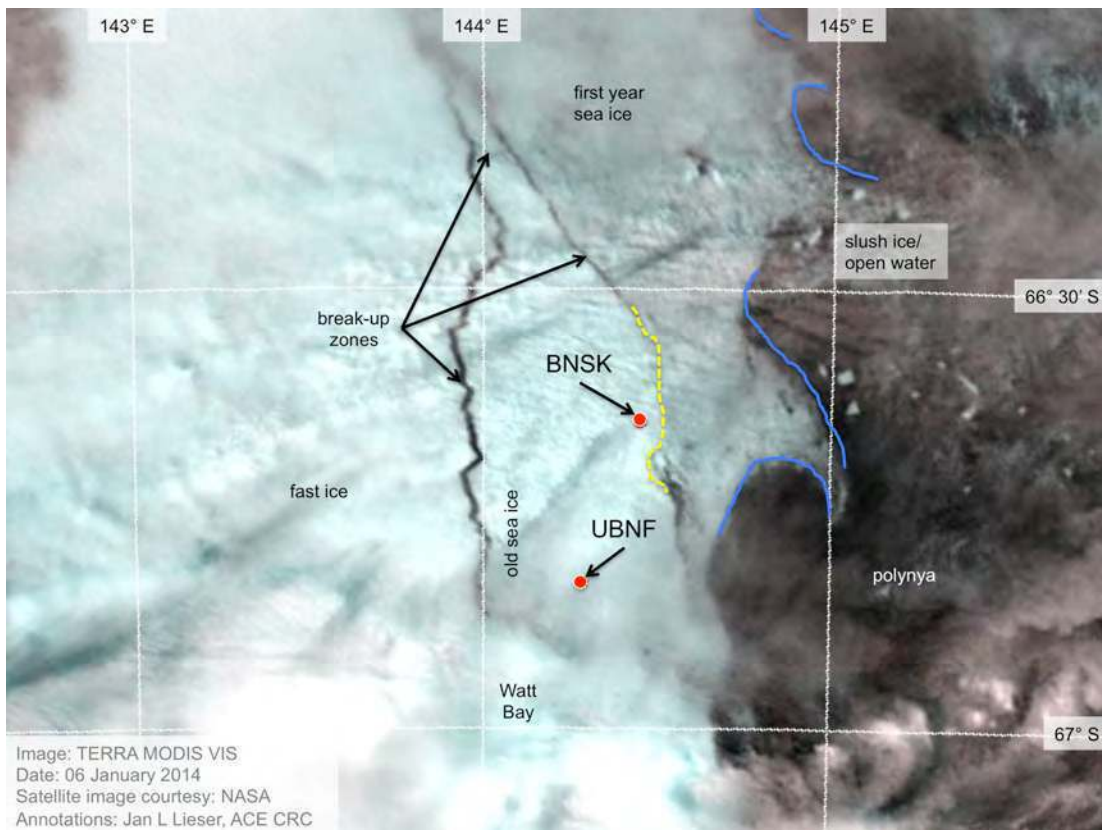
Figure 2: MODIS image, acquired 06/01/2014 and provided by NASA.

Figure 2 shows a zoomed cut-out of Figure 1 to examine the cracks in more detail. The main crack between the fast ice and the old pack ice (which is stretching even further north) is about one nautical mile wide at the moment. MV *Xue Long* appears to be only 1.5 or two nautical miles to the west of a former shear line (indicated as yellow dashed line in Figure 2). This estimate is subject to precise geo-referencing of the image, ship's position update, and *in-situ* circumstances.

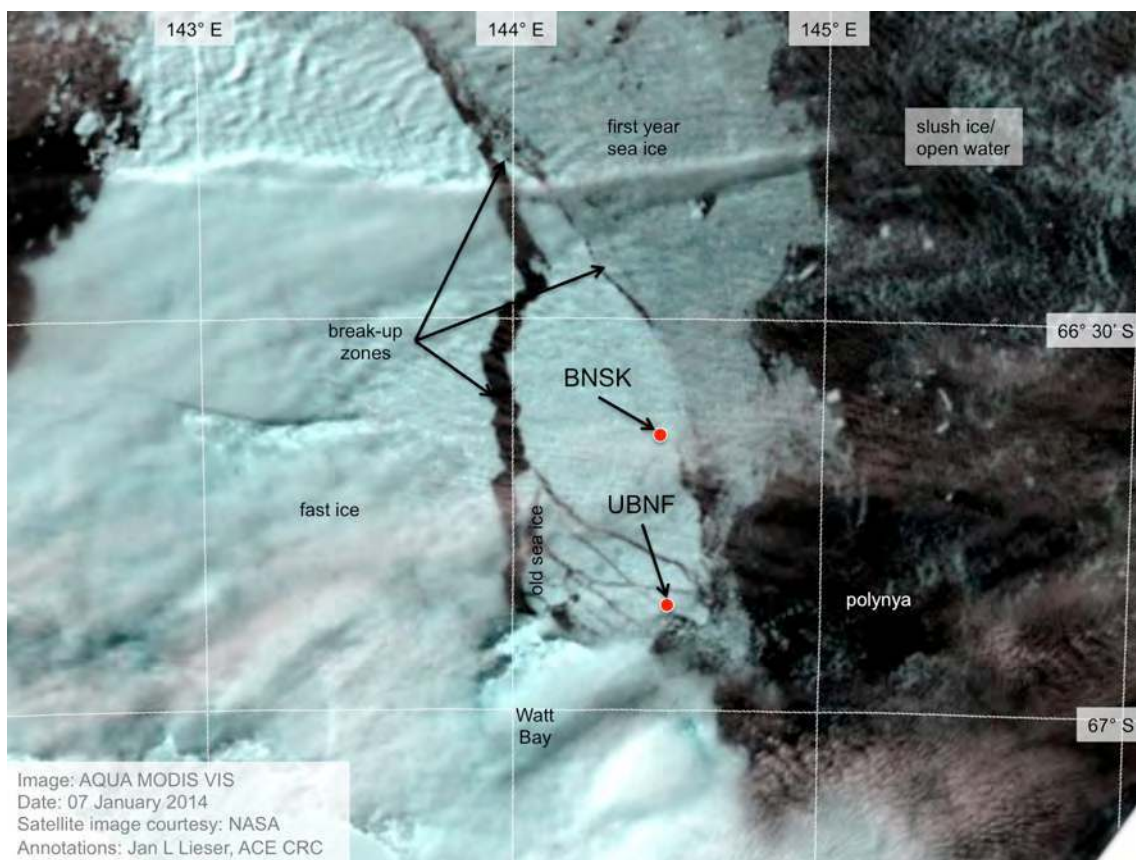
Figure 1: MODIS image, acquired 07/01/2014 and provided by NASA.

Over the six hours between the acquisition discussed in Sea Ice Report #01c/2014 and the acquisition shown in Figure 1, the major crack between the fast ice surrounding iceberg B09B and the old sea ice has doubled in width, and is now about two nautical miles wide. The southern part of the large sheet of old and new compacted sea ice has fractured into more pieces, as can be clearly seen in the figure as dark serrated, criss-crossing lines.

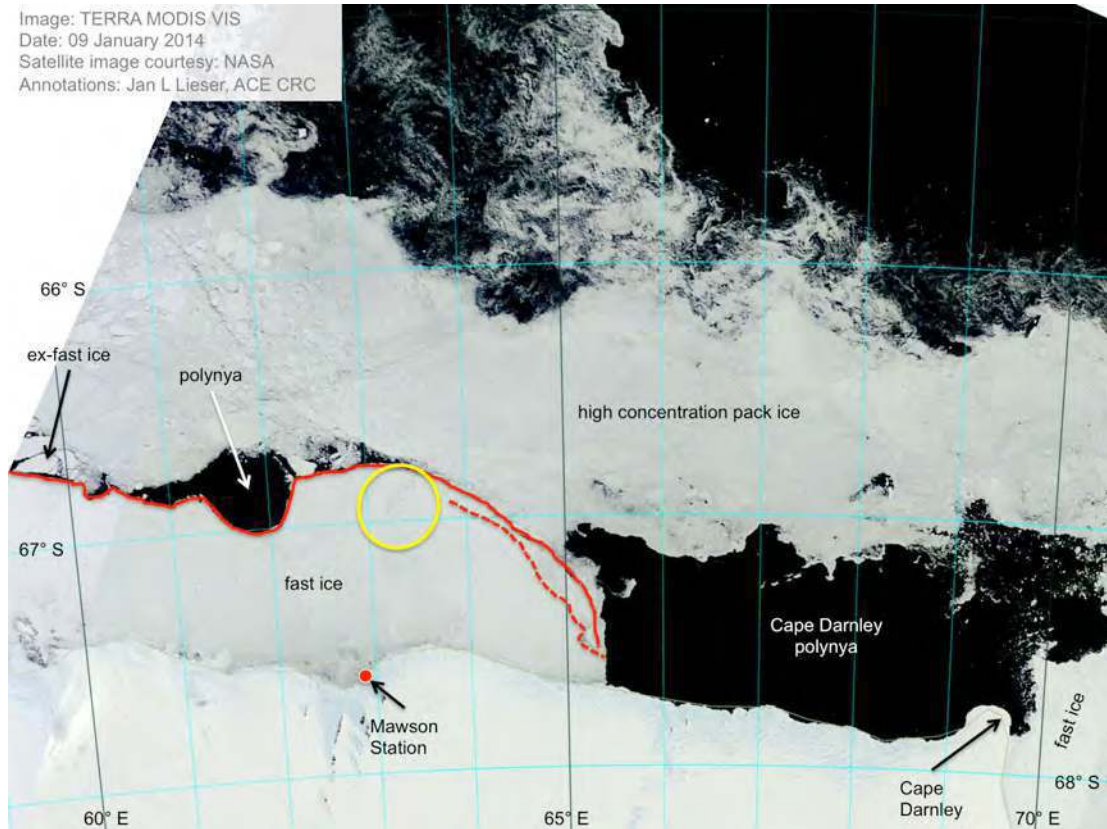
Figure 1: MODIS image, acquired 09/01/2014 and provided by NASA.

The MODIS image (Figure 1) reveals many shear lines and potential leads within the high concentration pack ice zone between 66° S and 67° S. These lines are zig-zagging and criss-crossing the pack ice. The northern marginal ice zone (and therefore the edge of the pack ice) shows a wide latitudinal spread and many undulations.

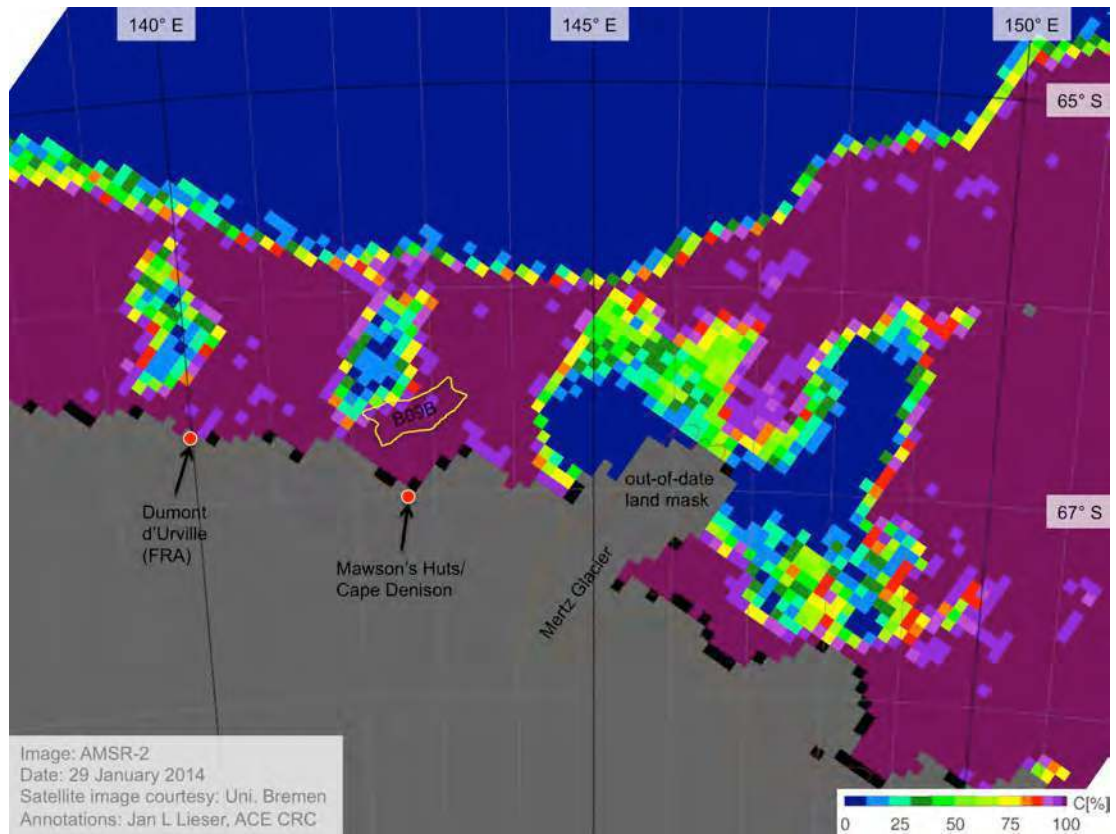
Figure 4: AMSR-2 image, acquired 29/01/2014 and provided by Universität Bremen.

been under thicker clouds recently (Figure 5), the microwave data (Figure 4) provide some insight into the apparent onset of freezing conditions in the region, as can be seen from the increased, but still low ice concentration in the polynyas north of Dumont D'Urville Station, iceberg B09B, and the Mertz Glacier polynya
