Sea ice reports for the season 2013-2014

Prepared by: Dr Jan L Lieser (Jan.Lieser@acecrc.org.au), Dr Robert A Massom (Rob.Massom@acecrc.org.au), Dr Petra Heil (Petra.Heil@acecrc.org.au), Antarctic Climate and Ecosystems Cooperative Research Centre, April 2014

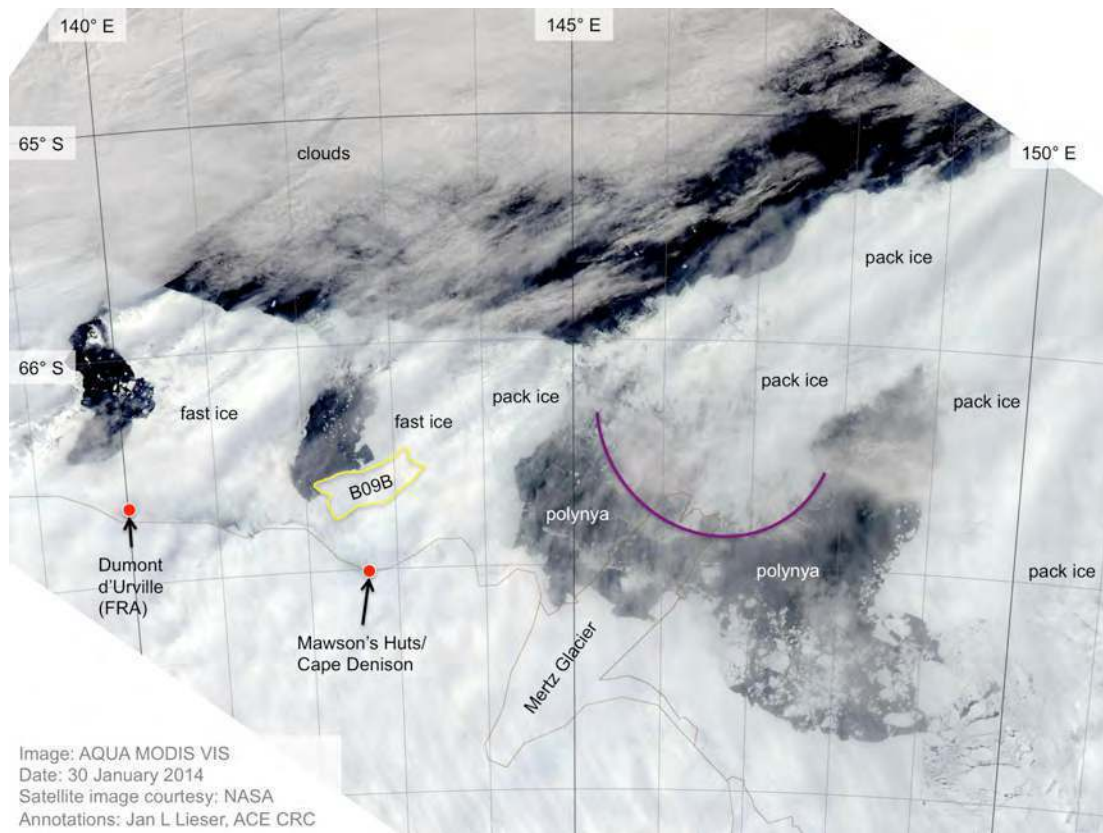
Figure 3: MODIS image, acquired 30/01/2014 and provided by NASA.

Figure 3 shows the region between Dumont D'Urville Station and the Mertz Glacier polynya under less clouds than Figure 5 of yesterday's Sea Ice Report. The increase in sea ice concentration reported yesterday appears to be a result of more sea ice floes floating in the various polynyas, combined with the onset of new ice formation. This newly formed sea ice can be quickly pushed to one side once wind strength is strong enough and may therefore appear as a reduction in ice concentration in future imagery. From north of $66^{\circ} S$ and west of $150^{\circ} E$, the pack ice entering the polynya off the Mertz Glacier seems to be spreading in a fan-like pattern, as indicated by the purple arc in Figure 3. At $145^{\circ} E$ and $66^{\circ} S$, the gap between the pack ice creeping from the east and the pack ice west of the fast ice surrounding iceberg B09B appears to be almost closed.

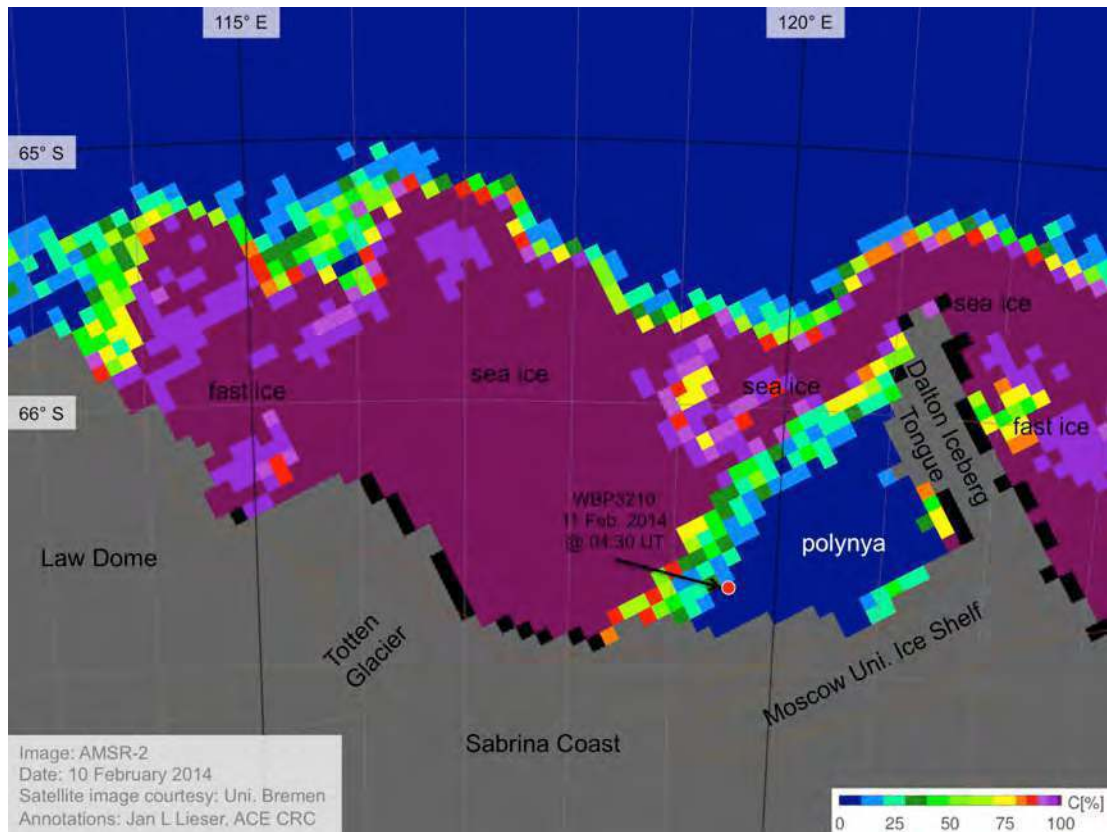
Figure 4: AMSR-2 image, acquired 10/02/2014 and provided by Universität Bremen.

Even though the region is still under a large cloud cover, the open water and sea ice covered areas can be well distinguished through the thin clouds. With the corresponding AMSR-2 data shown in Figure 4 the edge between the pack ice off Totten Glacier and the polynya to the west of the Dalton Iceberg Tongue can be seen in Figure 5, at about 119° E close to the coast.

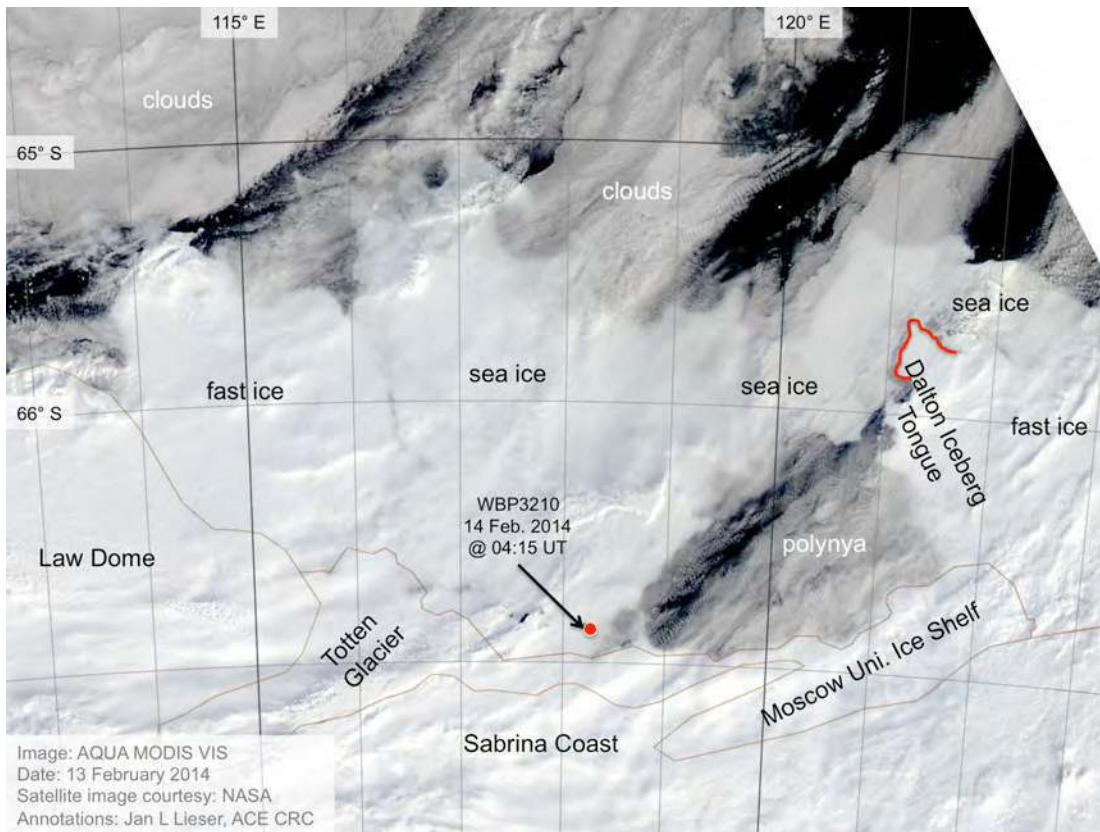
Figure 1: MODIS image, acquired 13/02/2014 and provided by NASA.

The polynya north of the Moscow University Ice Shelf appears well maintained, but the condition of the sea ice cover off the Totten Glacier can not be assessed from Figure 1. The region has been under clouds for about a week now, preventing the acquisition of visible imagery. But between 119° E and 121° E, a slight northward expansion of the sea ice cover can be noticed in both data sets (MODIS and AMSR-2), together with an increase in sea ice concentration of about 25%. At the same time, around the northern tip of the Dalton Iceberg Tongue (annotated by a red scribble line in Figure 1), a gap between the ice tongue and the pack ice appears to be shining through the clouds, about 1.5 nautical miles wide. Immediately west of 121° E, a few more openings and leads seem to be visible through the clouds as well. But those openings are likely to be below the detection limit of the AMSR-2 sea ice concentration algorithm, especially close to the margin of the land mask (shown in grey in Figure 2).

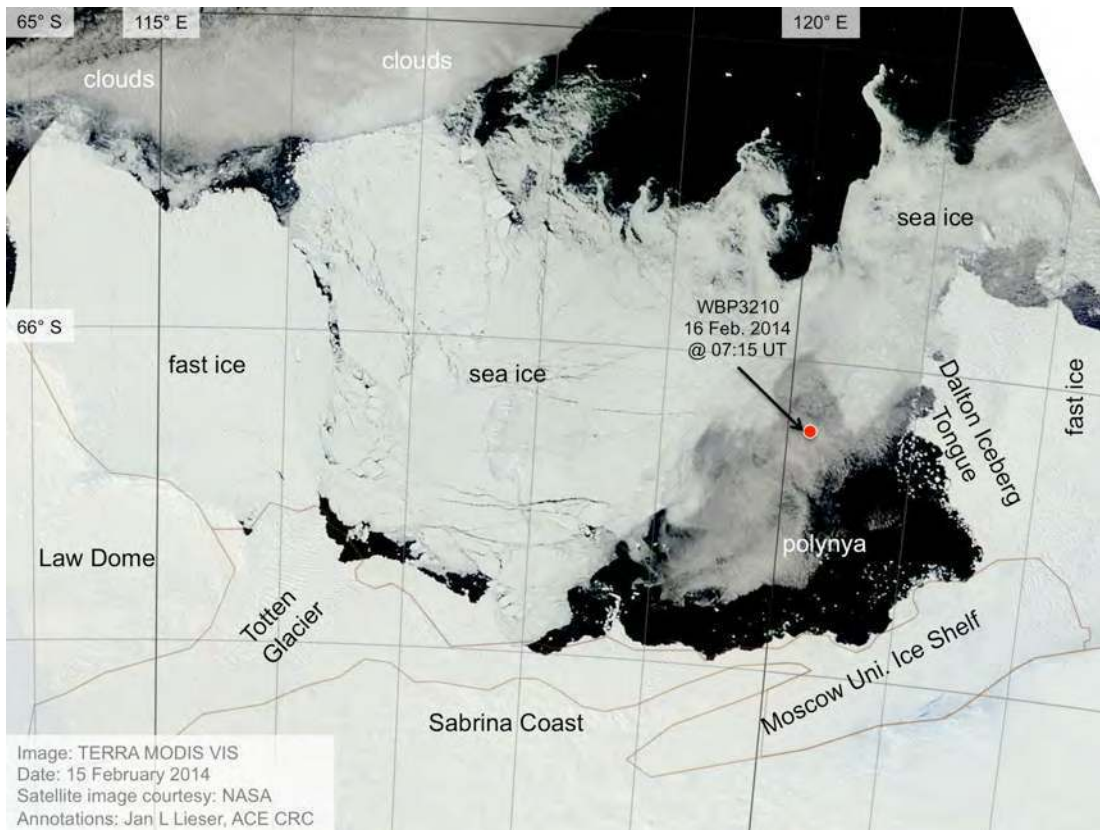
Figure 1: MODIS image, acquired 15/02/2014 and provided by NASA.

Figure 1 provides a largely cloud free view on the ice conditions between Law Dome and the Dalton Iceberg Tongue, two days ago. The position of RSV *Nathaniel B Palmer* (WBP3210; time annotated) is marked in the figure as a red dot. In the 24 hours preceding this acquisition, the sea ice north of Sabrina Coast had moved slightly northward, loosening up a little and showing more cracks and leads in east-west direction.

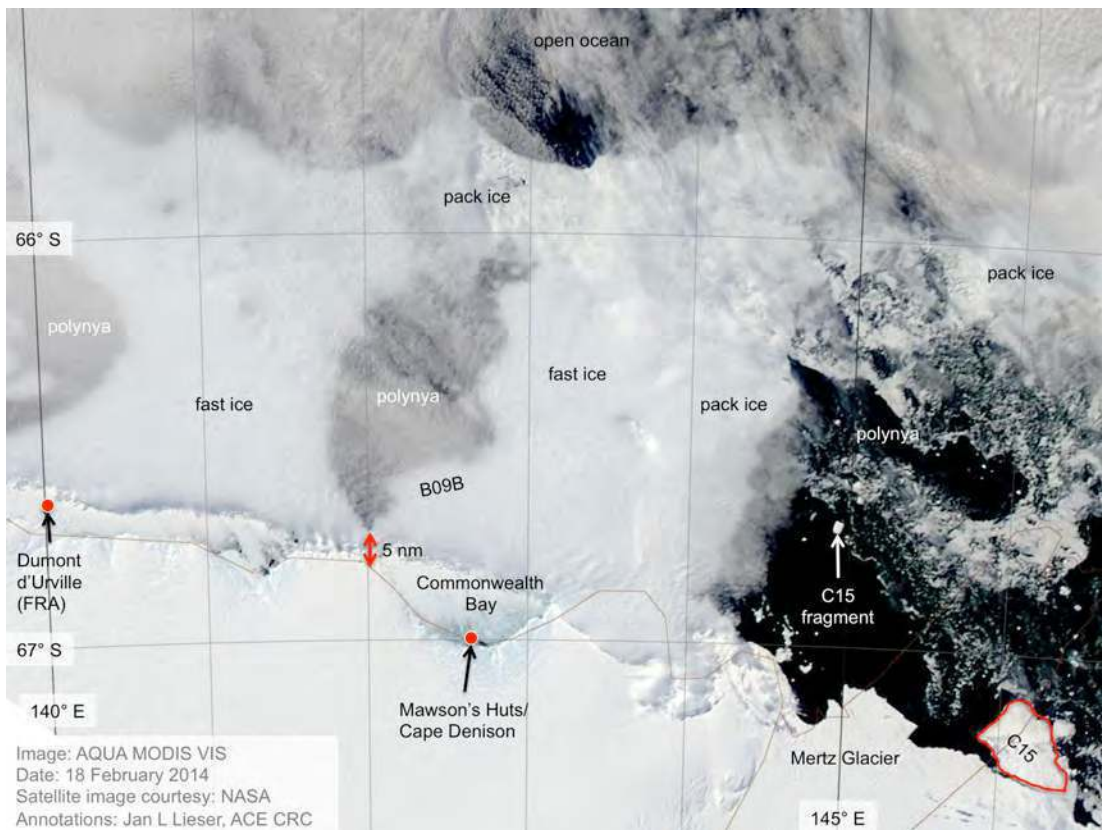
Figure 2: MODIS image, acquired 18/02/2014 and provided by NASA.

During the past two weeks, the overall sea ice conditions off Commonwealth Bay and the Mertz Glacier have not changed significantly (Figure 2). In front of Metz Glacier, the polynya appears still well maintained with light pack ice conditions between 145° E and 146° E. A fragment of iceberg C15, that broke away from the berg when it started to wiggle (see Sea Ice Report #05b/2014 from 03/02/2014), is now located about 40 nautical miles away from where it broke off.

Even though the scene displayed in Figure 2 is largely obscured by clouds (except for the Mertz Glacier polynya region), the dark open ocean in the polynya north of iceberg B09B (this iceberg's exact shape can not be identified through the clouds) can be clearly distinguished from ice covered waters. It is noted that the fast ice at the western end of Commonwealth Bay has retreated further to the coast, so that only about five (5) nautical miles of fast ice remain at this location (see red double arrow in Figure 2).

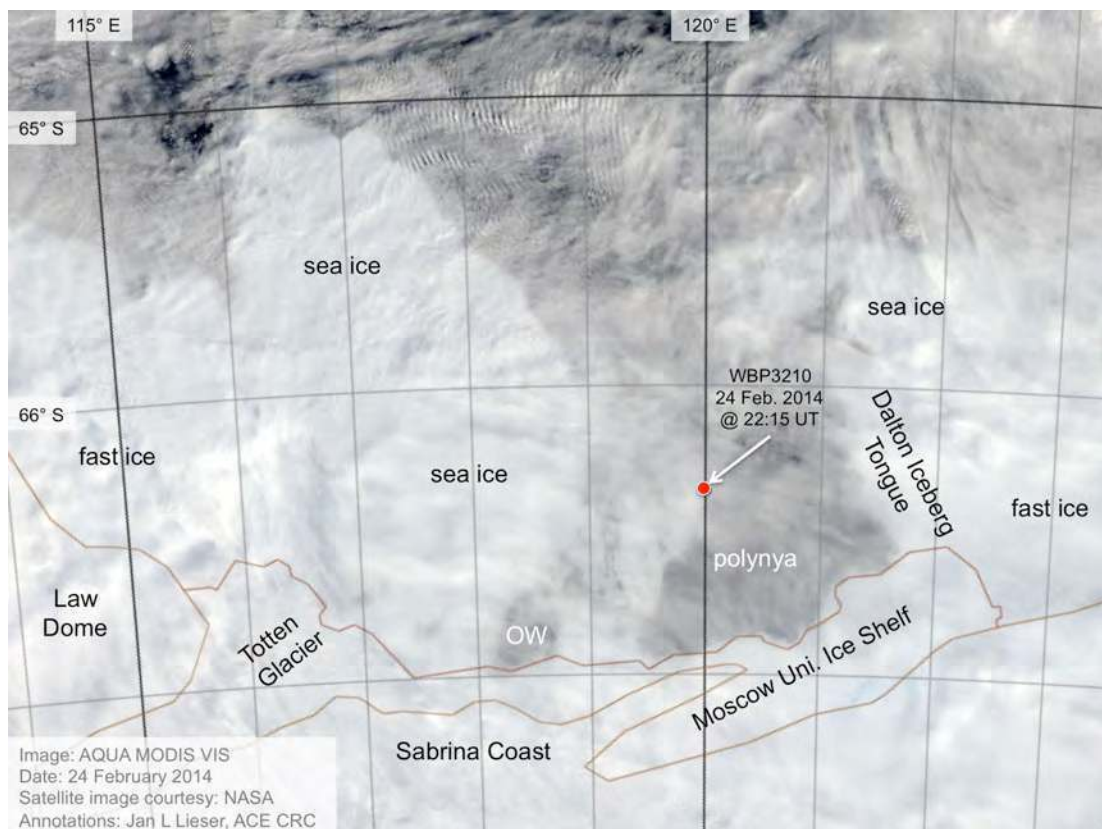
Figure 1: MODIS image, acquired 24/02/2014 and provided by NASA.

Between 119° E and 121° E, an area of loose sea ice cover appears in this sector. Close to the coast, between 118° E and 119° E, a relatively large area of open water (a darker patch; marked 'OW' in Figure 1) with low sea ice concentration can also be identified.

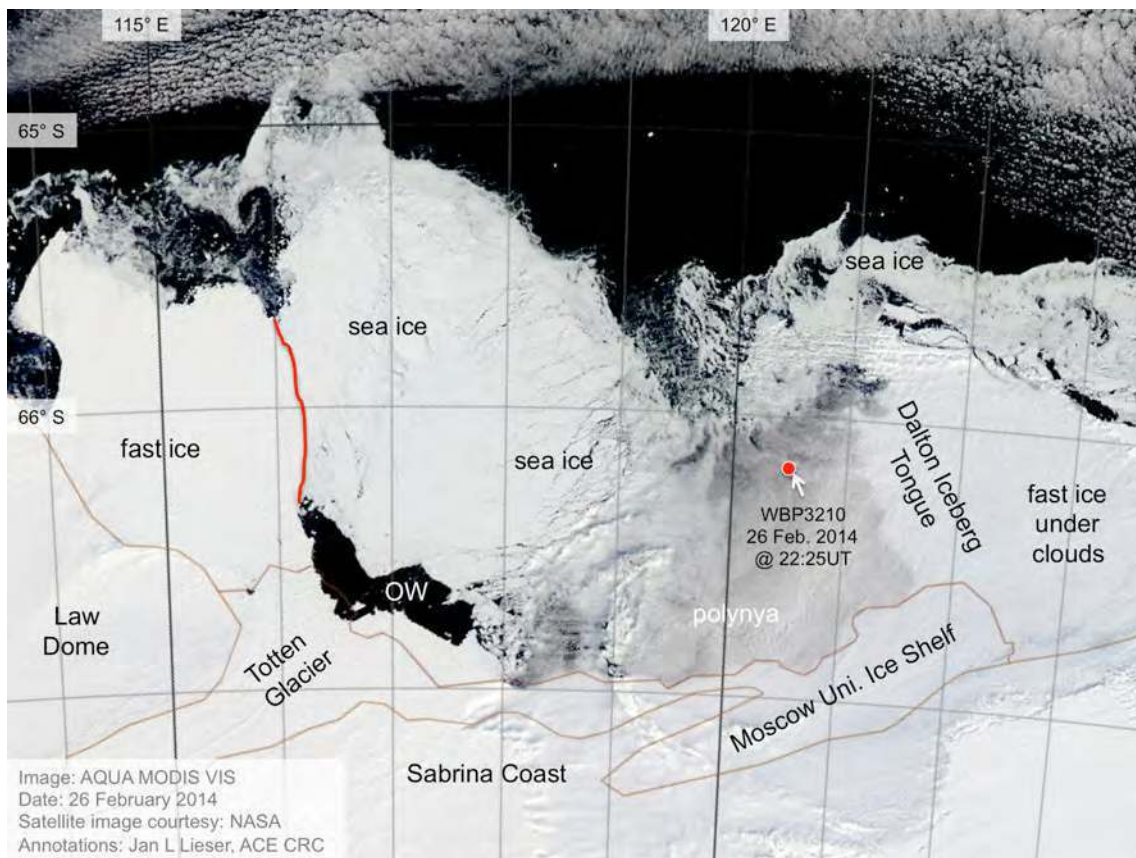
Figure 1: MODIS image, acquired 26/02/2014 and provided by NASA.

Figure 1 shows sea ice conditions between the eastern flank of Law Dome and the Dalton Iceberg Tongue. The position of RSV *Nathaniel B Palmer* (WBP3210, time annotated) is shown as a red dot. The boundary between fast ice and pack ice north of Totten Glacier is marked with a red scribble line.

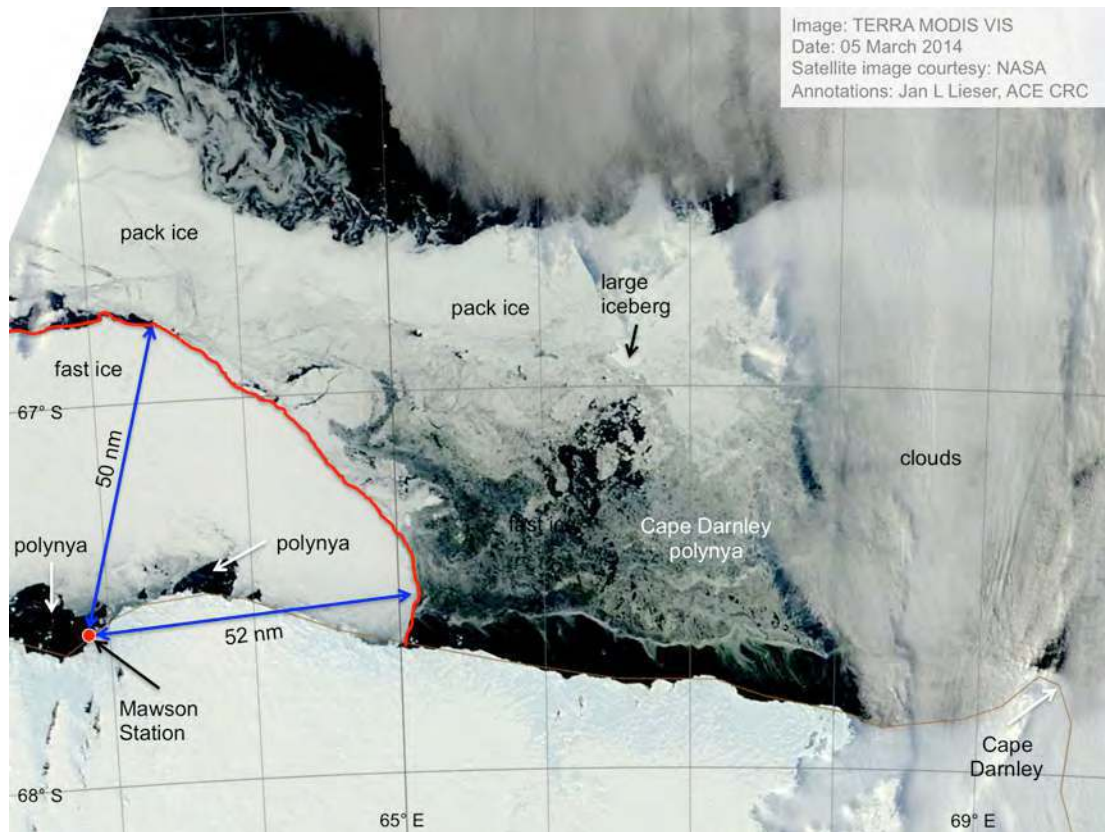
Figure 1: MODIS image, acquired 05/03/2014 and provided by NASA.

Figures 1 and 2 show the same geographical frame off Mawson Station as seen by the MODIS instrument and RADARSAT-2, respectively. The location of the fast ice edge is indicated by the red line in the MODIS image (Figure 1). Yesterday, between the two acquisitions by the different satellites, a substantial piece of fast ice has broken away from the eastern side of the fast ice surrounding Mawson Station. The now ex-fast ice is indicated by the light green shape in Figure 2. This event has shortened the distance from the fast ice edge at the Cape Darnley polynya to the station by about five nautical miles.

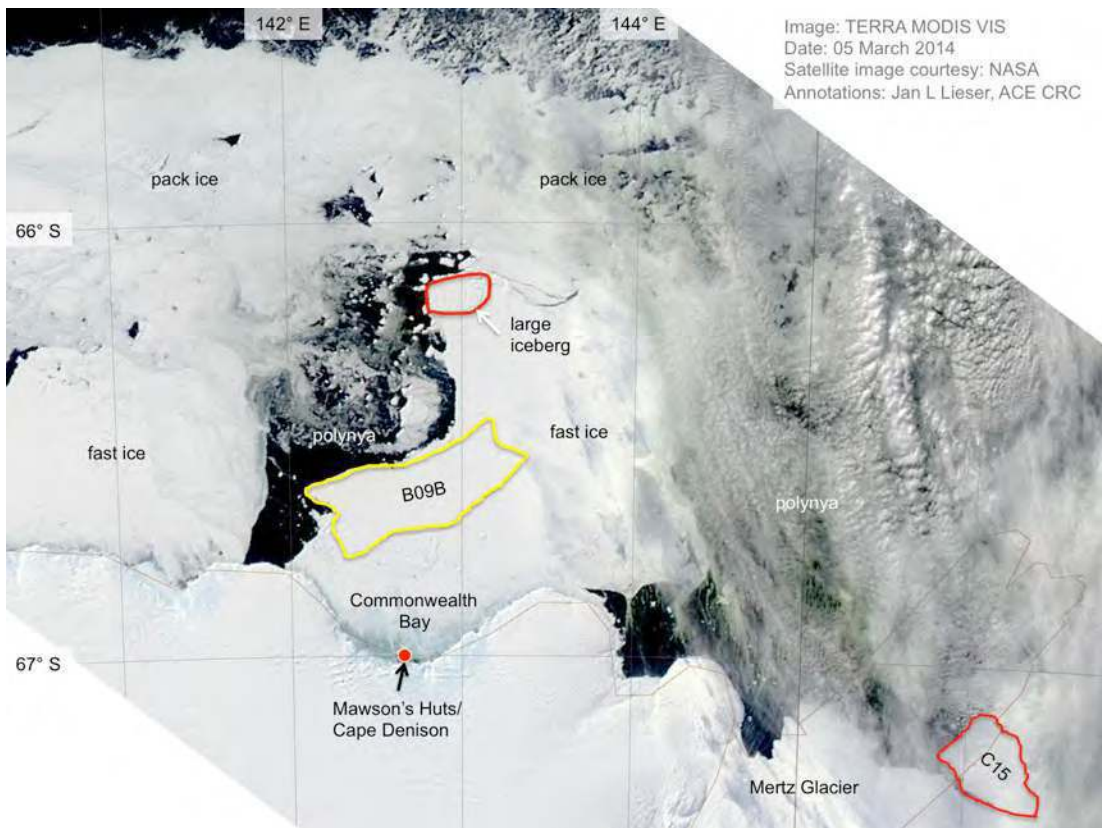
Figure 4: MODIS image, acquired 05/03/2014 and provided by NASA.

To the west of iceberg B09B, fast ice has retreated completely and about five nautical miles of coast are now exposed to the polynya (see Figure 4). North of the berg, a large piece of fast ice has also broken away.

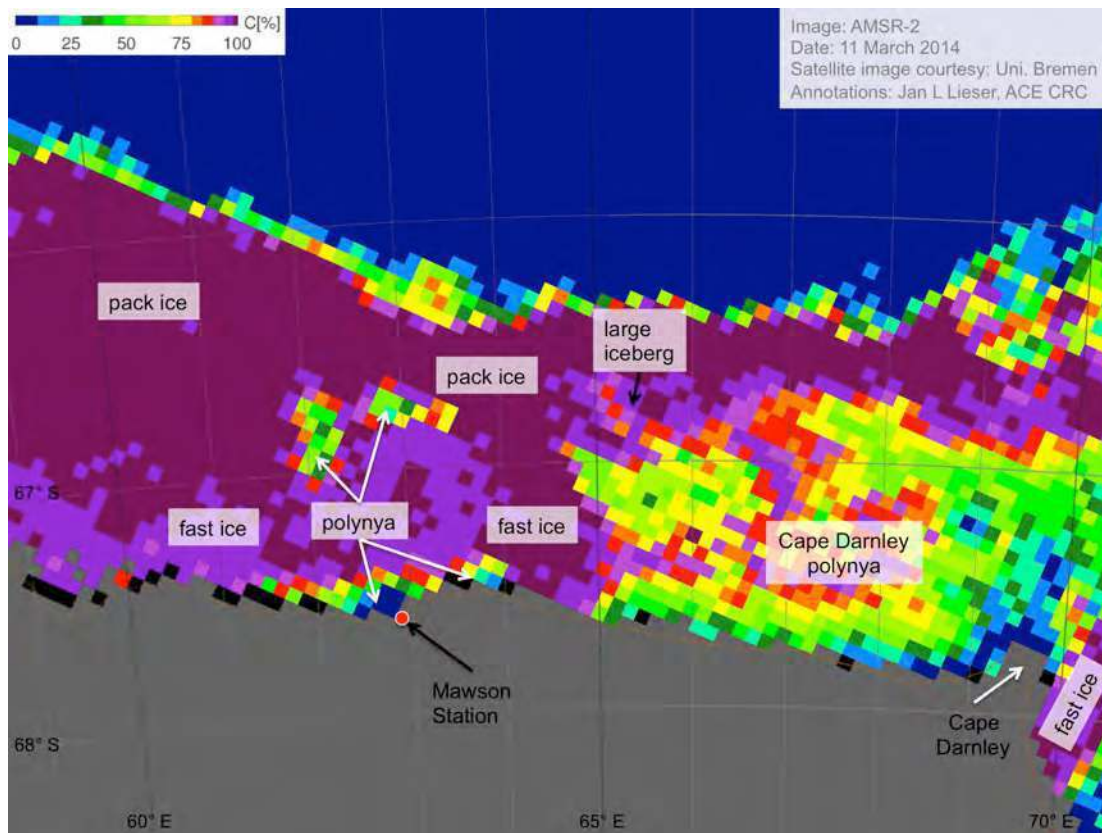
Figure 2: AMSR-2 image, acquired 11/03/2014 and provided by Universität Bremen.

The general sea ice conditions appear typical for late summer/early autumn with light sea ice concentration in the Cape Darnley polynya and only a small band of higher concentration consisting of sea ice that has just survived the summer season, centred at about 66° 30' S between 65° E and 70° E. The northern sea ice edge can be seen as a relatively well defined line in the AMSR-2 data (Figure 2), possibly caused by the persistent southeasterly winds recently.

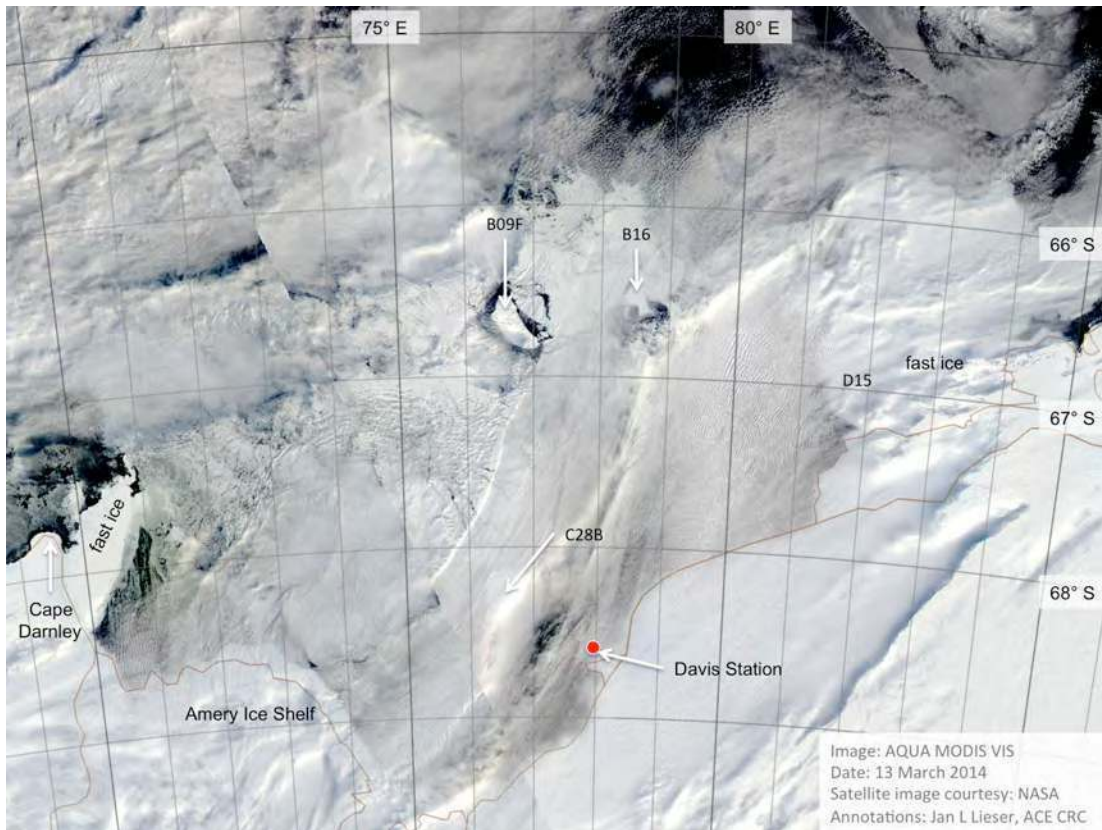
Figure 1: MODIS image, acquired 13/03/2014 and provided by NASA.

Even though the freezing season seems fully established in the region the sea ice conditions appear still loose and highly variable, especially west of 75° E. The MODIS image (Figure 1) is largely obscured by clouds, but through some of the thinner clouds the sea ice surface can be seen. In the central part of the image, between 67° S and 68° S and 75° E and 77° E, large openings and leads can be detected within pack ice zone. In both figures, three large icebergs are identified floating freely through the sea ice. The surrounding of B09F indicates that the entire region is currently under low horizontal pressure. Note: D15 is stationary to the north of the West Ice Shelf.

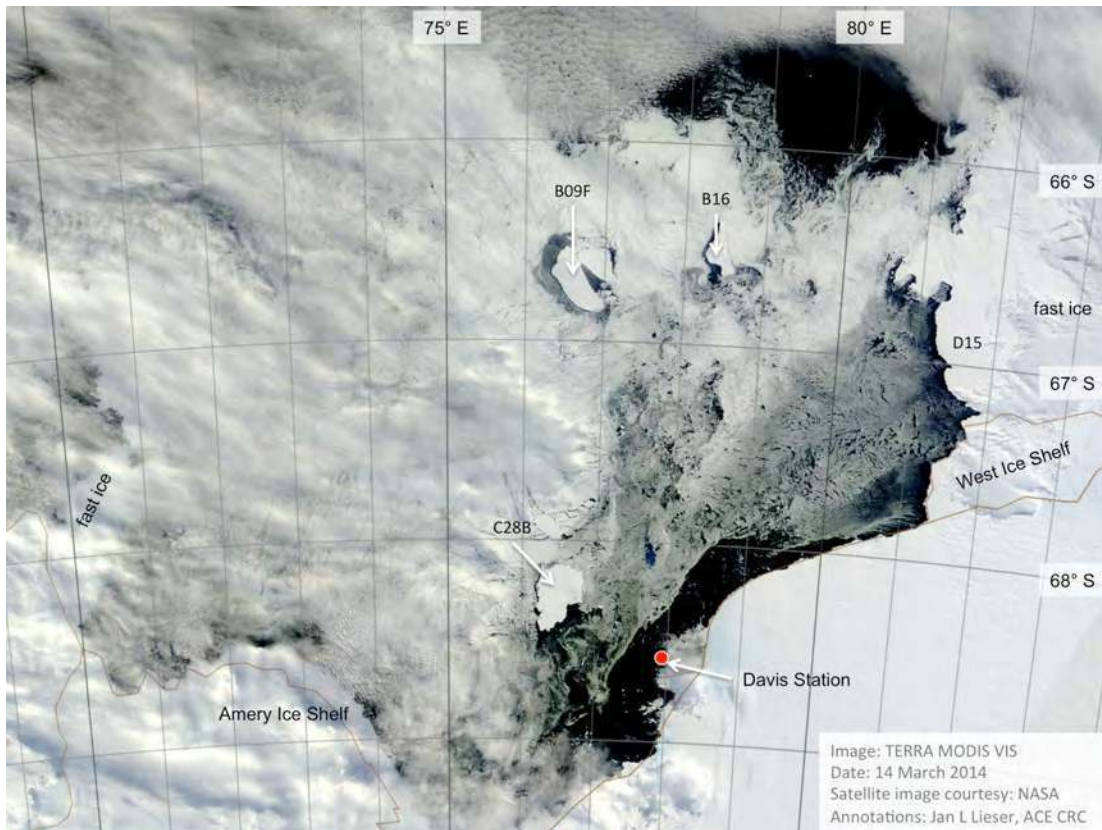
Figure 1: MODIS image, acquired 14/03/2014 and provided by NASA.

Sea ice conditions appear to have not changed significantly during the past 24 hours, but the MODIS image (Figure 1) provides a clearer view of the scene, between 77° E and 82° E. In this sector and between 66° S and 67° S, sea ice concentrations appear relatively high (around 80%), but the conditions around icebergs B09F and B16 still indicate low horizontal pressure. South of 67° S in the same sector, sea ice concentrations are low to moderate at the moment.

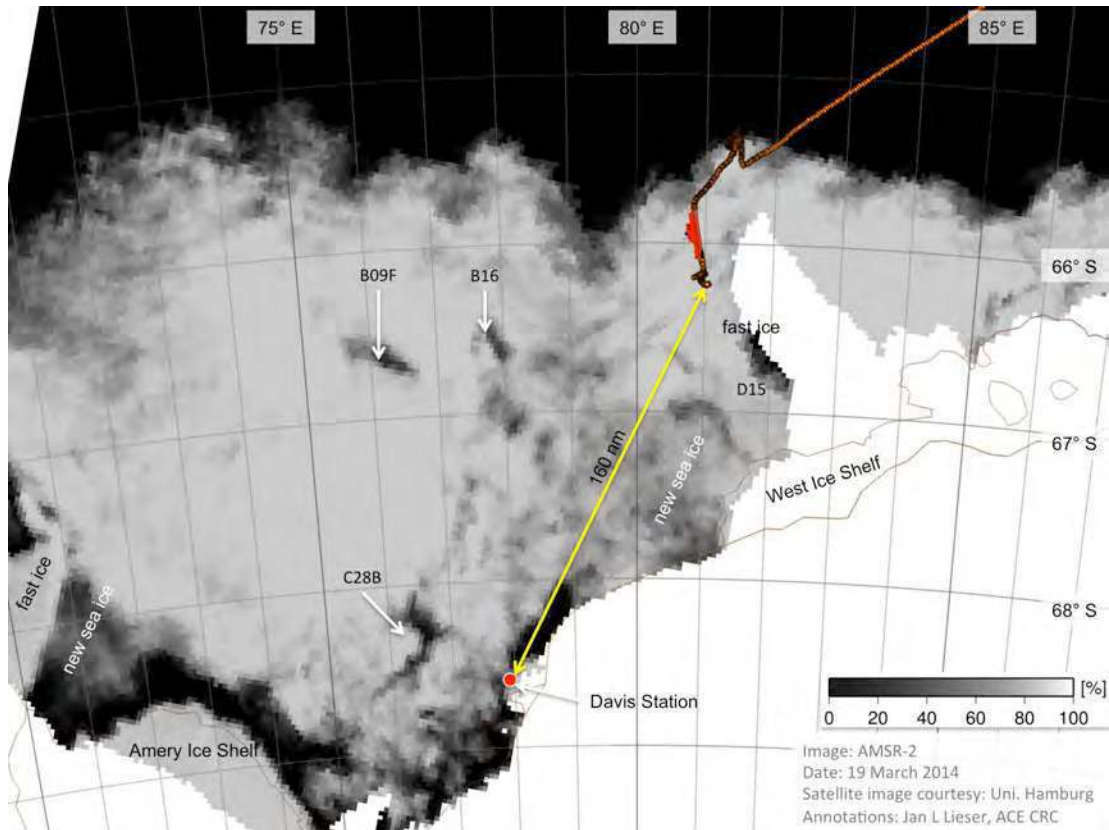
Figure 4: AMSR-2 image, acquired 19/03/2014 and provided by Universität Hamburg.

North of the current ship's position, open water is visible in yesterday's MODIS image (Figure 5), even though the AMSR-2 data (Figure 4) indicate high sea ice concentration. The different resolution of the two sensors can be attributed to this apparent discrepancy.

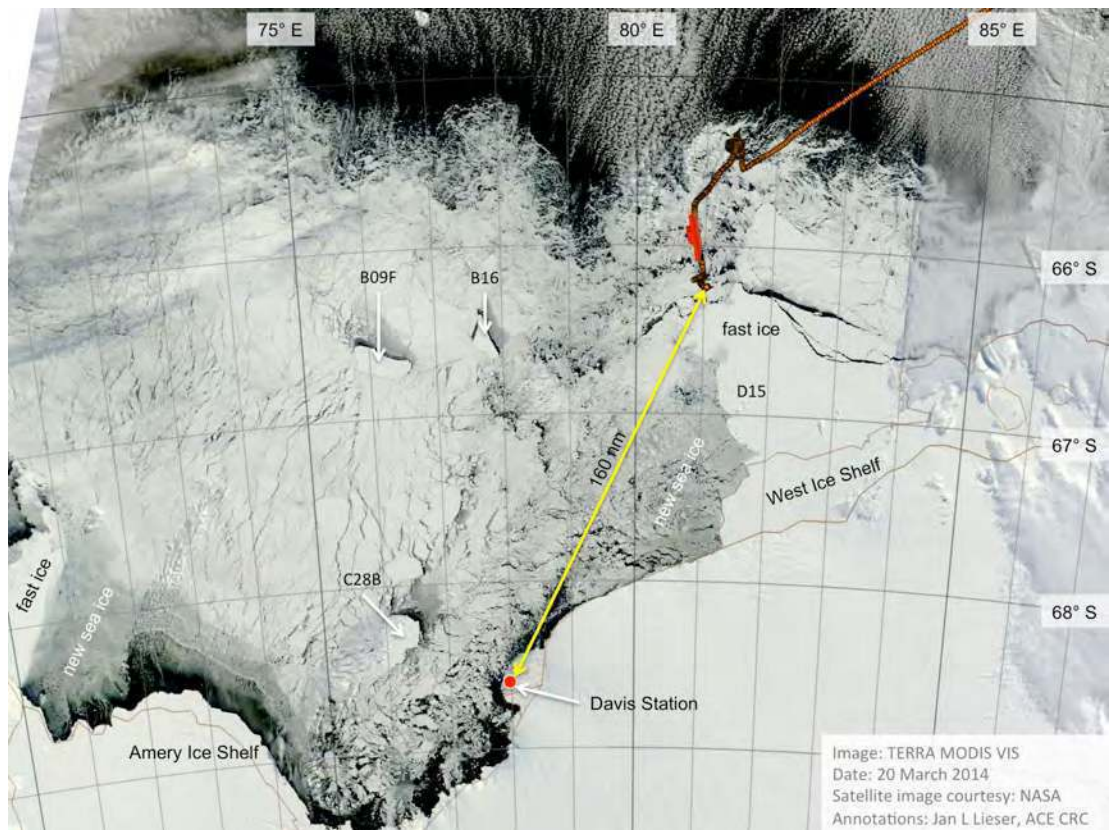
Figure 5: MODIS image, acquired 20/03/2014 and provided by NASA.

82° E and 84° E, the separation is clearly visible in the MODIS image (Figure 5). To the north of this ex-fast ice and spanning a bit further to about 81° 30' E, a large lead separates the ex-fast ice from the old sea ice mentioned above.

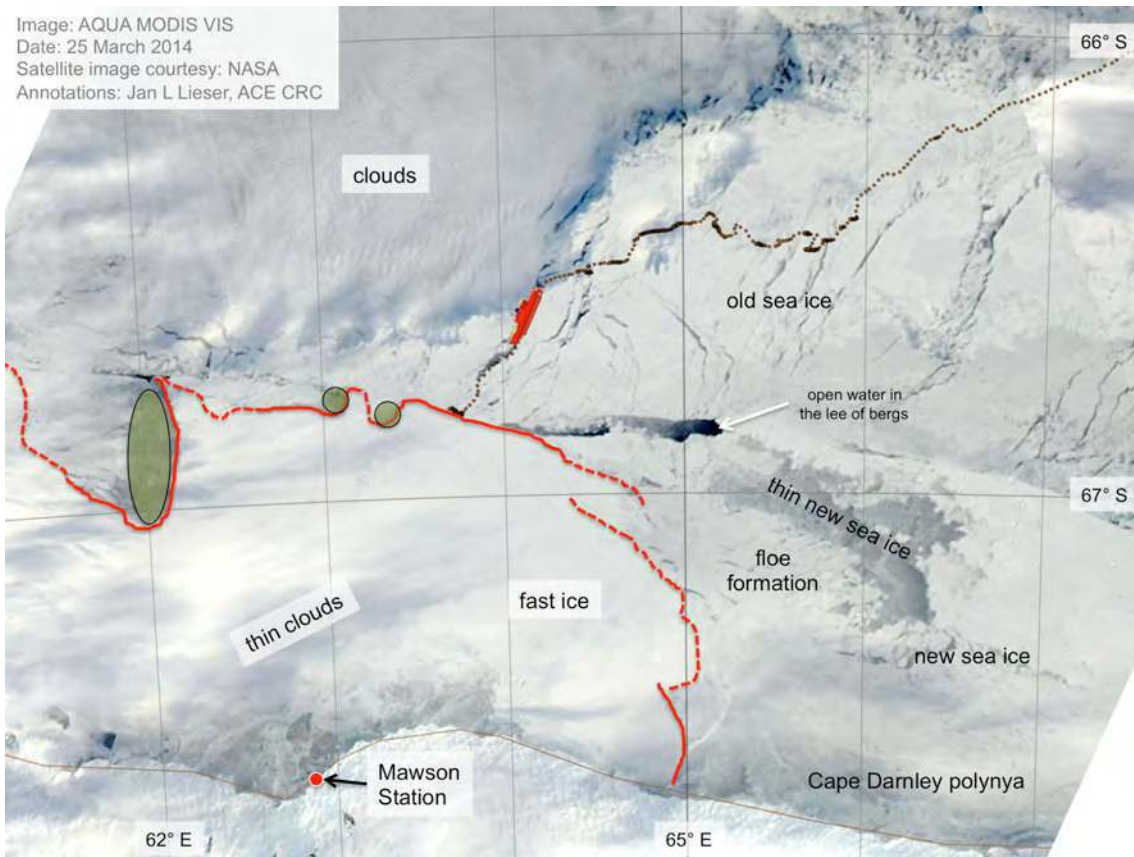
Figure 1: MODIS image, acquired 25/03/2014 and provided by NASA.

The general sea ice conditions as discussed earlier (for example Sea Ice Report #12a/2014) has not changed. In Figure 1, three green shaded areas are identified where lee effects behind fast ice promontories creates persistent low ice concentration, thin ice regions. Those areas are high sea ice production regions, and sea ice accumulates at the windward opposite site of these embayments where it thickens and backfills the bay. This same mechanism is seen clearly in the western part of Cape Darnley polynya, where new sea ice is rafting on top of each other and forming larger floes.

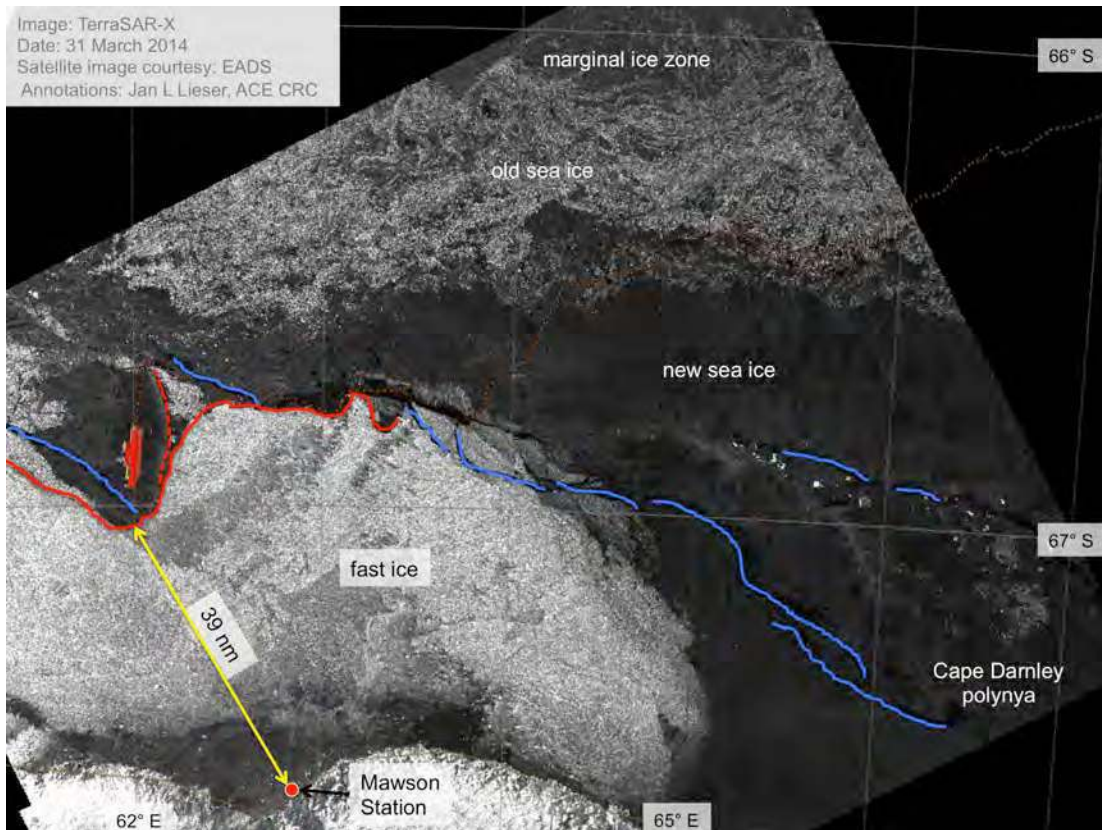
Figure 1: TerraSAR-X image, acquired 31/03/2014 and provided by EADS.

West of 63° 30' E, the solid red line denotes the edge of old fast ice with the dashed extension surrounding fast ice behind a series of icebergs. Blue scribble lines indicate major openings in the sea ice zone. The edge of the consolidated fast ice is expected to be close to these lines, but at least in two instances (between 63° 30' E and 64° E) large sheets of fast ice appear to be separating from the main fast ice body. East of 65° E, newly formed sea ice from the Cape Darnley polynya is accumulating against the old fast ice, but might only be loosely attached to it.

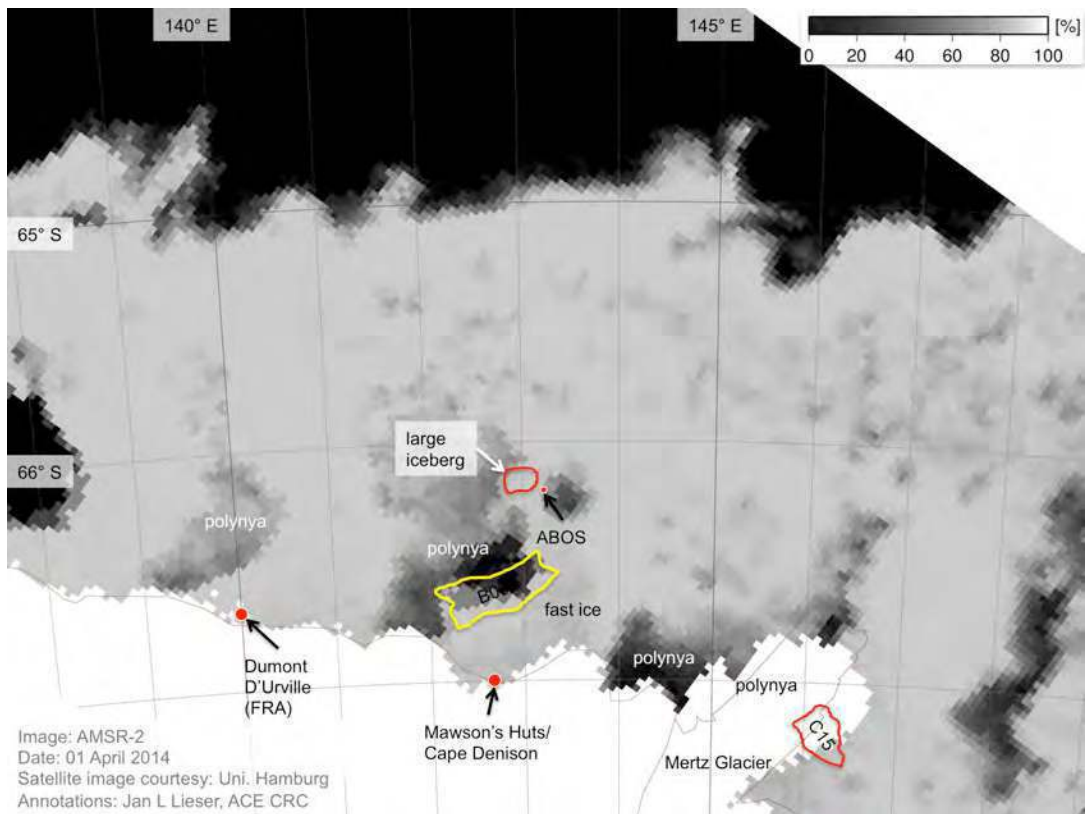
Figure 5: AMSR-2 image, acquired 01/04/2014 and provided by Universität Hamburg.

Figures 5 and 6 are based on data from the same instrument (AMSR-2), that are processed with different algorithms resulting in a doubling in resolution for the sea ice concentration product by Universität Hamburg (Figure 5) compared to the same product by Universität Bremen (Figure 6). Both products are computed using an outdated land mask with respect to the Mertz Glacier tongue. At the location of iceberg B09B, it is also clear that both algorithms overestimate the size of the polynya to the north of the berg. The open water at 66° S and 138° E (and further west from there) is a consistent, recurring and wrong feature in the AMSR-2 data set; this issue has been raised with the data providers in Hamburg and Bremen.

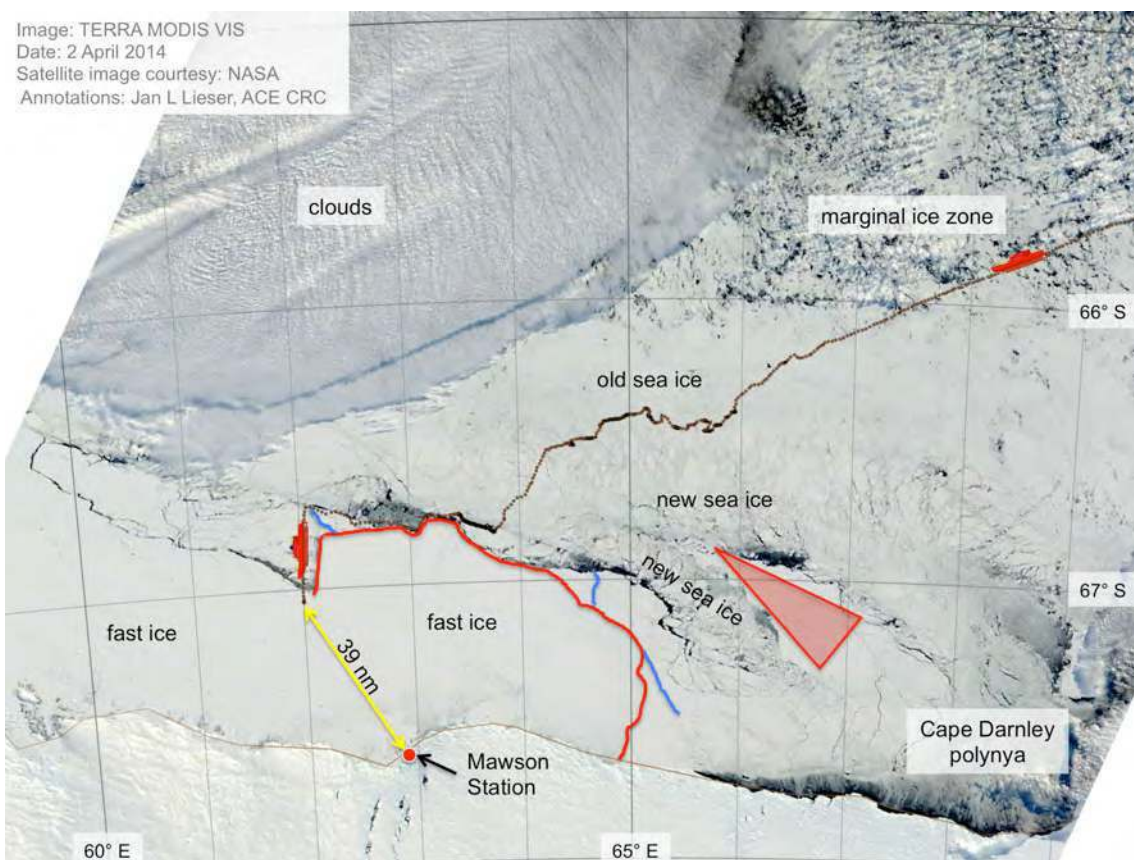
Figure 1: MODIS image, acquired 02/04/2014 and provided by NASA.

A largely cloud free scene of the sea ice zone north of Mawson Station is shown in Figure 1. The red line indicates the edge of old fast ice to the north and east of the station. Blue lines indicate major cracks in recently accumulated sea ice loosely attached to the fast ice. West of 62° E, a large crack can be seen at the northern edge of the fast ice. The orange dotted line represents the cruise track of RSV *Aurora Australis*.

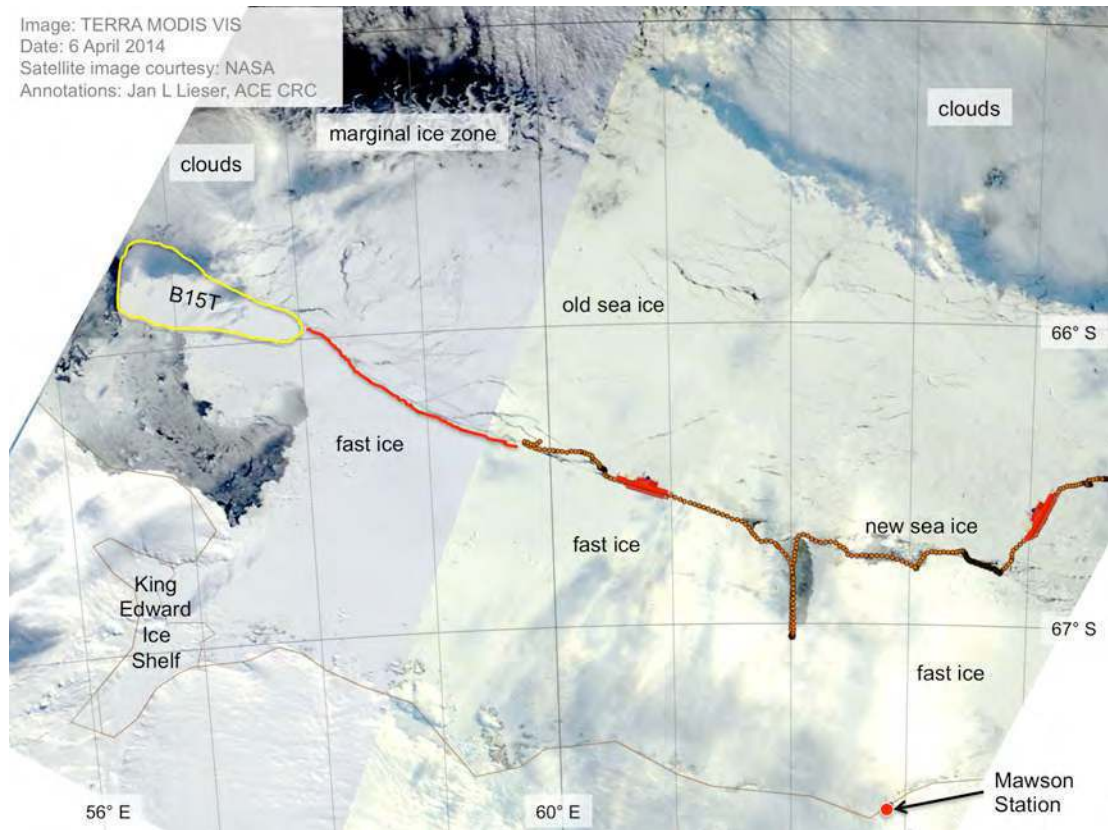
Figure 1: MODIS image, acquired 06/04/2014 and provided by NASA.

The fast ice off Mawson Station continues along the coast towards King Edward Ice Shelf. The northern edge of this fast ice is well defined towards the eastern corner of iceberg B15T. The mixture of old and new sea ice drifting along this edge appears to be detached from the fast ice at the moment, which has opened a lead in northwest-southeast direction. West of 60° E, many cracks and leads are visible between the fast ice edge and 66° S, some in arched shape.
