Sea ice reports for the Antarctic shipping season 2014 - 2015

Prepared by: Dr Jan L Lieser (Jan.Lieser@acecrc.org.au), Dr Robert A Massom (Rob.Massom@acecrc.org.au) & Dr Petra Heil (Petra.Heil@acecrc.org.au)
Antarctic Climate & Ecosystems Cooperative Research Centre, May 2015

The sea ice reports compiled in this document are weekly reports on sea-ice conditions for East Antarctica, including sub-weekly updates. They were prepared to support ship operations in East Antarctica during the 2014/2015 shipping season. These reports were primarily used to guide the Australian Antarctic program, but were partly provided to other Antarctic operators. In particular, we assisted Chinese National Antarctic Research Expeditions (RSV *Xue Long*), the Royal New Zealand Navy, the New Zealand National Institute of Water and Atmospheric Research (RV *Tangaroa* Voyage 2), the Australian Marine National Facility (RV *Investigator*) and the US Antarctic Program (RVIB *Nathaniel B. Palmer* Voyage 15-03). During the season, these reports informed eight voyages, all of which returned within schedule or early due to navigational choices made by the ships' captains based on sea-ice reports.

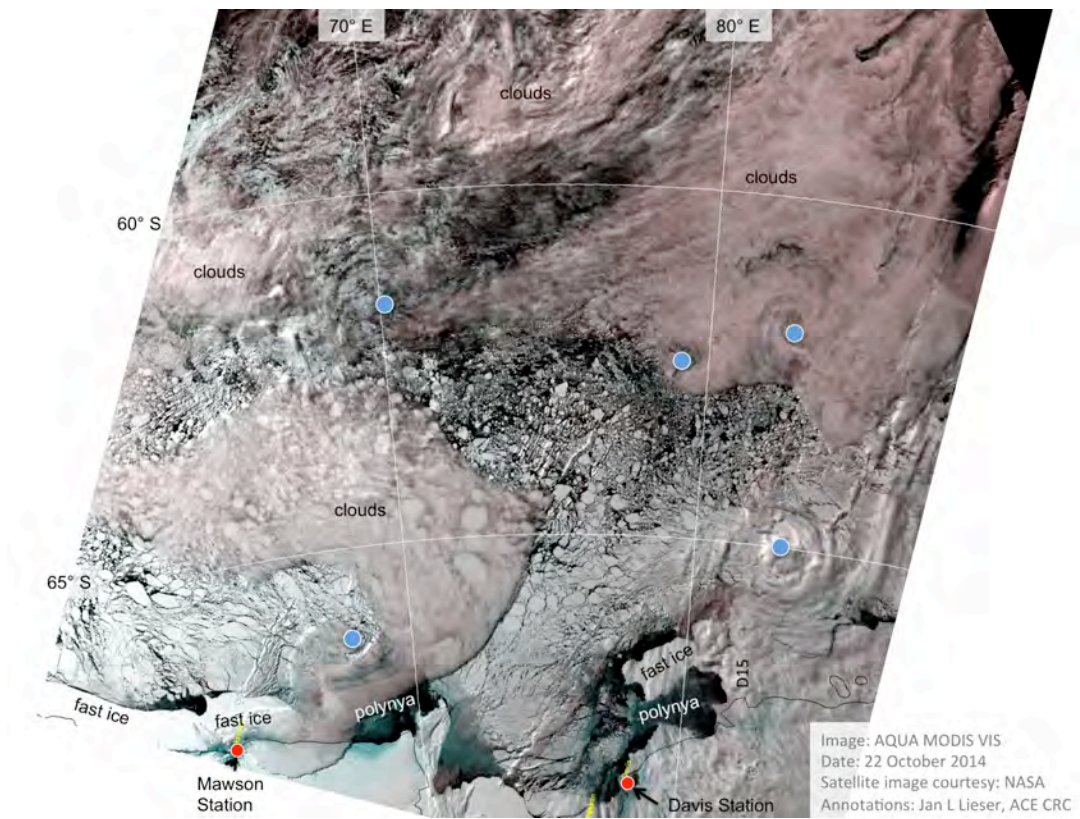
Figure 1: MODIS image, acquired 22/10/2014 and provided by NASA.

In Prydz Bay north of 65° S, sea-ice concentration is low to moderate and many individual floes can be identified in the MODIS image (Figure 1). This outer part of the pack ice is generally moving to the east and dispersing. The cloud patterns exhibit a number of eddy structures (the most prominent indicated by the blue dots). These small scale pressure systems act currently to loosen the pack ice further. South of 65° S, a band of high sea-ice concentration is still prevalent, originating north of the West Ice Shelf and iceberg D15 and turning southwest into the Prydz Bay at about 80° E and 65° S. The polynya off Davis Station and the fast ice distribution north of the station remains unchanged, including the tongue of fast ice extending west from iceberg D15.

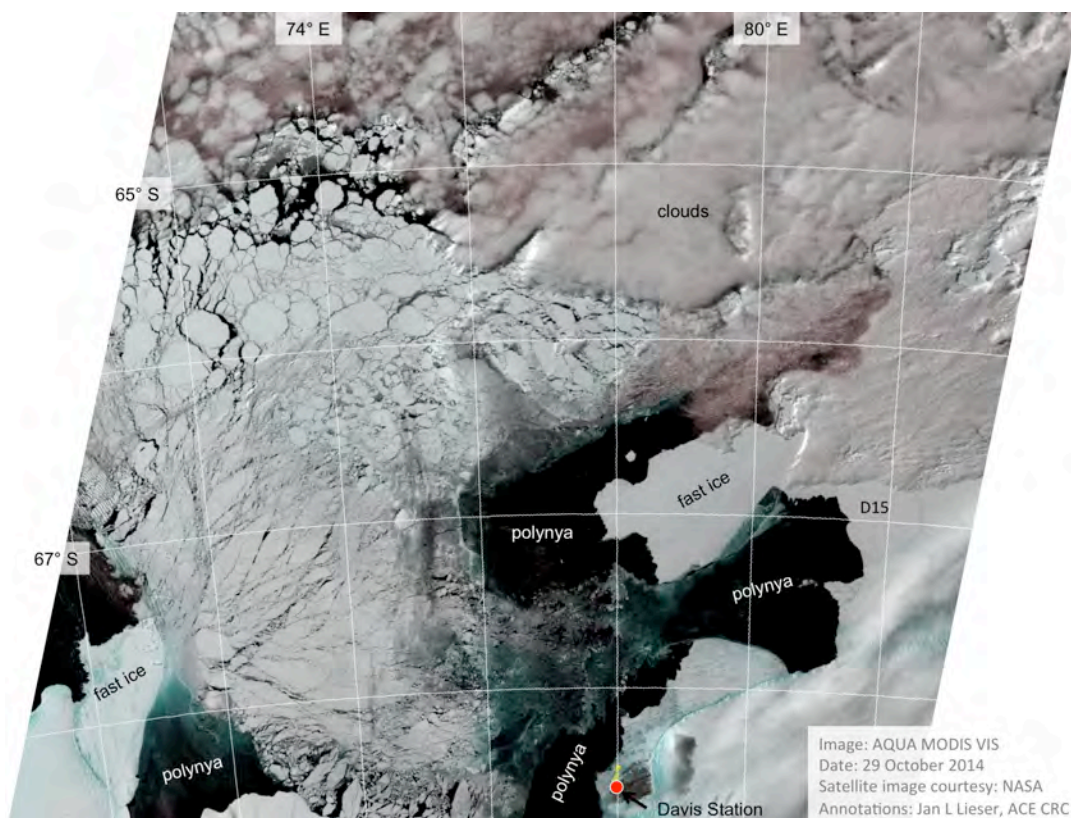
Figure 2: MODIS image, acquired 29/10/2014 and provided by NASA.

North of Davis Station and south of 65° S, many individual floes can be identified in the MODIS image (Figure 2). This is a high sea-ice concentration region, and only minor cracks and leads can be seen, mostly in northwest-southeast orientation east of 76° E, and southwest-northeast orientation west of 74° E, with a region of no prominent lead orientation in between.

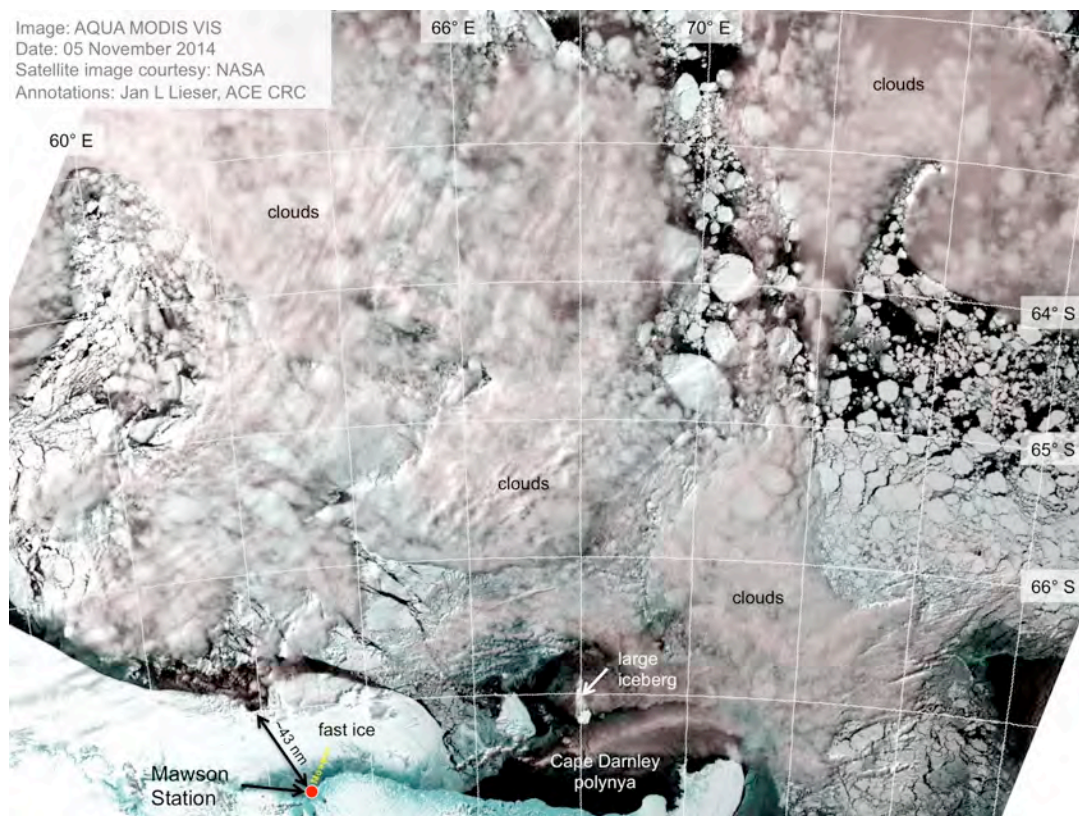
Figure 1: MODIS image, acquired 05/11/2014 and provided by NASA.

Figure 1 provides a high-resolution overview of sea-ice conditions off Mawson Station. The scene is partly obscured by thin clouds. North of 65° S, a large number of vast sea-ice floes can be seen in the eastern part of the image, drifting in loose pack. West of about 70° E, the sea-ice concentration is getting higher, and reaching further north.

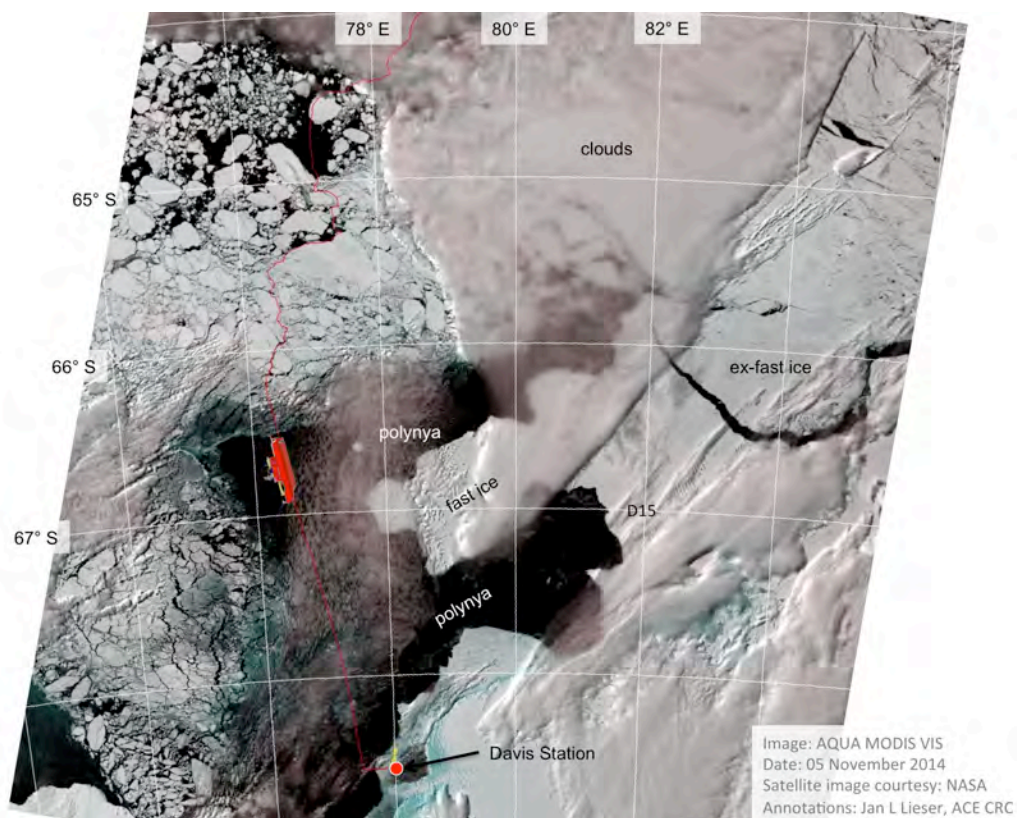
Figure 2: MODIS image, acquired 05/11/2014 and provided by NASA.

Fast ice has broken off from the West Ice Shelf east of iceberg D15, on 04/11/14. North of this now ex-fast ice, a region of very high concentration sea ice stretches up to about 64° 30' S (partly obscured by clouds in Figure 2).

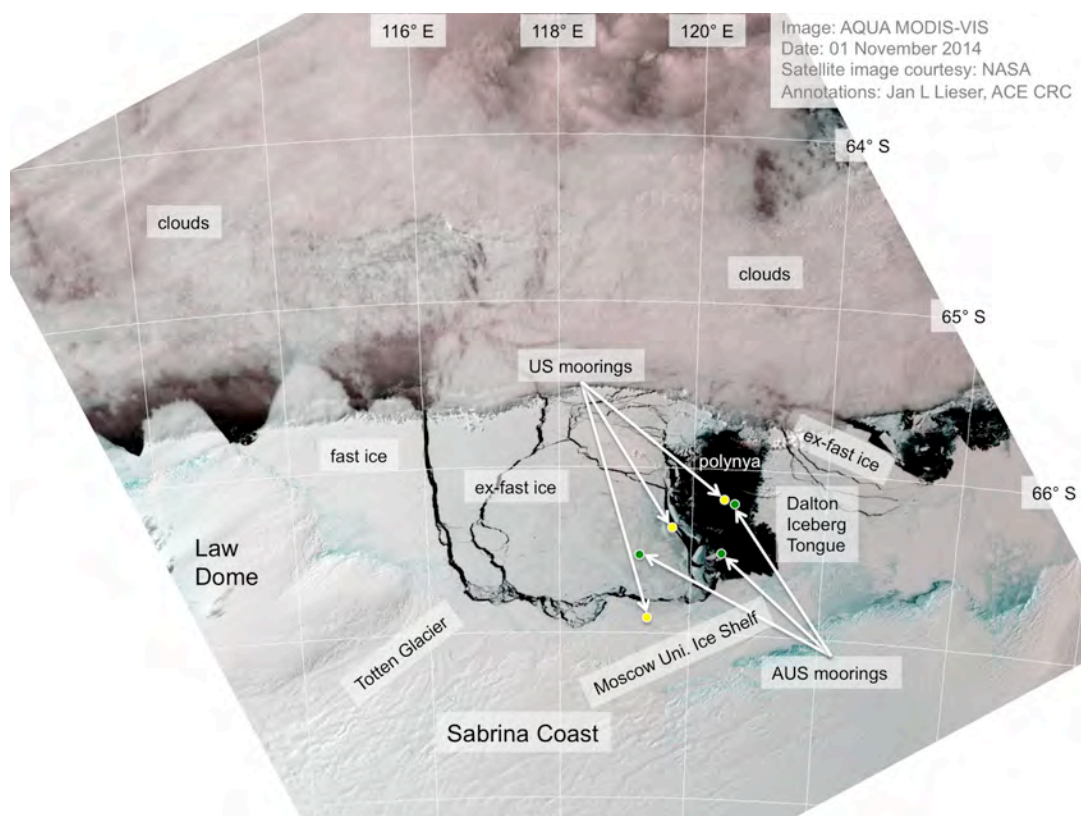
Figure 4: MODIS image, acquired 01/11/2014 and provided by NASA.

Figure 4 gives a cloud-free view of ex-fast ice north of Sabrina Coast, which has broken off on 31/10/14. The cracks leading north and east from the face of the Totten Glacier can be seen clearly in the image. The polynya west of the Dalton Iceberg Tongue appears well maintained. The approximate locations of three Australian (green dots) and three US (yellow dots) moorings are marked in Figure 4. On

01/11/14, fast ice has also broken away from the eastern side of the Dalton Iceberg Tongue.

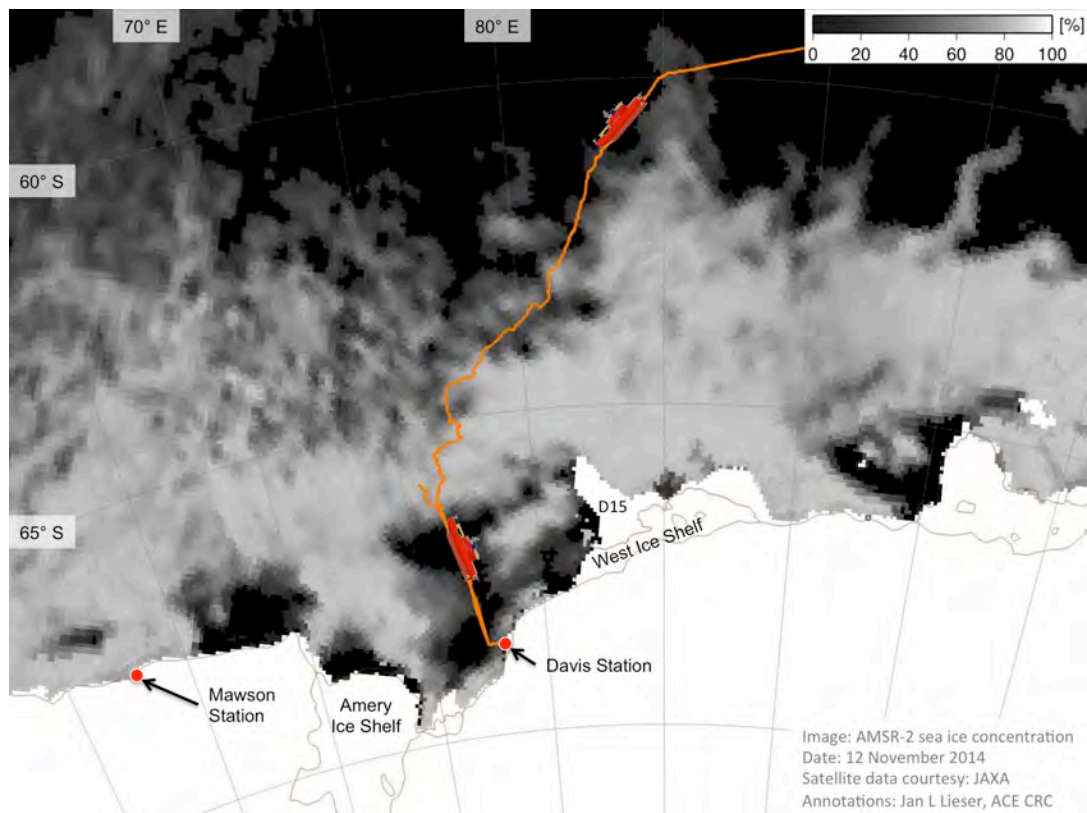
Figure 2: AMSR-2 image, acquired 12/11/2014 and provided by Drift & Noise Polar Services.

RSV *Aurora Australis* is currently on her way out from Davis Station through the highest concentration band of sea ice north of the station. Once north of 65° S, sea-ice conditions are expected to ease. The southernmost part of the sea-ice edge is just north of 63° S, between 78° E and 79° E (see Figure 2).

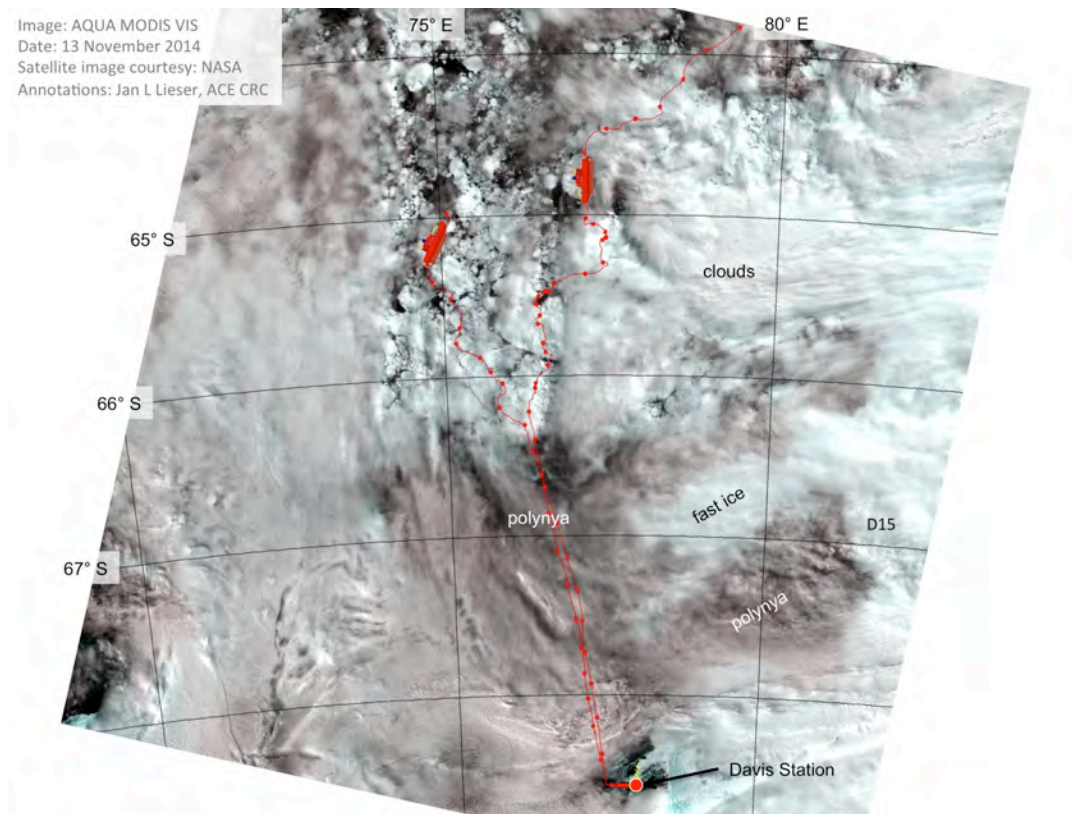
Figure 1: MODIS image, acquired 13/11/2014 and provided by NASA.

RSV *Aurora Australis* has crossed 65° S northwards and sea-ice conditions have eased. The cruise track can be seen as a thin red line with hourly dots in Figure 1.

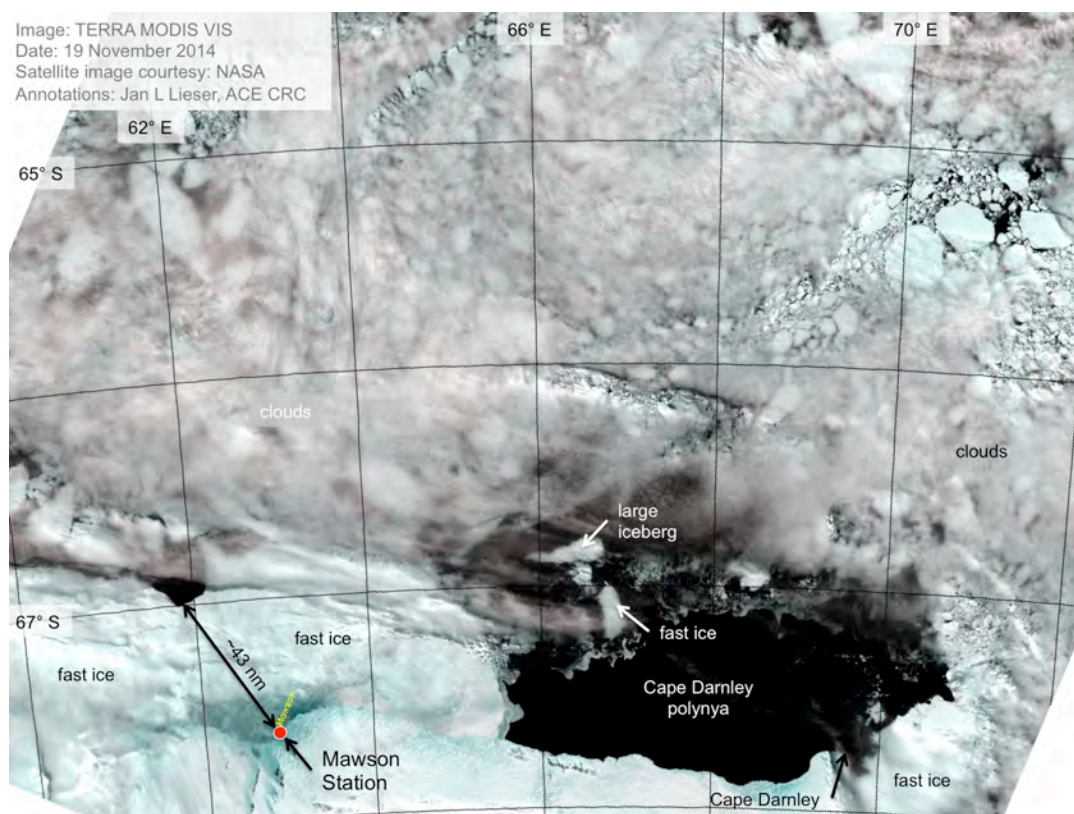
Figure 1: MODIS image, acquired 19/11/2014 and provided by NASA.

Figure 1 shows the Antarctic coast between Mawson Station and Cape Darnley and the sea ice to the north of it. During the past week, a sheet of accumulated pack ice against the fast ice off Mawson Station, about 15 nautical miles wide, has broken away from the eastern end of the fast ice, west of 66° E. About one degree further east from there, a large iceberg (annotated in Figure 1) has collided with a large patch of fast ice, currently to the southeast of the berg, and mobilised about 50% of the patch, which is now drifting with the westward current. Also, some ice has started to break away from the fast ice to the east of Cape Darnley.

Between 65° S and about 67° S, pack ice of various floe sizes and high to very high concentration is drifting predominantly westward in a compact band. Lesser concentration sea ice is found north of 65° S and currently reaching beyond (north of) 60° S.

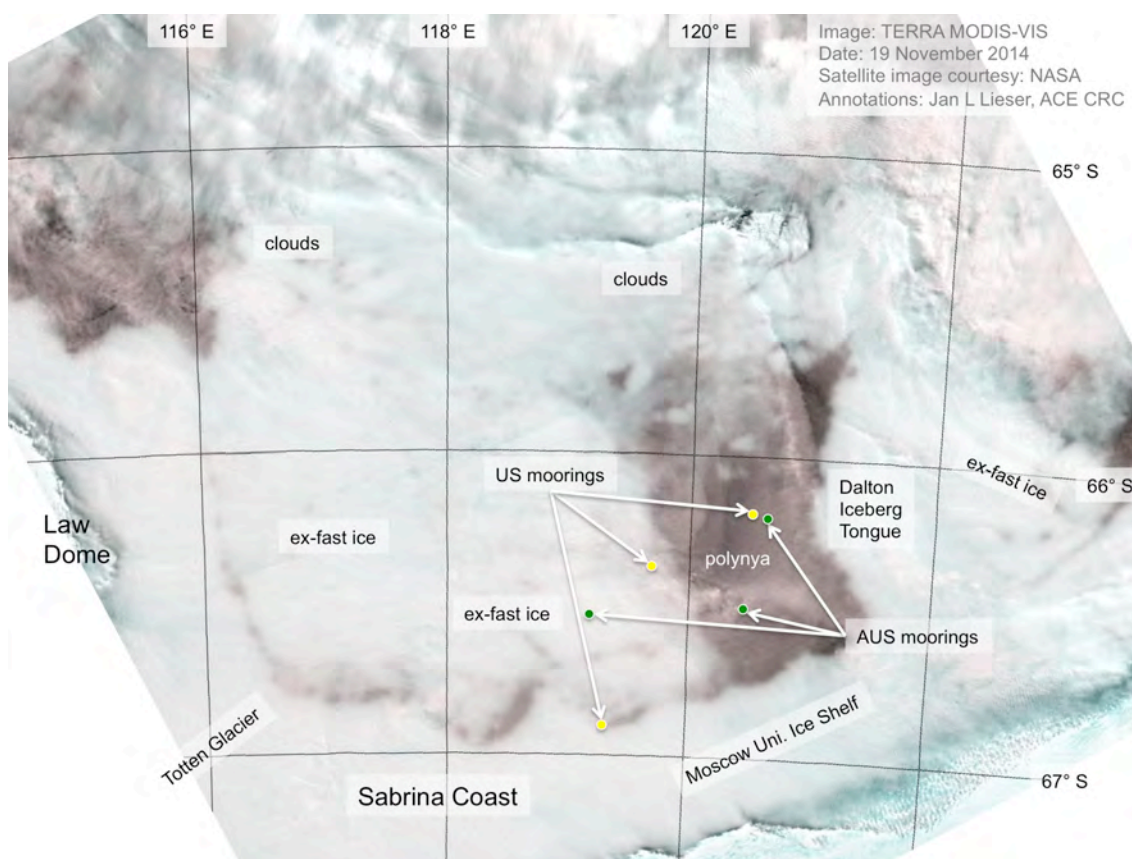
Figure 2: MODIS image, acquired 19/11/2014 and provided by NASA.

Figure 2 shows the region north of Sabrina Coast, between Law Dome and the Dalton Iceberg Tongue, almost entirely obscured by clouds. However, open water can be detected as darker patches through the cloud cover. The polynya west of the Dalton Iceberg Tongue remains active, and the ex-fast ice off the eastern flank of Law Dome remains mobile, even though it does not escape the embayment, yet. The pack ice north of this embayment reaches as far north as 63° 30' S, which is about one degree latitude further south than the pack ice edge described in the previous section.

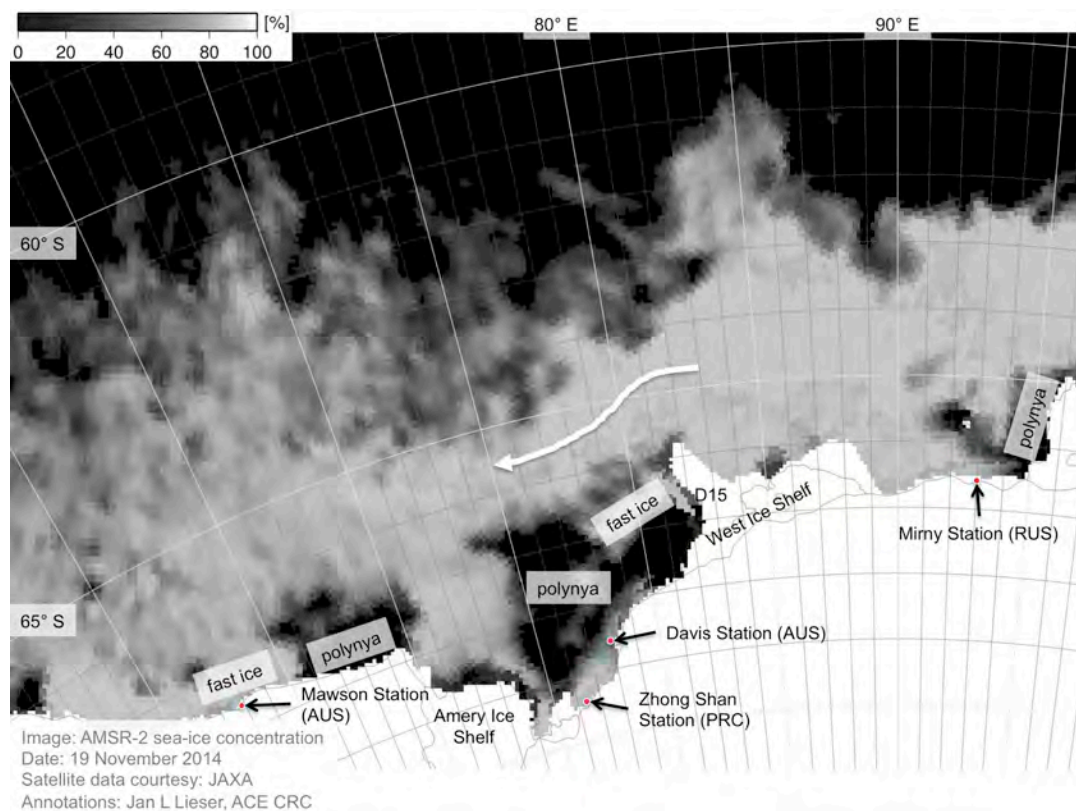
Figure 2: AMSR-2 image, acquired 19/11/2014 and provided by Drift & Noise Polar Services.

A larger overview of sea-ice concentration in the region is provided in Figure 2. The white arrow in the sea-ice zone between 64° 30' S and 65° 30' S indicates the general drift direction of a band of very high (up to 100%) sea-ice concentration. Overall, the sea-ice zone is contracting towards the south, as the sea-ice edge is retreating with the advancing summer conditions. The general sea-ice drift pattern within Prydz Bay north of the Amery Ice Shelf is northwestward, expanding the polynya off the Vestfold Hills and Larsemann Hills.

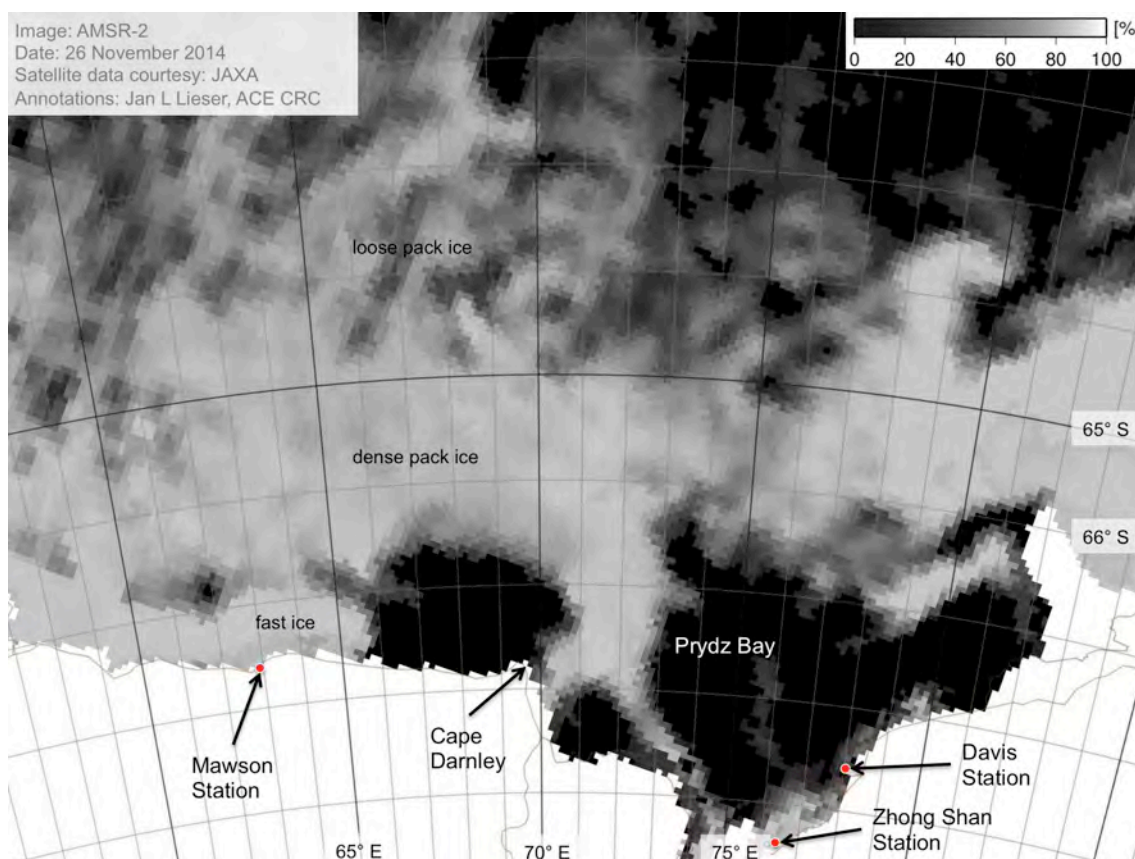
Figure 1: AMSR-2 image, acquired 26/11/2014 and provided by Drift & Noise Polar Services.

Sea ice is showing more signs of early summer retreat in Prydz Bay and north of Mawson Station. The western edge of the Prydz Bay polynya off the Vestfold and Larsemann hills has migrated about 50 nautical miles westward, from 75° E to about 73° E during the past week. At the same time, the northward drift of sea ice in western Prydz Bay (between 71° E and 73° E) has strengthened and more fast ice has broken off the eastern side of Cape Darnley.

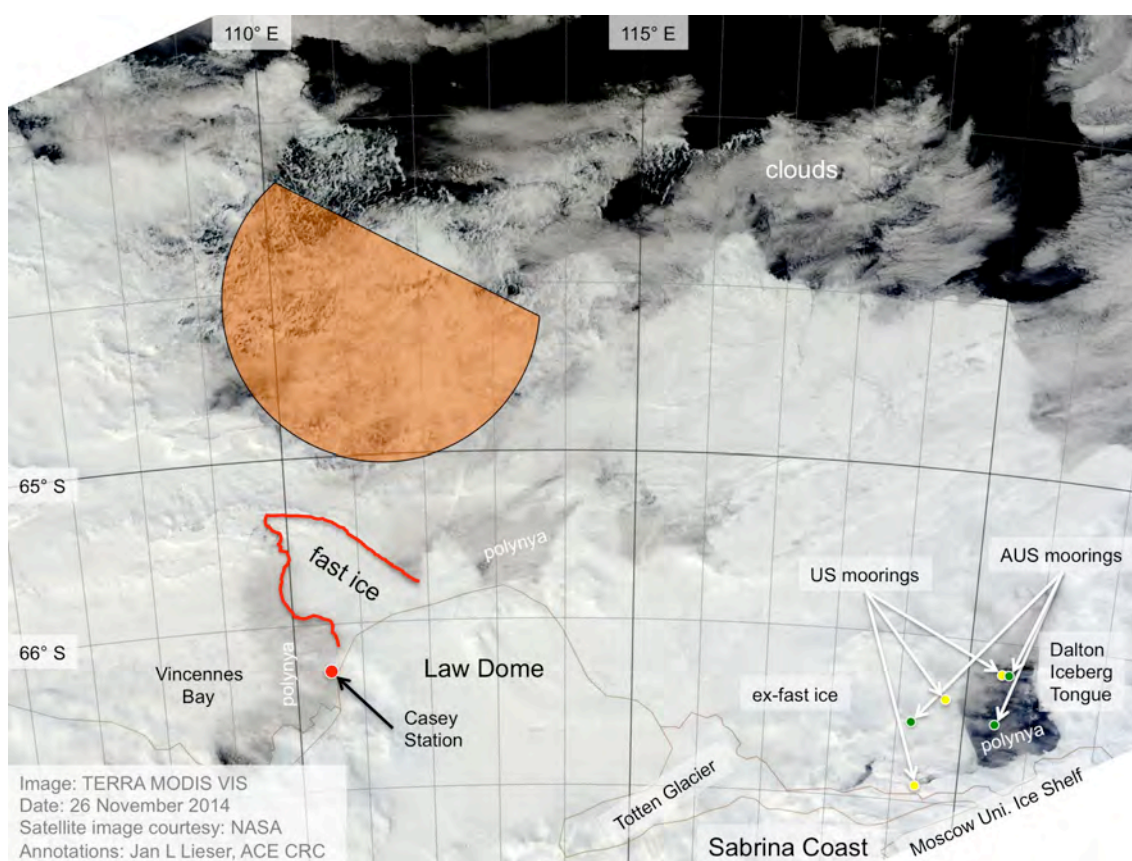
Figure 2: MODIS image, acquired 26/11/2014 and provided by NASA.

Sea-ice conditions in the polynya west of the Dalton Iceberg Tongue remain largely unchanged. The northern sea-ice edge between 115° E and 125° E (and even further east) has been compacted recently and exhibits a very defined northern boundary.

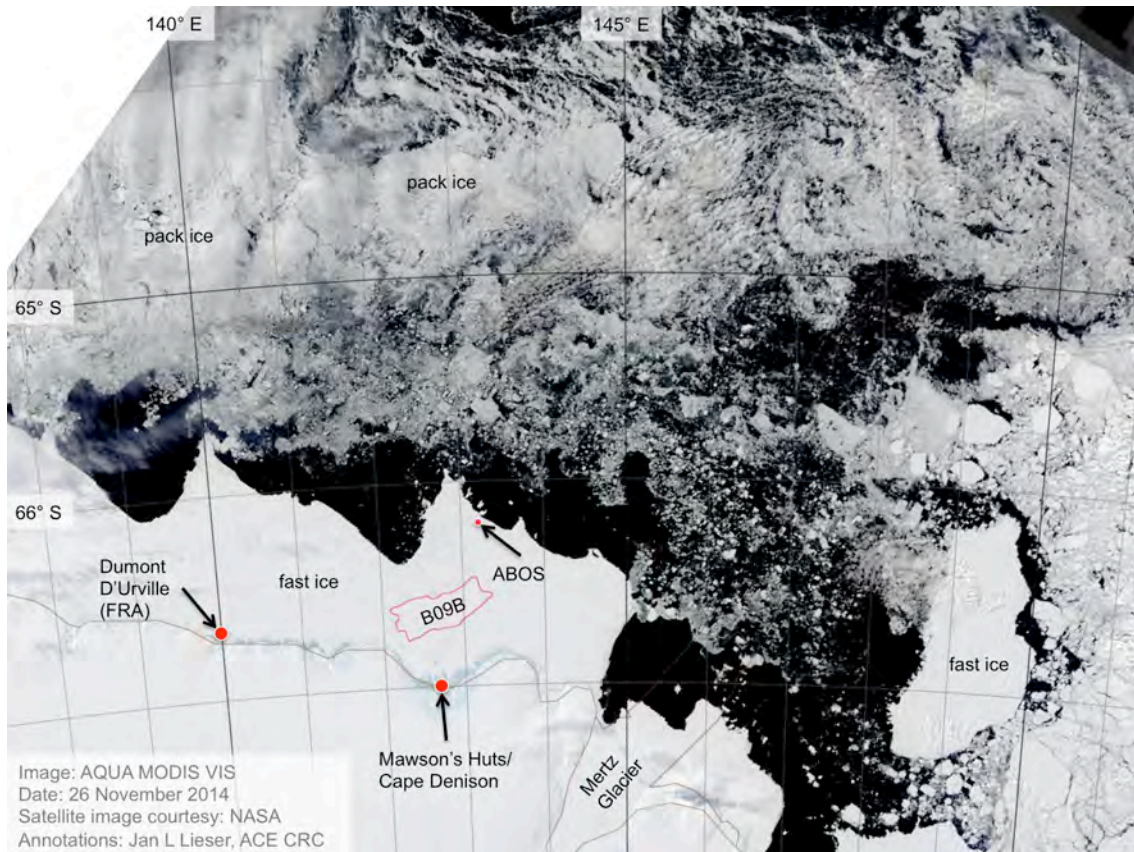
Figure 3: MODIS image, acquired 26/11/2014 and provided by NASA.

The overall fast ice distribution off Commonwealth Bay and Dumont d'Urville Station has not changed significantly during the past week, but small bits of fast ice are breaking away from the main body of fast ice north of iceberg B09B. Another large iceberg remains centred at 142° 57' E and 66° 09' S. The location of the ABOS mooring is still covered by fast ice to the southeast of this berg and about two

naautical miles (at a bearing of about 210°) south of the fast ice edge.

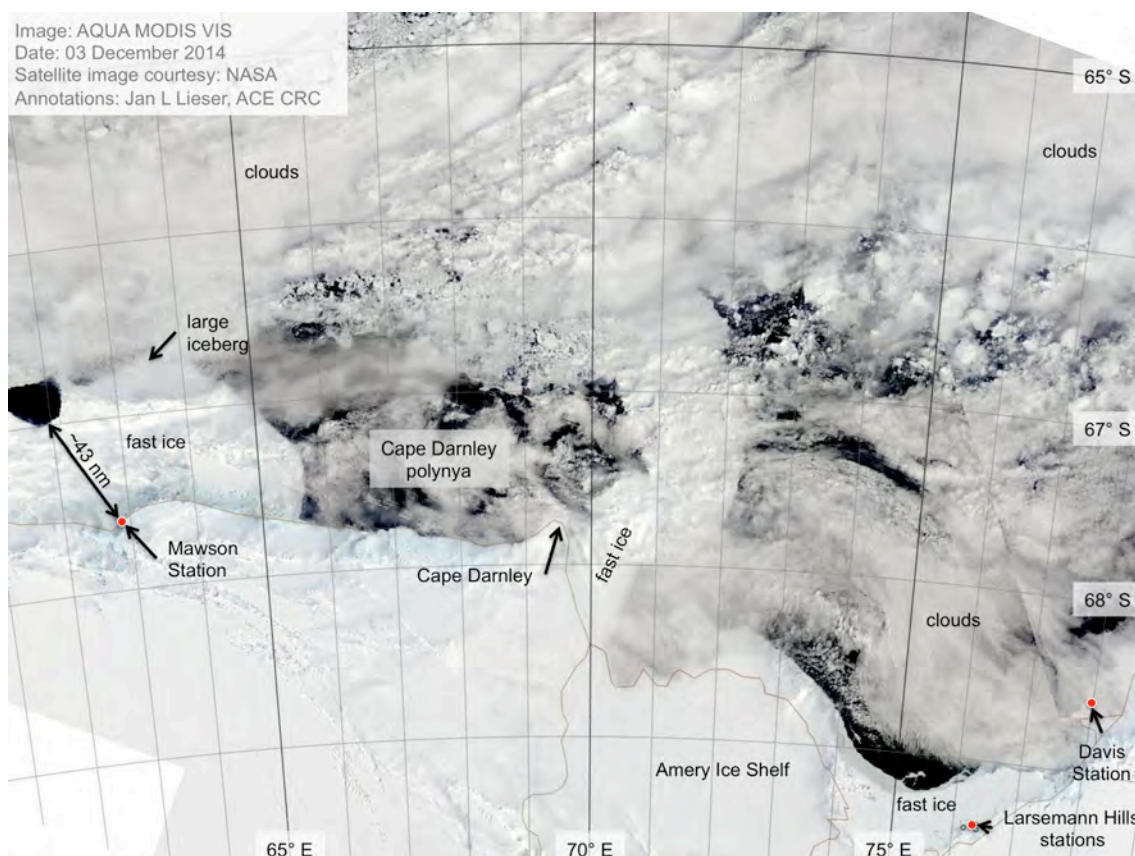
Figure 1: MODIS image, acquired 03/12/2014 and provided by NASA.

Figure 1 shows the Antarctic coast between Mawson and Davis stations. The extent of the fast ice off Mawson Station appears largely unchanged since last week, but the fast ice island in the middle of the Cape Darnley polynya (see Figure 1 of Sea Ice Report #26/2014 for reference) has disintegrated and more little bits of fast ice are breaking off the large body of fast ice to the east of Cape Darnley. A large iceberg is moving westward north of the fast ice edge off Mawson Station and is currently centred at about 66° 42' S and 63° 47' E.

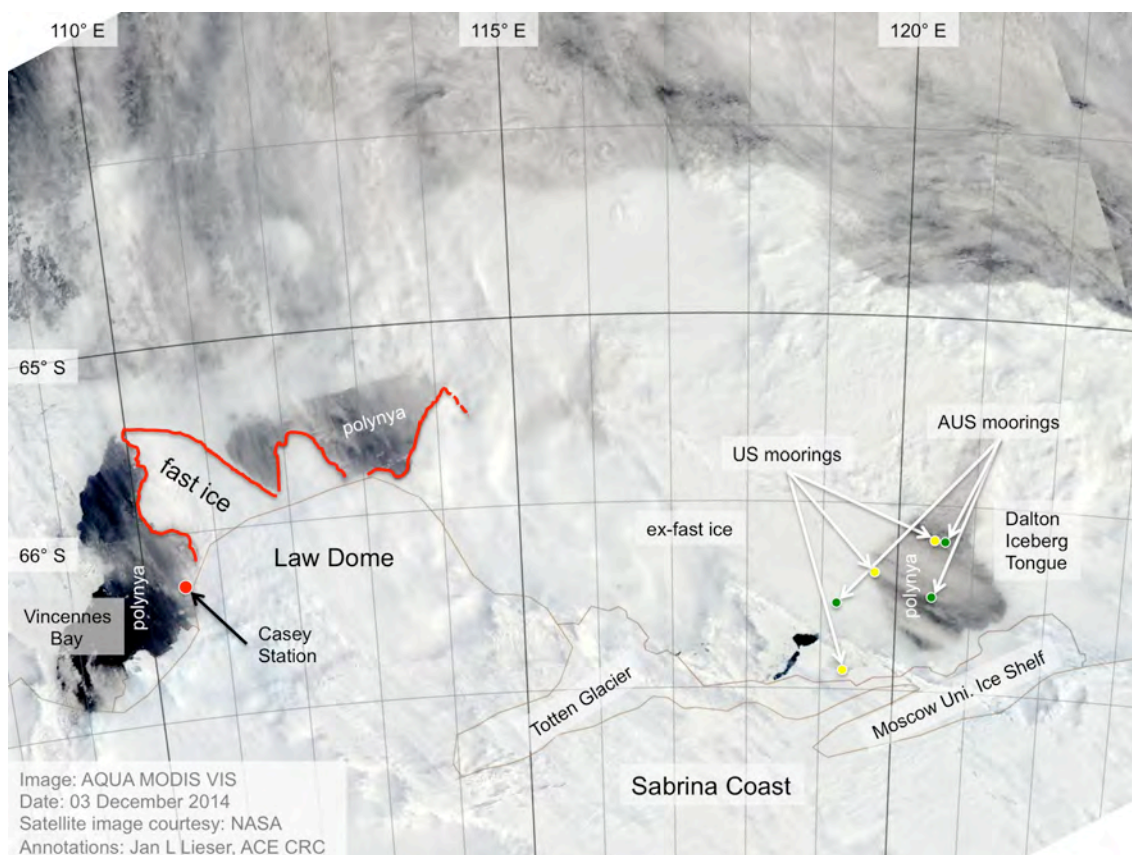
Figure 2: MODIS image, acquired 03/12/2014 and provided by NASA.

The eastern part of Vincennes Bay (off Casey Station) remains largely sea ice free, while the western part is still fully covered by sea ice. During the past week, the extent of the fast ice attached to the northwestern side of Law Dome is largely unchanged, but the pack ice to the north of it is retreating further south. While some sea ice can be found north of 64° S, especially along 110° E, the band of very high concentration sea ice immediately north of the fast ice north of Casey Station (see Sea Ice Report #27/2014) has thinned in north-south extent. Its northern edge towards the very open pack ice is now south of 65° S, at about 65° 10' S between 109° 30' E and 111° 30' E.

In the polynya west of the Dalton Iceberg Tongue, the ex-fast ice had broken into many pieces but has recently been pushed south again and compacted against the coast. The locations of six moorings are indicated in Figure 2. The three western moorings are under changing sea-ice cover, while the three eastern moorings are in the open water of the polynya.

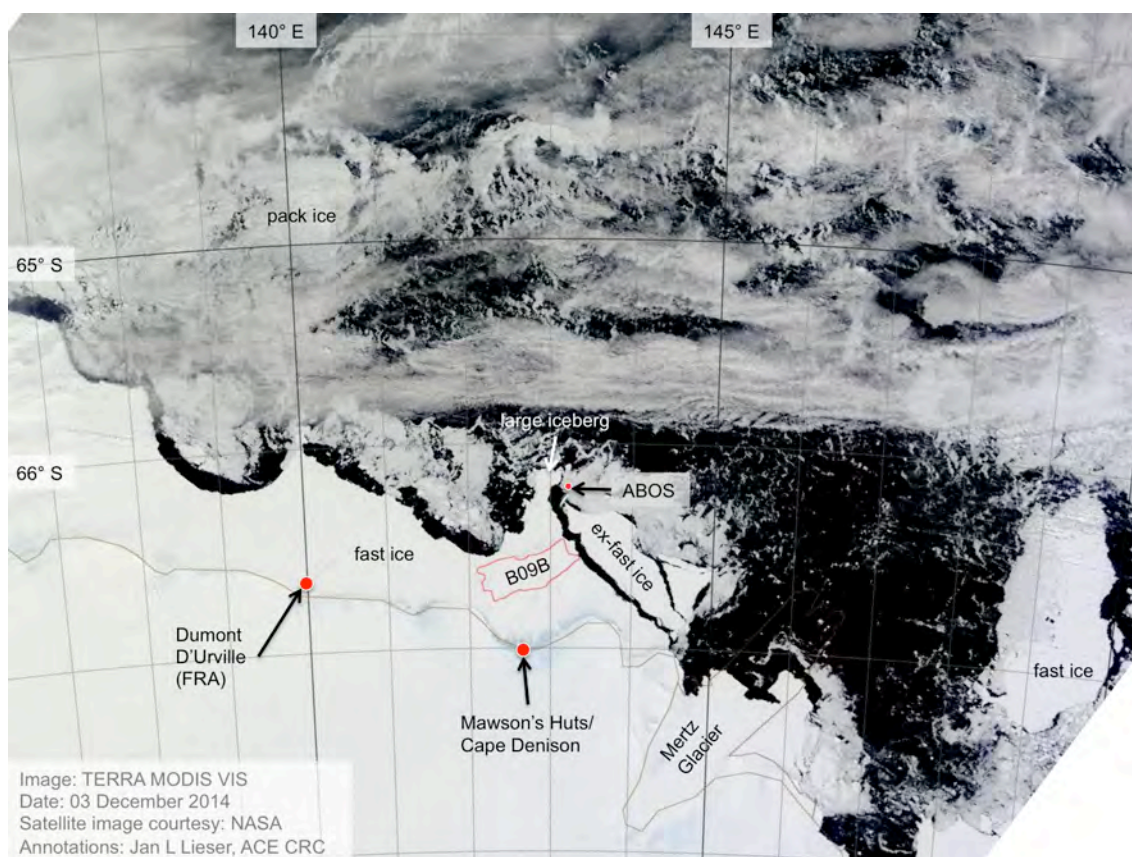
Figure 3: MODIS image, acquired 03/12/2014 and provided by NASA.

During the past week, significant pieces of fast ice have broken off from the large area of fast ice west of the Mertz Glacier, and further west between iceberg B09B and Dumont d'Urville Station, as well as to the west of 140° E. To the east of iceberg B09B alone, more than 5,000 square kilometres of old fast ice have broken away (about the size of Trinidad, or six times the size of iceberg B09B). As a result of this large scale break-off, the location of the ABOS mooring is now covered by drifting ex-fast ice. The large iceberg north of iceberg B09B remains still in place and attached to some fast ice connected to iceberg B09B.

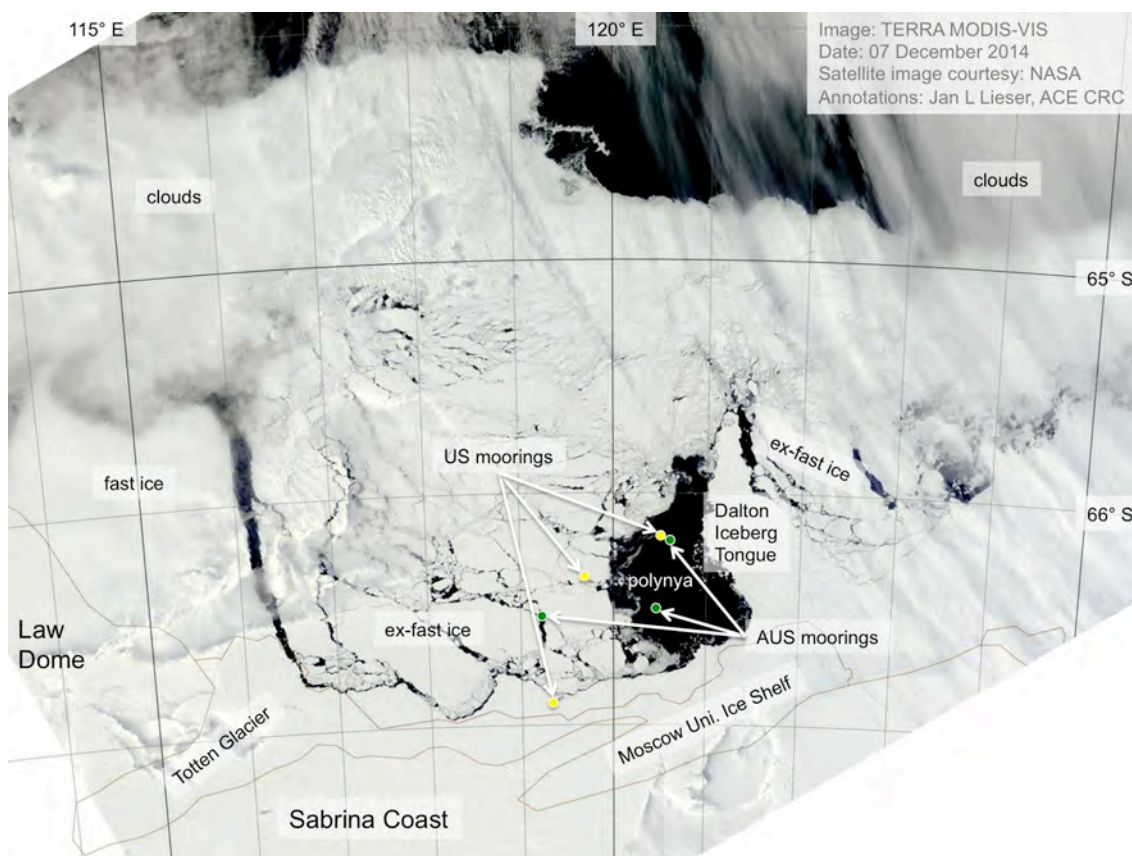
Figure 1: MODIS image, acquired 07/12/2014 and provided by NASA.

Off the Totten Glacier, the ex-fast ice is quite dynamic. It has broken into further pieces but remains largely in the embayment between Law Dome and the Dalton Iceberg Tongue, north of Sabrina Coast. Three of the marked moorings in Figure 1 are in open water of the polynya, three are covered by broken ex-fast ice. To the east of the Dalton Iceberg Tongue, ex-fast ice has also broken further into smaller floes.

Between 115° E and 125° E, the northern sea-ice edge is well defined and compacted.

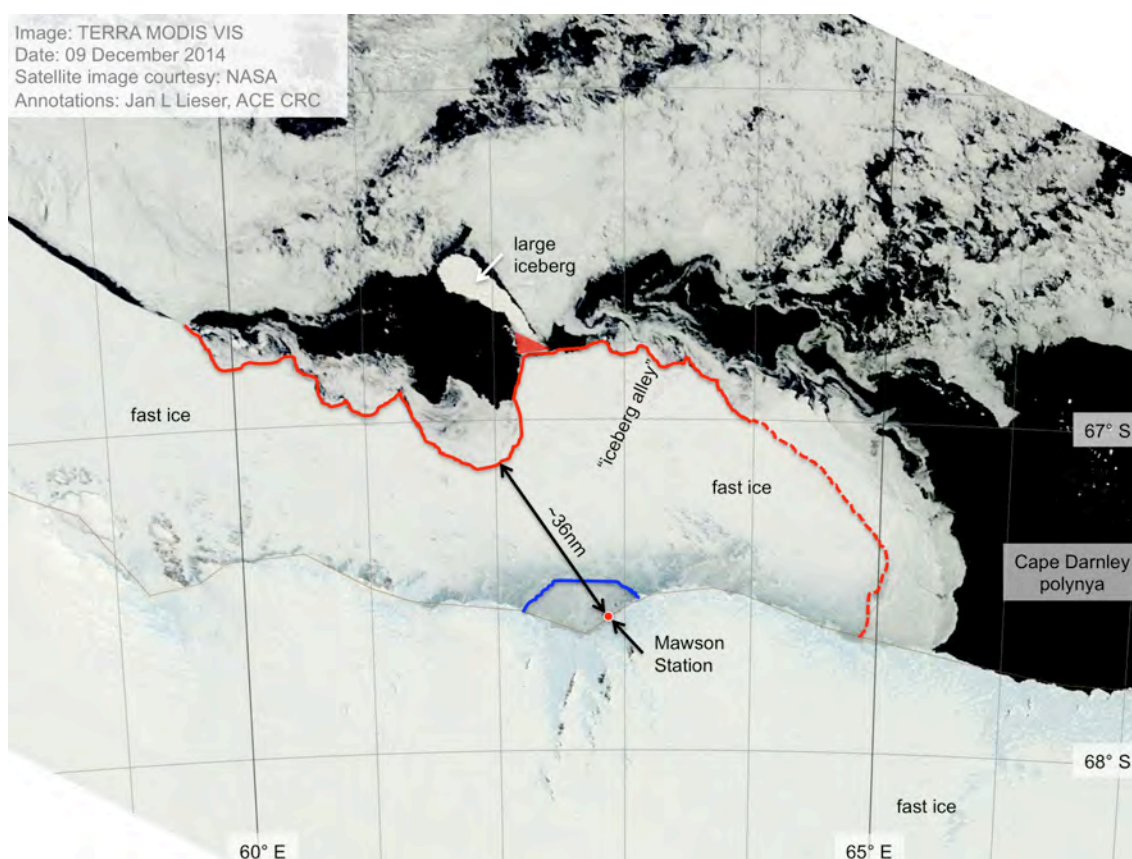
Figure 1: MODIS image, acquired 09/12/2014 and provided by NASA.

Figure 1 shows an entirely cloud free scene of the Mawson Coast. The large iceberg drifting westward north of the fast ice edge can be seen centred at $61^{\circ} 53' E$ and $66^{\circ} 35' S$. Its pointy southern end has recently collided with the northern tip of the fast ice off Mawson Station and shattered it (indicated by the red-shaded triangle).

The large body of fast ice north of Mawson Station shows early signs of retreat. The largest proportion of fast ice has broken away from the edge of the so-called north-west polynya, reducing the distance between the fast ice edge and the station to about 36 nautical miles. The new fast ice edge is drawn as a red line in Figure 1. The dashed

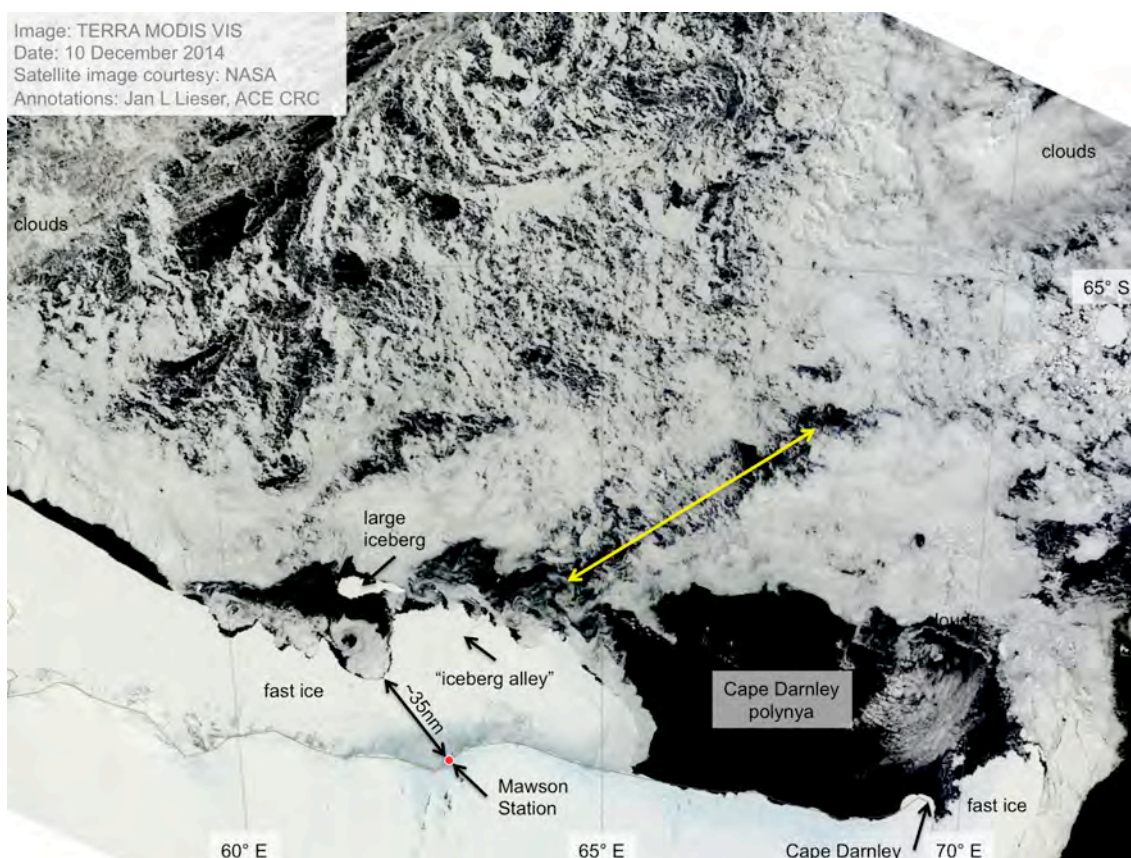
Figure 1: MODIS image, acquired 10/12/2014 and provided by NASA.

The pack ice is clearly separated from the fast ice and the coast, with the only exception to this east of the fast ice east of Cape Darnley. Summer conditions are more and more visible with general reduction of sea-ice concentration and major openings appearing in the pack ice, for example as indicated by the yellow double arrow.

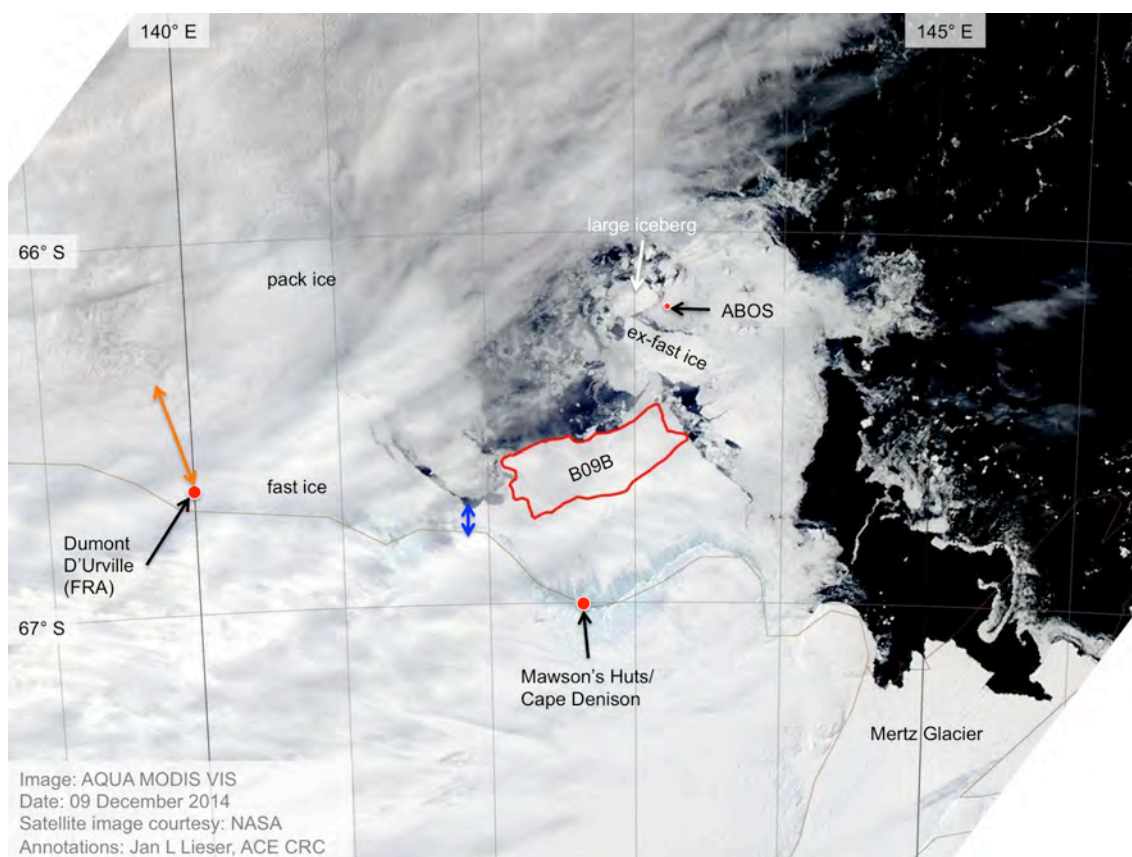
Figure 3: MODIS image, acquired 09/12/2014 and provided by NASA.

Fast ice break-up continues off Dumont d'Urville Station and Commonwealth Bay (Figure 3). Almost three sides of iceberg B09B are now free of fast ice and fast ice retreated almost back to the coast, west of the berg. The blue double arrow indicates a distance of about 4 nautical miles. The large iceberg north of iceberg B09B

(annotated) remains grounded and a large sheet of ex-fast ice is still between these icebergs. The location of the ABOS mooring is covered by pieces of ex-fast ice with localised high concentration.
