Sea ice reports for the Antarctic shipping season 2014 - 2015

Prepared by: Dr Jan L Lieser (Jan.Lieser@acecrc.org.au), Dr Robert A Massom (Rob.Massom@acecrc.org.au) & Dr Petra Heil (Petra.Heil@acecrc.org.au)
Antarctic Climate & Ecosystems Cooperative Research Centre, May 2015

The sea ice reports compiled in this document are weekly reports on sea-ice conditions for East Antarctica, including sub-weekly updates. They were prepared to support ship operations in East Antarctica during the 2014/2015 shipping season. These reports were primarily used to guide the Australian Antarctic program, but were partly provided to other Antarctic operators. In particular, we assisted Chinese National Antarctic Research Expeditions (RSV *Xue Long*), the Royal New Zealand Navy, the New Zealand National Institute of Water and Atmospheric Research (RV *Tangaroa* Voyage 2), the Australian Marine National Facility (RV *Investigator*) and the US Antarctic Program (RVIB *Nathaniel B. Palmer* Voyage 15-03). During the season, these reports informed eight voyages, all of which returned within schedule or early due to navigational choices made by the ships' captains based on sea-ice reports.

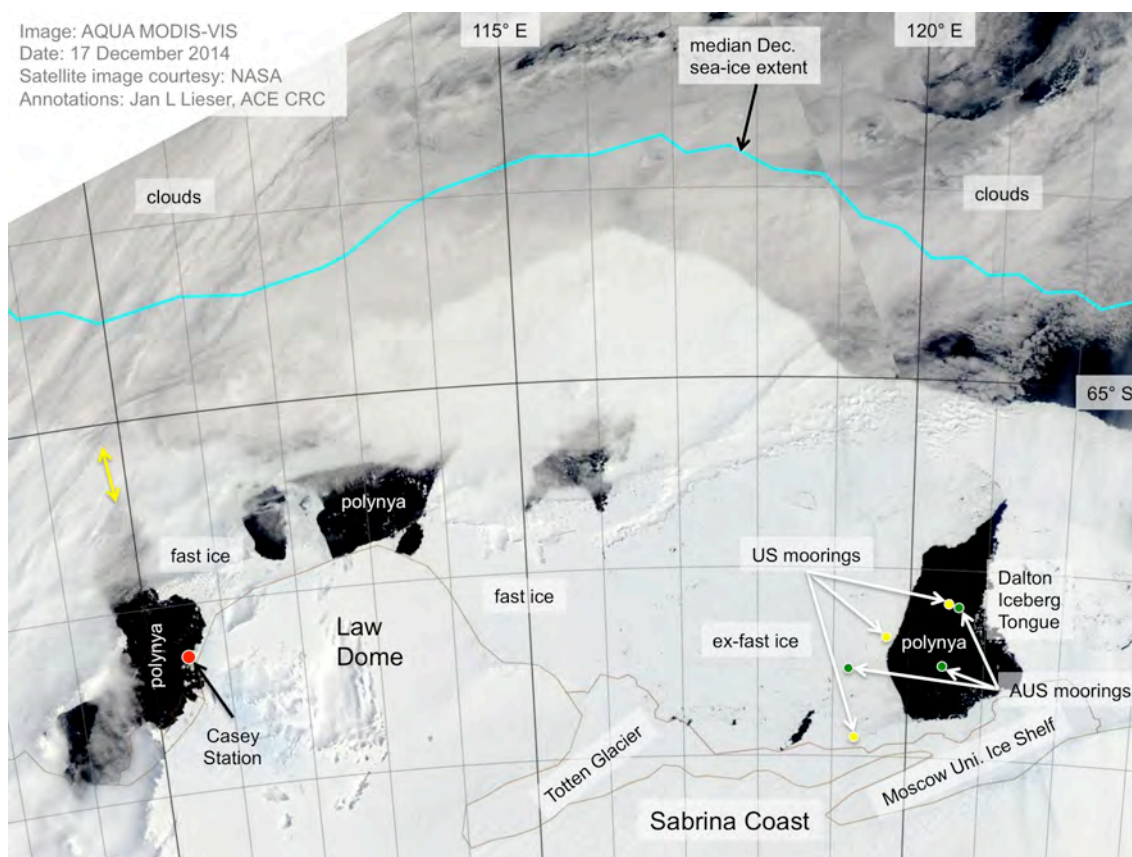
Figure 2: MODIS image, acquired 17/12/2014 and provided by NASA.

Figure 2 provides a visible impression of the sea-ice conditions between Casey Station and the Dalton Iceberg Tongue. The northern and western part of the scene is obscured by clouds but the open water of polynyas and the open ocean shines through the clouds. The northern sea-ice edge can be clearly identified as a well defined boundary, between 25 nautical miles and 50 nautical miles south of the 30-year median sea-ice extent (marked as a cyan line in the figure).

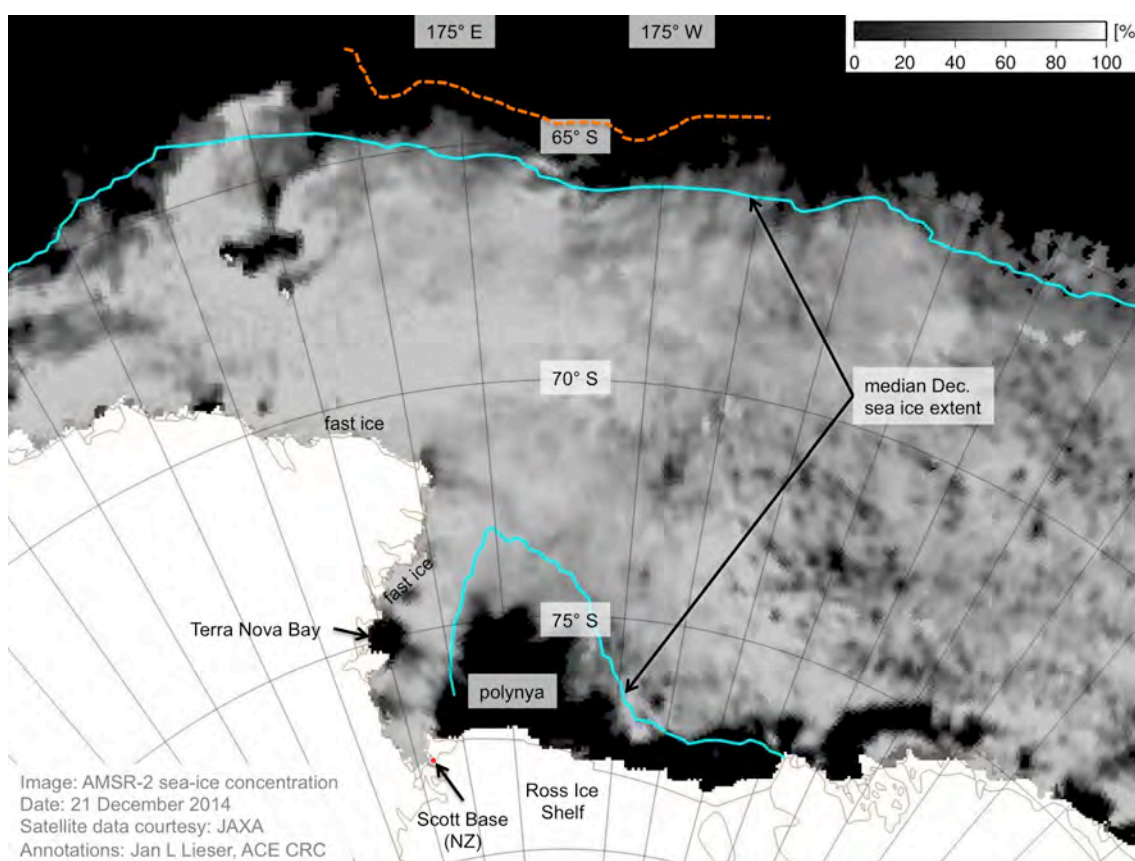
Figure 1: AMSR-2 image, acquired 21/12/2014 and provided by Drift & Noise Polar Services.

Figure 1 shows a map of sea-ice concentration for the Ross Sea and adjacent areas. The cyan line indicates the 30-year (1981-2010) median sea-ice extent for December in the region. Between 170° E and 170° W, the orange dashed line marks the northern edge where sea ice can reasonably be expected currently.

The northern sea-ice edge is continuing to retreat southward slowly. The polynya off the face of the Ross Ice Shelf is still growing in extent. Terra Nova Bay remains largely free of sea ice.

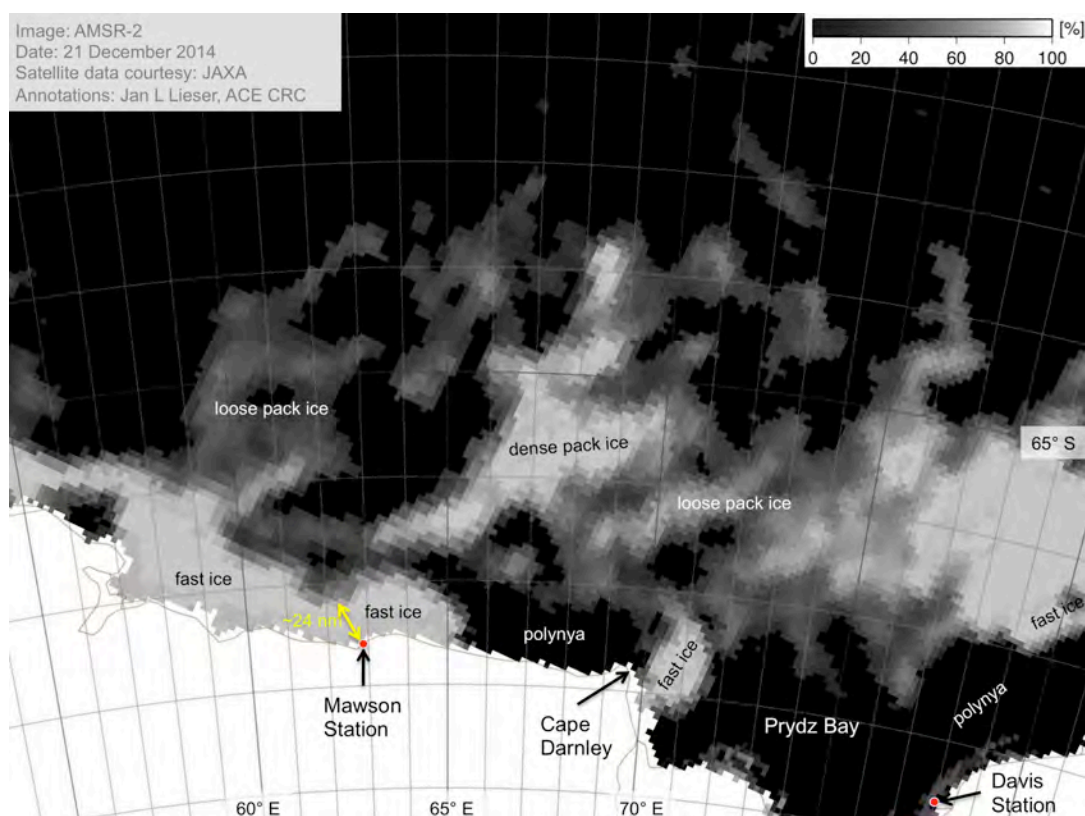
Figure 1: AMSR-2 image, acquired 21/12/2014 and provided by Drift & Noise Polar Services.

Off Mawson Station, fast ice continues to break up. The distance to the so-called northwest polynya is currently about 24 nautical miles, down from about 28 nautical miles four days ago. The large iceberg (see Sea Ice Report #29/2014) has left the area and continues its westward drift. It is currently centred at about 58° 25' E and 66° 16' S. North of Mawson Coast, the pack ice shows further reduction and very patchy concentration. Prydz Bay polynya remains much larger than usual (see Figure 1).

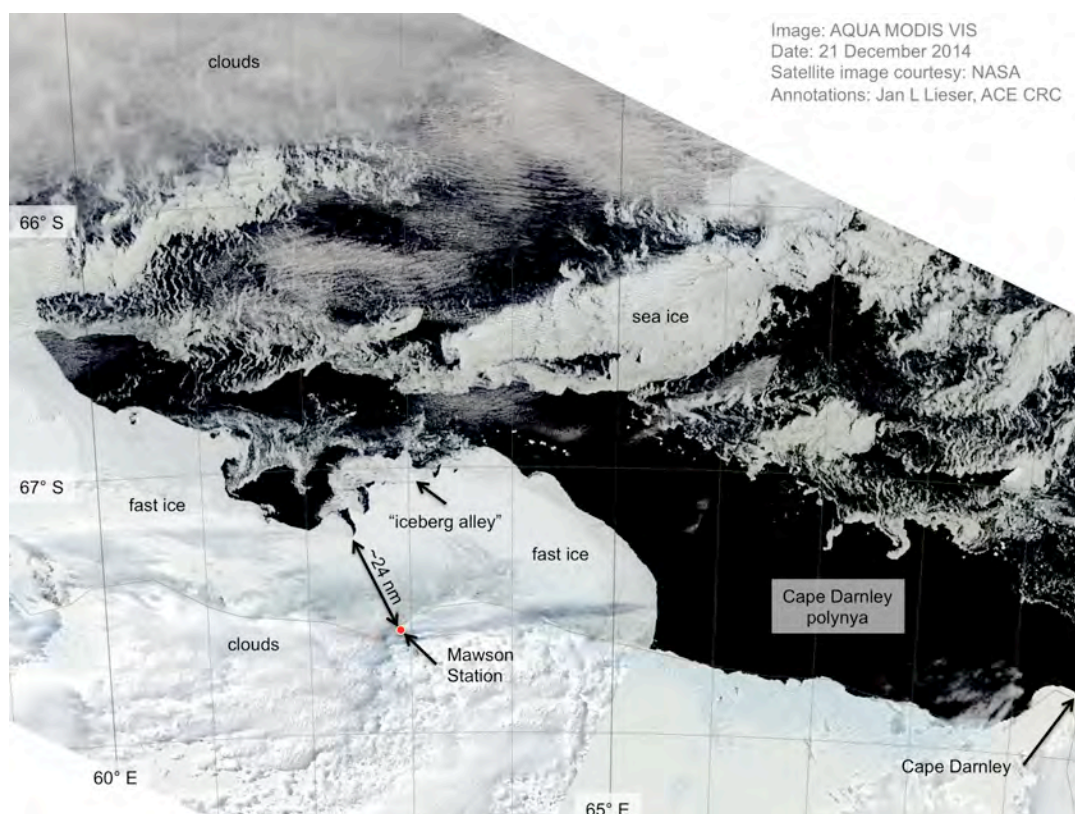
Figure 2: MODIS image, acquired 21/12/2014 and provided by NASA.

North of Mawson Station, the fast ice edge has progressed southward and is now south of 67° S (see Figure 2 and for comparison Sea Ice Report #28c/2014). The so-called 'iceberg alley' appears to be free of fast ice, even though broken up ex-fast ice is still in the area.

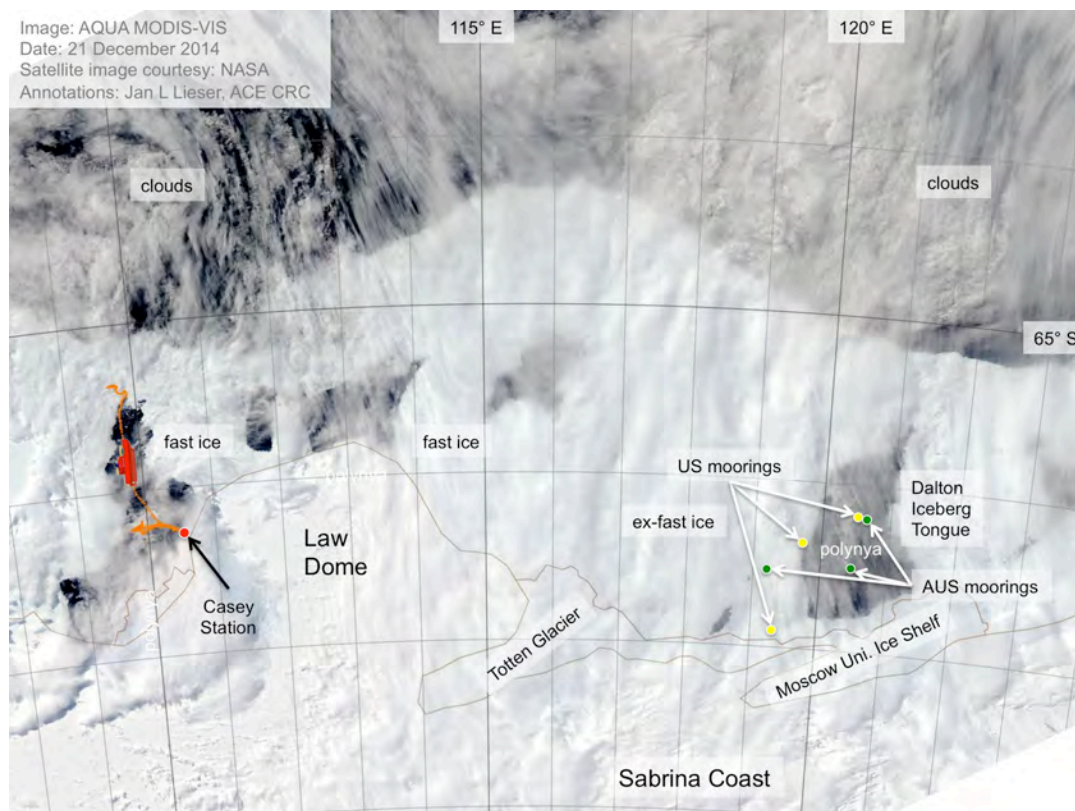
Figure 3: MODIS image, acquired 21/12/2014 and provided by NASA.

Figure 3 provides a visible image of the sea-ice conditions between Casey Station and the Dalton Iceberg Tongue. The entire scene is obscured by clouds but the open water of polynyas and the open ocean shines through the clouds. The northern sea-ice edge has been compacted and can be clearly identified as a well defined boundary. The orange dotted line marks the cruise track of RSV *Aurora Australis* (up until 22/12/2014 04:00 UT), after finishing the resupply of Casey Station.

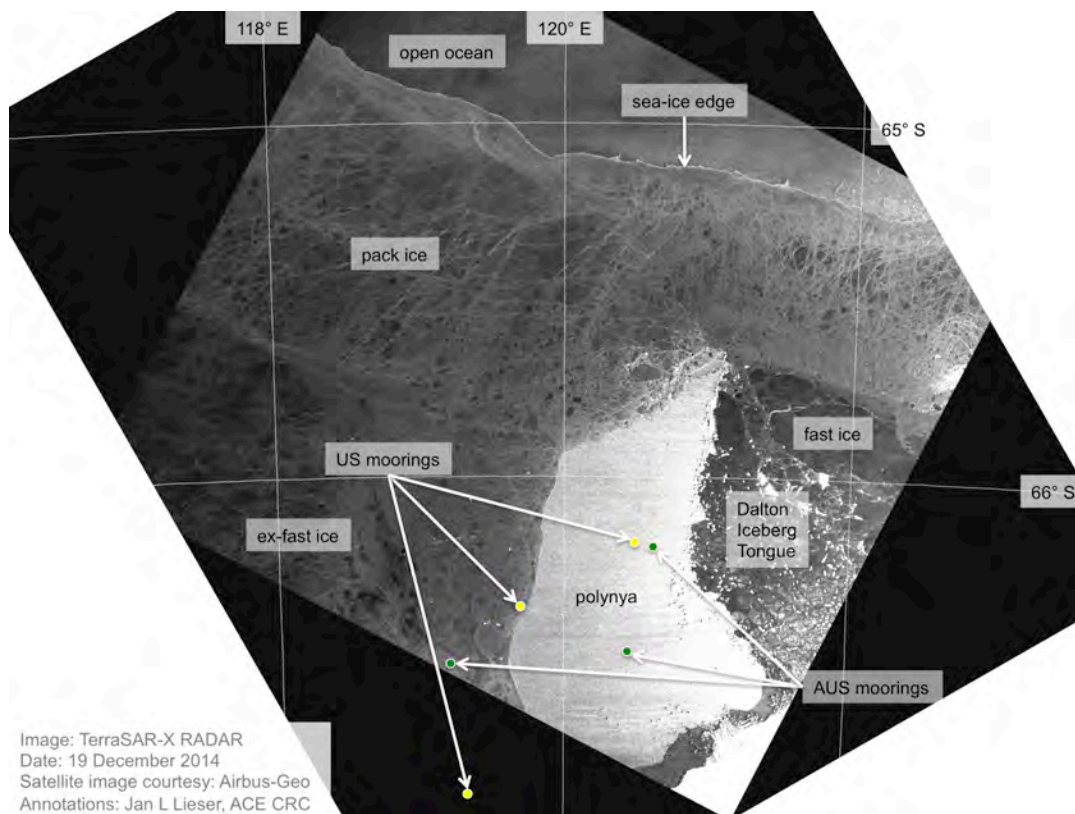
Figure 4: TerraSAR-X RADAR image, acquired 19/12/2014 and provided by Airbus-Geo.

Figure 4 gives a high resolution (100 m pixel size) RADAR image of the polynya west of the Dalton Iceberg Tongue and the pack ice north of it. The sea-ice edge is well defined and can be identified as a white line (high roughness/deformation) at the northern boundary of the pack ice. Many linear kinematic features (deformation lines) are criss-crossing the interior pack ice zone. There is no overall predominant orientation of these features apparent in the image. Immediately south of the sea-ice edge, these deformation lines appear arched, most likely as a result of recent compression by northerly winds. Between about 119° E and 121° E and north of the

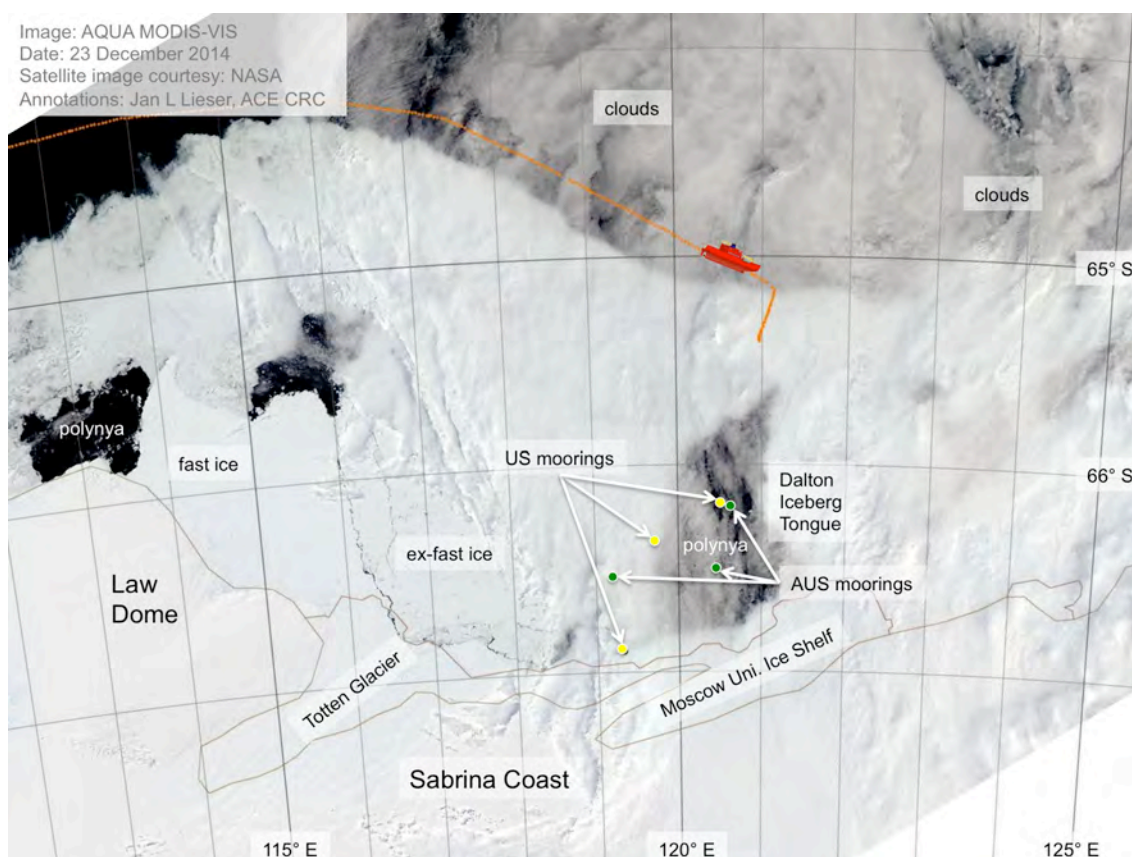
Figure 1: MODIS image, acquired 23/12/2014 and provided by NASA.

Figure 1 provides a visible impression of sea-ice conditions between Law Dome and the Dalton Iceberg Tongue. The orange dotted line denotes the recent cruise track of RSV *Aurora Australis* in the region (up until 24/12/2014 00:00 UT).

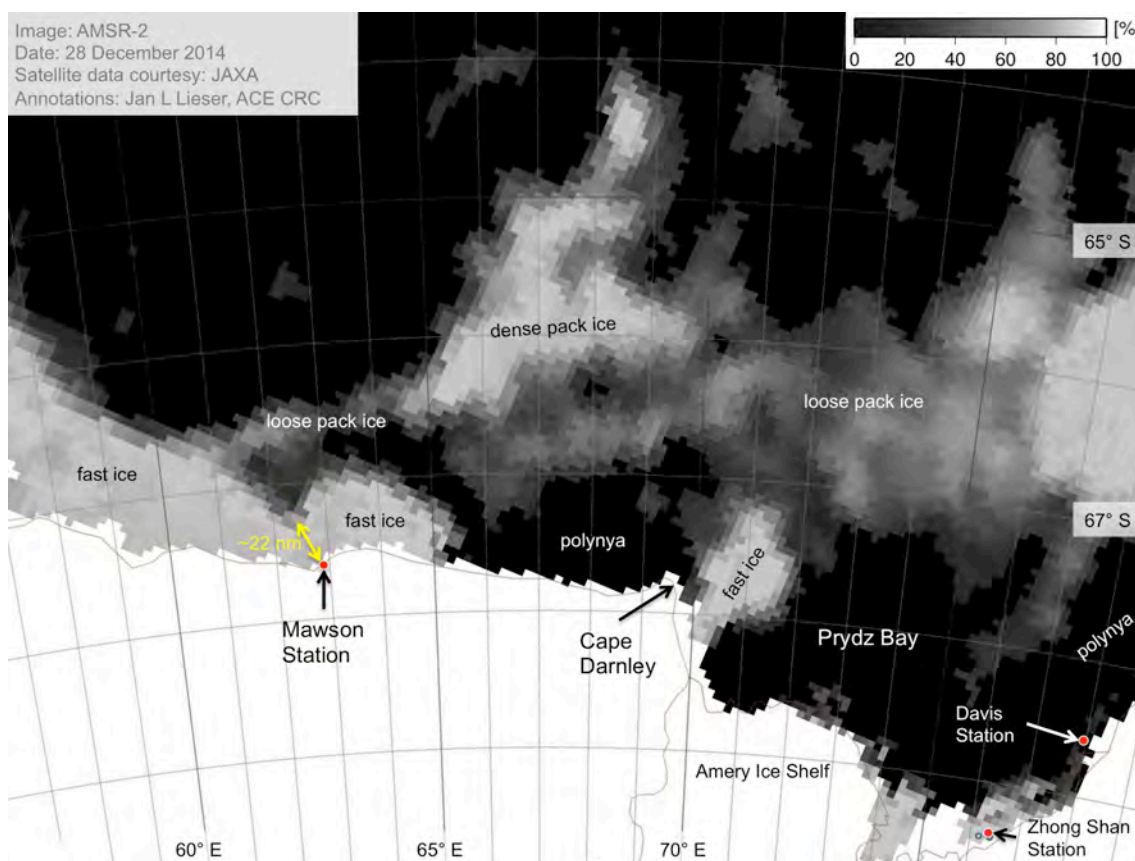
Figure 1: AMSR-2 image, acquired 28/12/2014 and provided by Drift & Noise Polar Services.

In northern Prydz Bay, only loose patchy sea ice remains (see Figure 1). North of the Cape Darnley polynya, higher sea-ice concentration is reducing further.

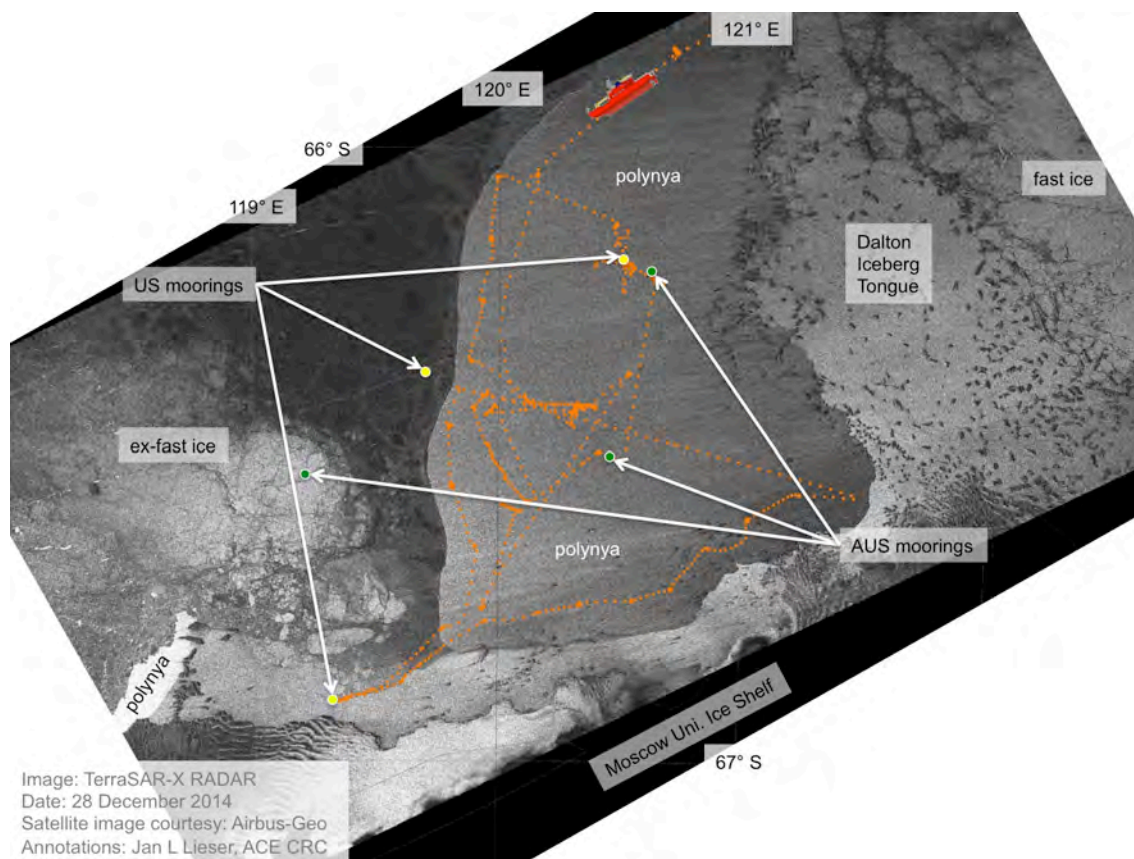
Figure 2: TerraSAR-X image, acquired 28/12/2014 and provided by Airbus-Geo.

Figure 2 shows a high resolution RADAR image of sea-ice conditions west of the Dalton Iceberg Tongue. The orange dotted line denotes the recent cruise track of RSV *Aurora Australis* in the region (up until 29/12/2014 00:00 UT).

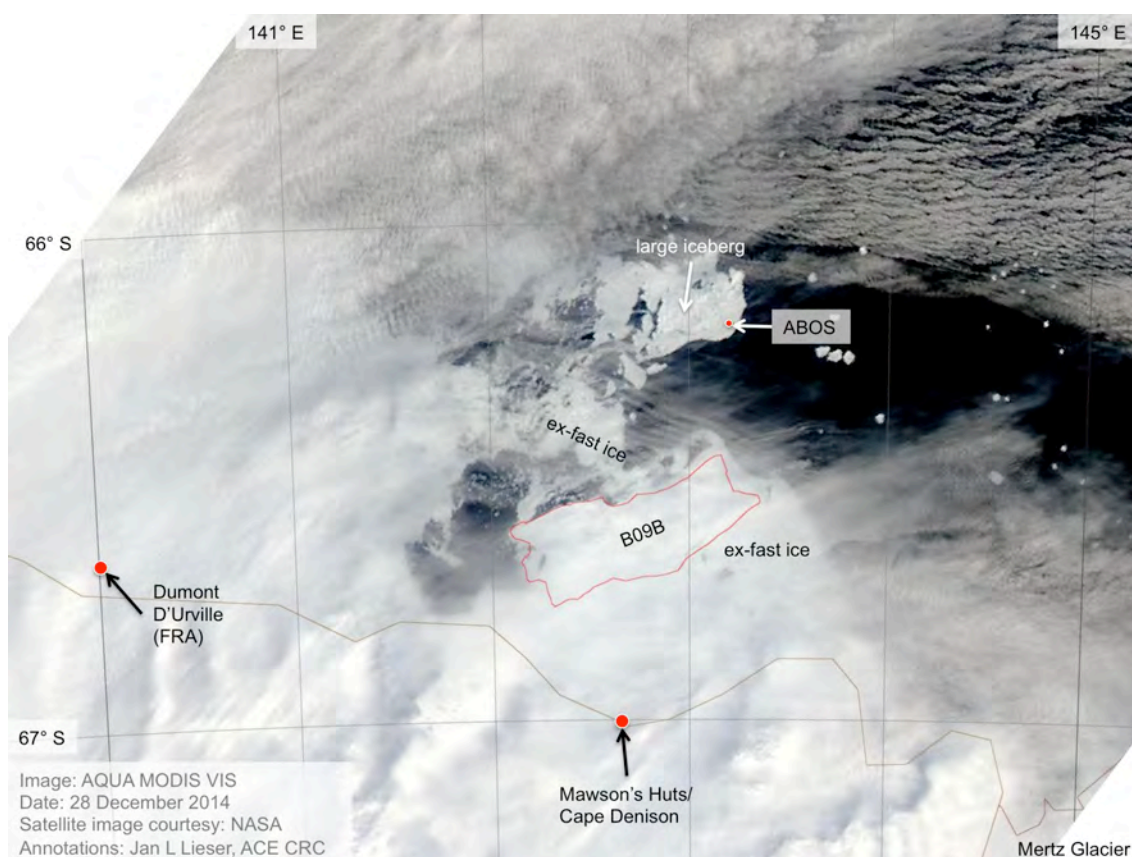
Figure 3: MODIS image, acquired 28/12/2014 and provided by NASA.

In Commonwealth Bay, fast ice continues to break up. The protective sea ice cover has gone entirely north of the Mertz Glacier (between 144° E and 149° E) and the fast ice south of iceberg B09B is now starting to break up at the eastern end of the berg. There are many free floating icebergs in the area.

While most of the scene shown in Figure 3 is obscured by clouds, the location of the ABOS mooring can be seen covered by sea ice, which is surrounding the large iceberg that is still grounded north of iceberg B09B.

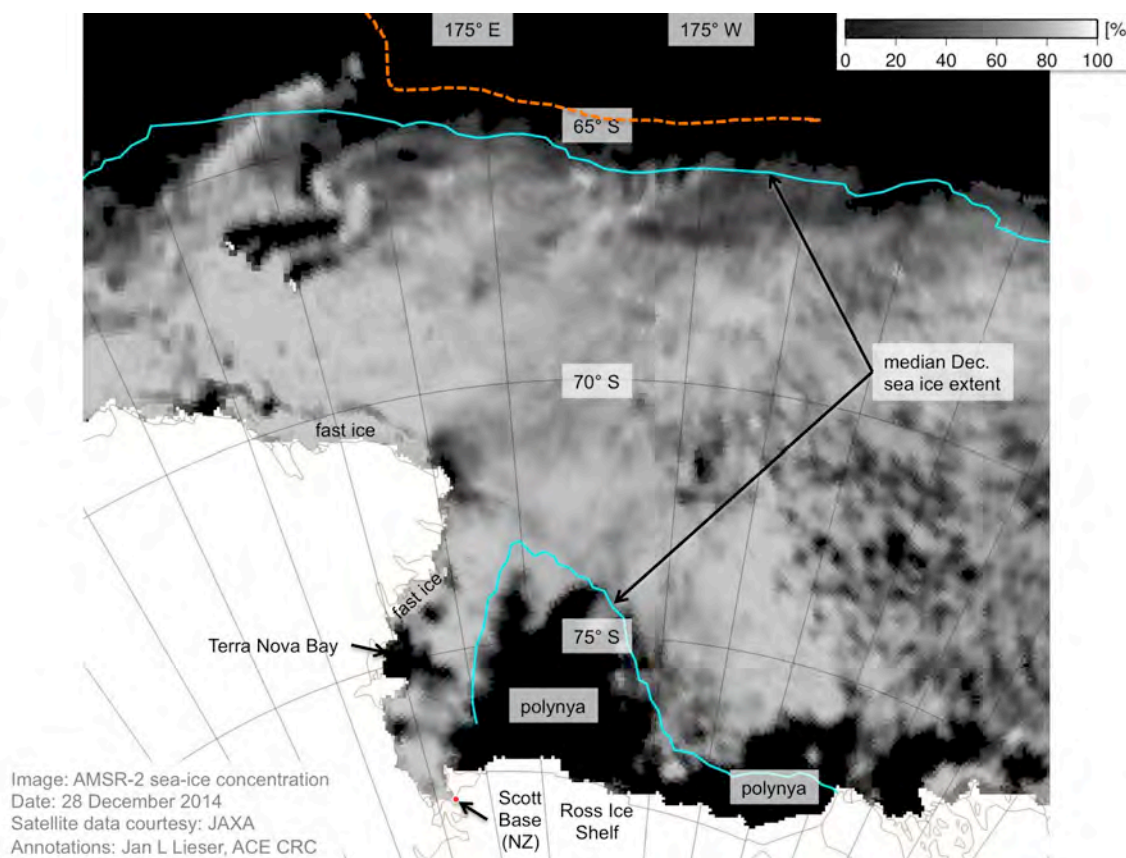
Figure 1: AMSR-2 image, acquired 28/12/2014 and provided by Drift & Noise Polar Services.

Figure 1 shows a map of sea-ice concentration for the Ross Sea and adjacent areas. The cyan line indicates the 30-year (1981-2010) median sea-ice extent for December in the region. Between 170° E and 170° W, the orange dashed line marks the northern edge where sea ice can reasonably be expected currently.

At the end of the month, the northern and southern sea-ice edges in the Ross Sea approach the long-term median distribution. The pack ice shows continuing signs of reduced sea-ice concentration. The

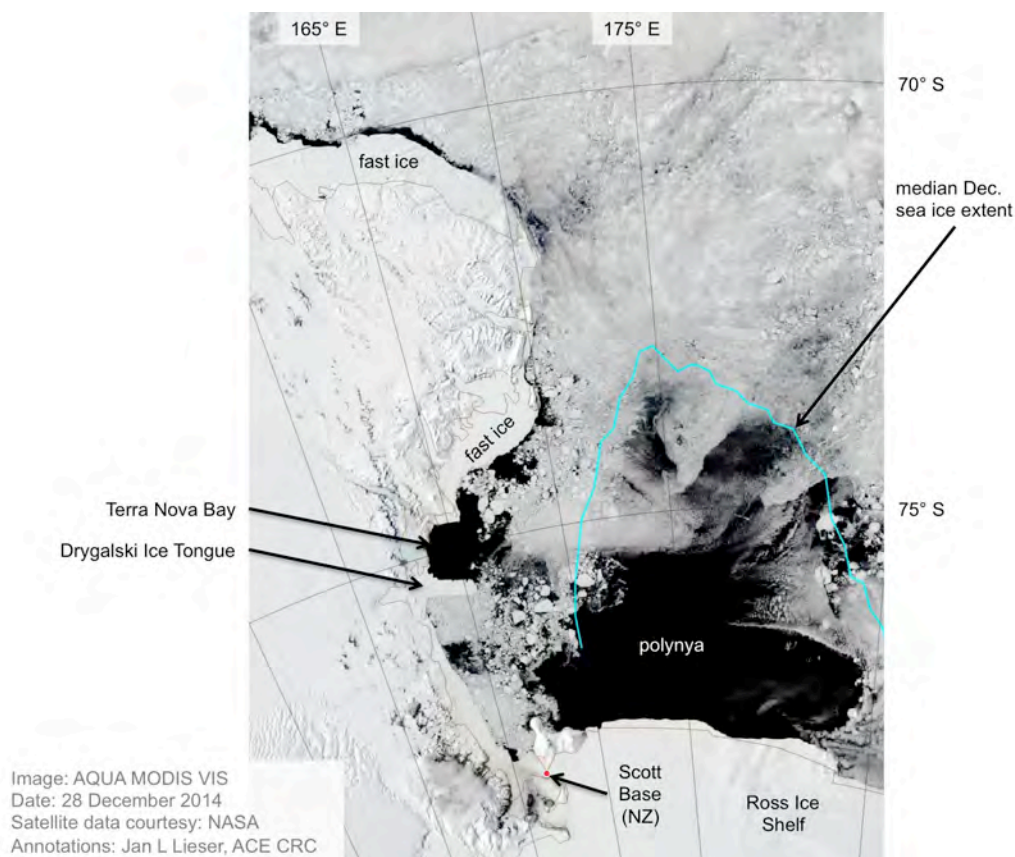
Figure 2: MODIS image, acquired 28/12/2014 and provided by NASA.

northern part of the sea ice down to about $65^{\circ} 45' S$ is more and more patchy, as is the pack ice east of $175^{\circ} W$.

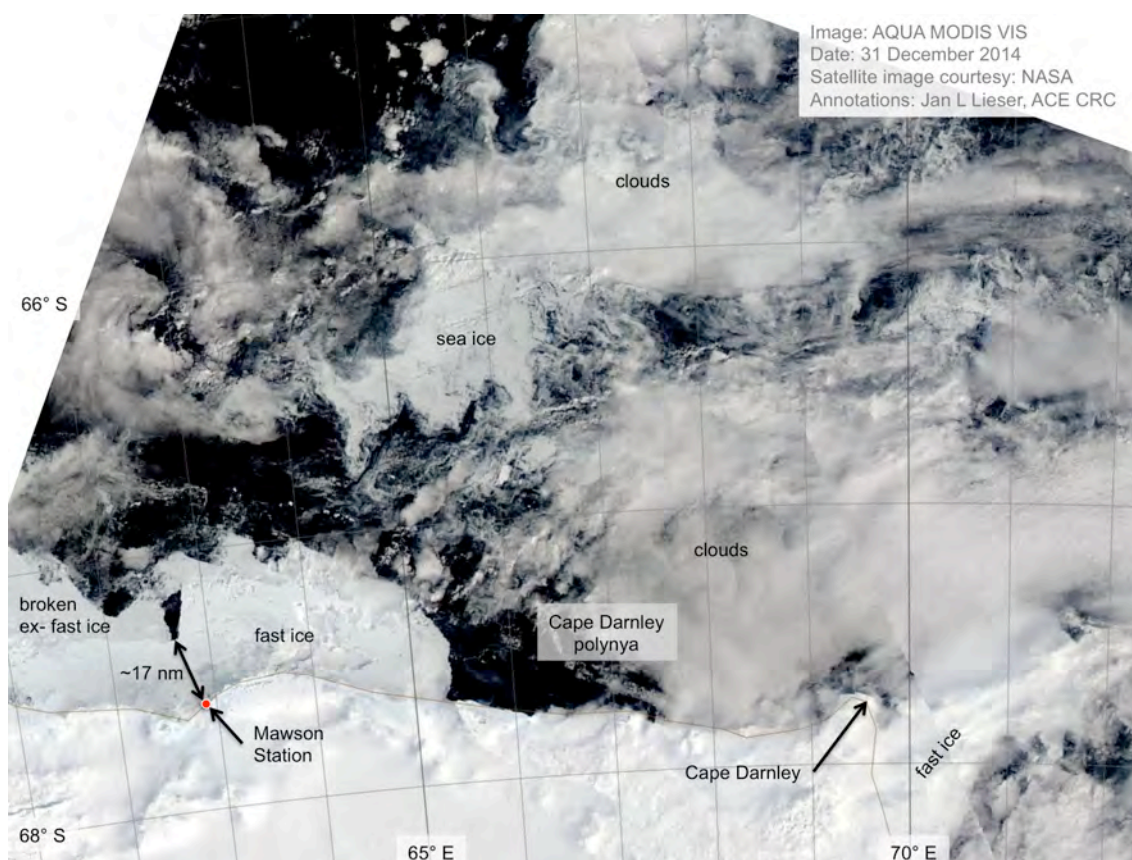
Figure 1: MODIS image, acquired 31/12/2014 and provided by NASA.

Off Mawson Station, more fast ice is breaking up. During the last three days, the fast ice edge progressed southward and is now about 17 nautical miles away from the station. West of 65° E, some broken ex-fast ice remains close to the new fast ice edge (see Figure 1).

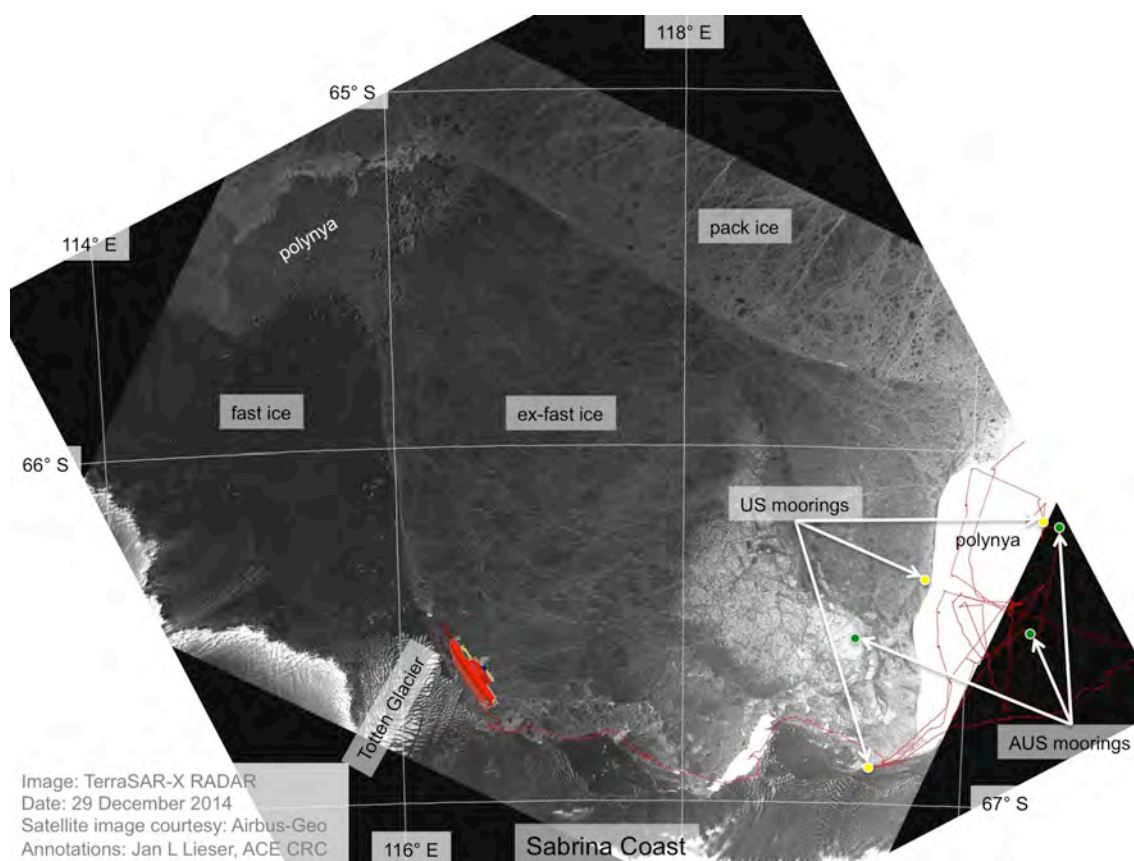
Figure 2: TerraSAR-X image, acquired 29/12/2014 and provided by Airbus-Geo.

Figure 2 shows a RADAR image of sea-ice conditions off Sabrina Coast and the Totten Glacier. The thin red line denotes the recent cruise track of RSV *Aurora Australis* in the region (up until 01/01/2015 00:00 UT).

Along 116° E, a boundary between fast ice locked to the eastern flank of Law Dome and ex-fast ice to the east of it can be seen. To the north of the fast ice, a polynya is a persistent feature west of a series of icebergs, that are grounded between 65° 12' S and 65° 40' S.

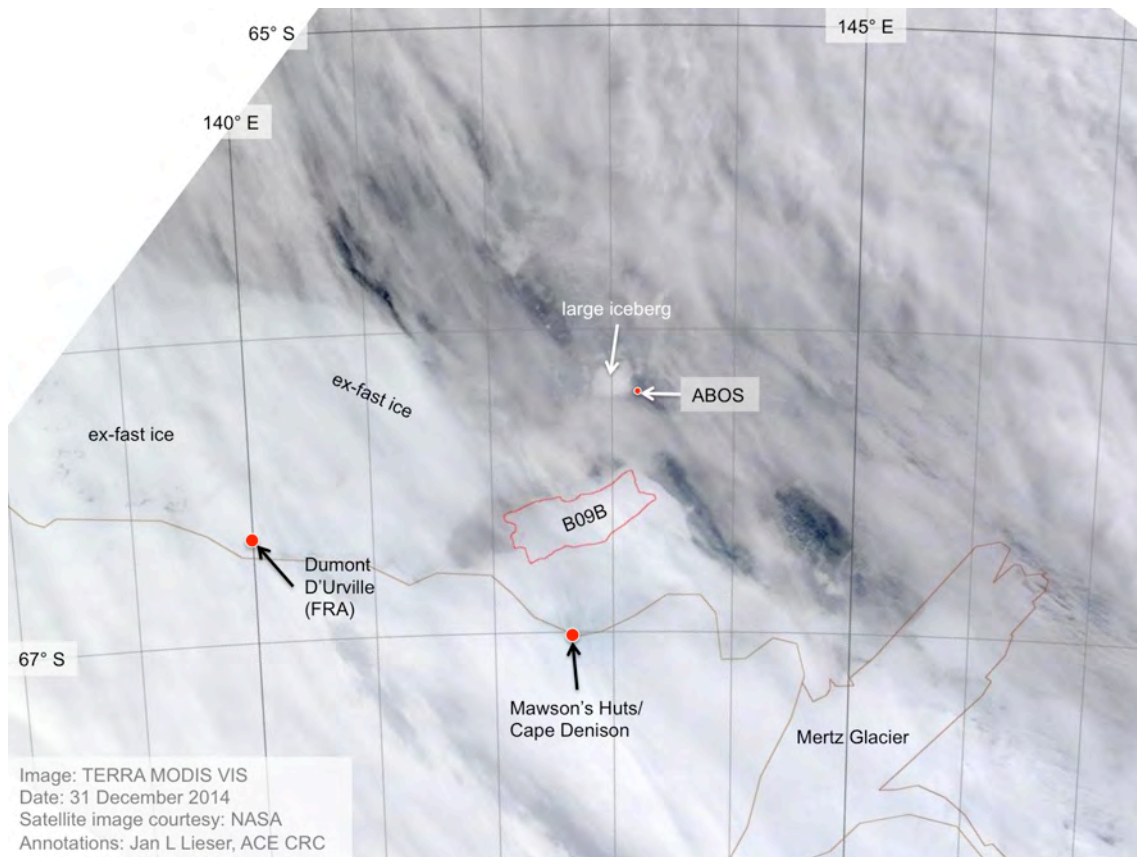
Figure 3: MODIS image, acquired 31/12/2014 and provided by NASA.

Further to the west, off Dumont d'Urville Station, the northern sea-ice edge is sharply defined. West of 140° E, some very small dark patches

are visible through the clouds. These patches can be interpreted as near-shore open water but are still about 13 nautical miles away from the station.

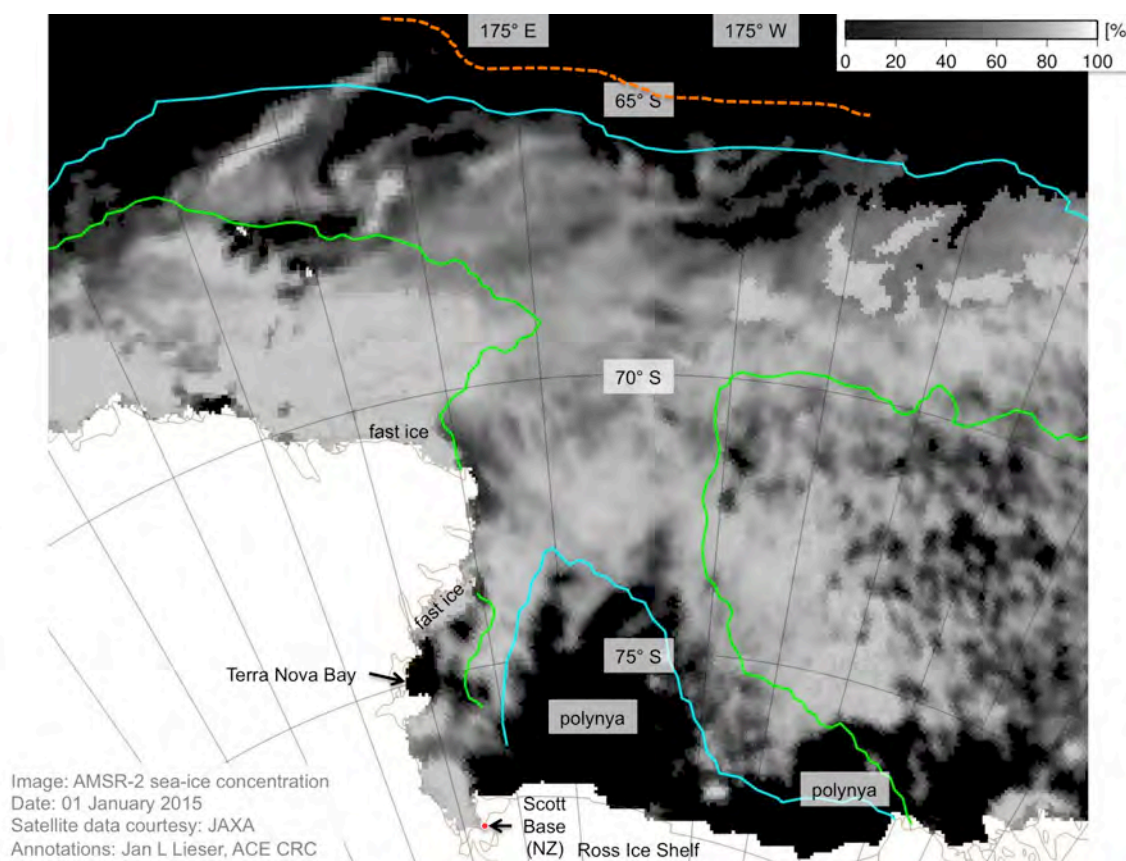
Figure 1: AMSR-2 image, acquired 01/01/2015 and provided by Drift & Noise Polar Services.

Figure 1 shows a map of sea-ice concentration for the Ross Sea and adjacent areas. The cyan line indicates the 30-year median sea-ice extent for December in the region, the green line indicates the January median sea-ice extent. Between 170° E and 170° W, the orange dashed line marks the northern edge where sea ice can reasonably be expected.

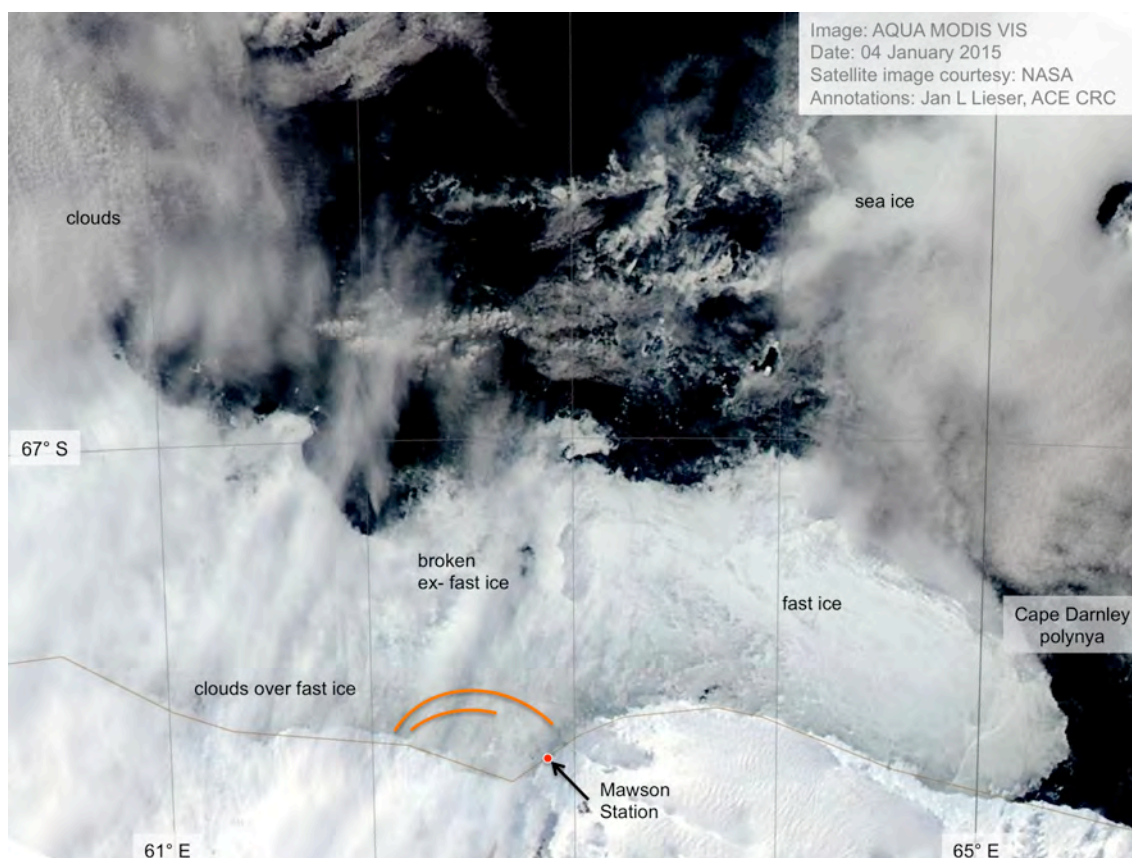
Figure 1: MODIS image, acquired 04/01/2015 and provided by NASA.

Close to the coast, some arching (dynamic lines of weakness through the sea ice between anchor points, coastal features) can be seen through the clouds. This is indicated by the orange lines in Figure 1. Further signs of apparent weakening of the fast ice can be detected along the coastline east of Mawson Station, for example at 67° 30' S and 63° 40' E.

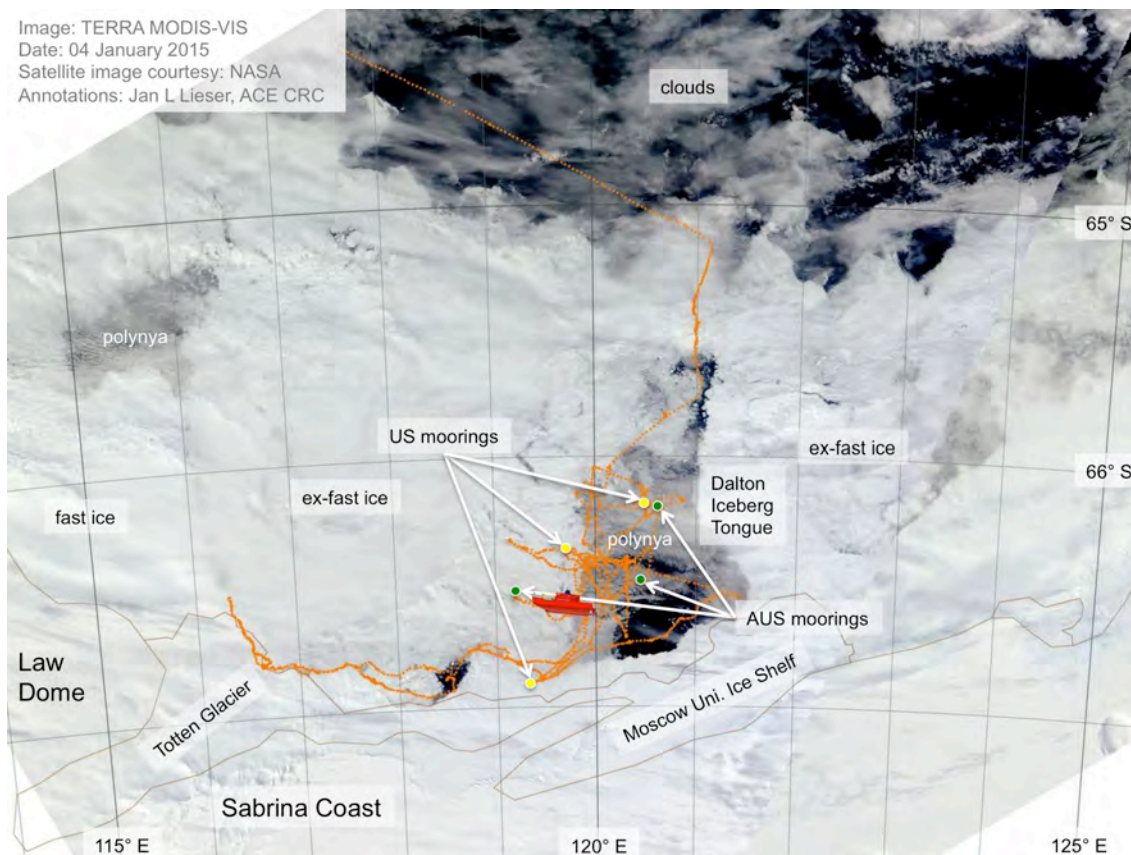
Figure 2: MODIS image, acquired 04/01/2015 and provided by NASA.

The scene of Figure 2 is almost entirely obscured by clouds, but an appreciation of sea-ice conditions off Sabrina Coast is possible. The orange dotted line denotes the recent cruise track of RSV *Aurora Australis* in the region (up until 05/01/2015 00:00 UT).

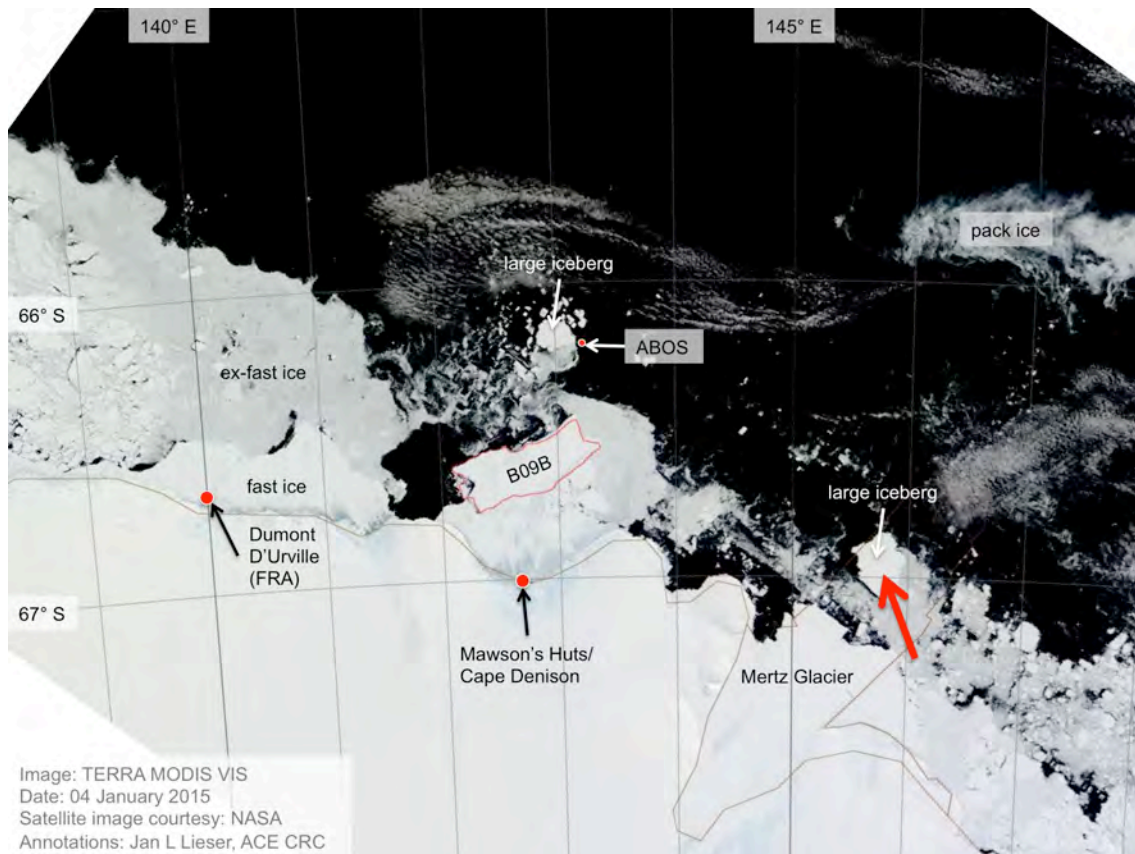
Figure 3: MODIS image, acquired 04/01/2015 and provided by NASA.

There is very little cloud cover in the visible MODIS image of Figure 3.

West of 142° E, almost 7.5 nautical miles of coast are exposed to the ocean now, but west from there fast ice remains land locked. Also, fast ice in Commonwealth Bay remains stable, at least south of 66° 50' S.

The location of the ABOS mooring continues to be free of sea ice.

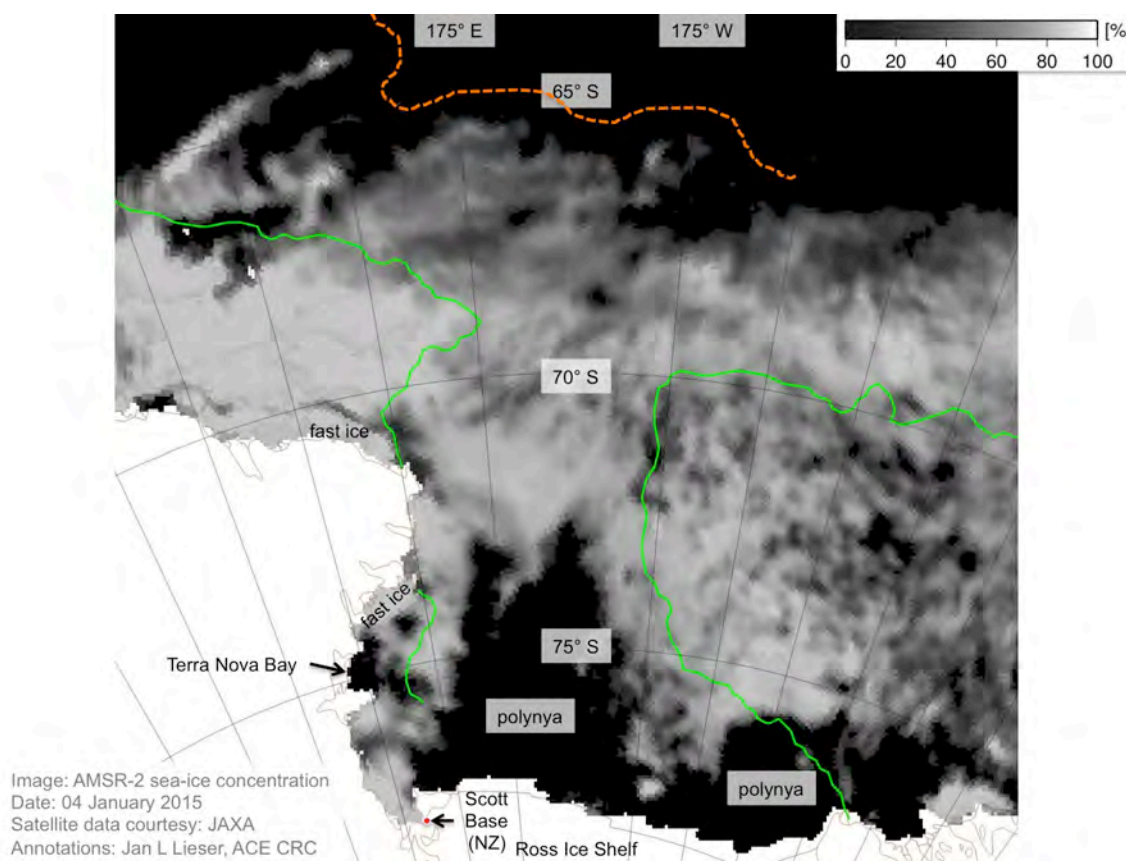
Figure 1: AMSR-2 image, acquired 04/01/2015 and provided by Drift & Noise Polar Services.

Figure 1 shows a map of sea-ice concentration for the Ross Sea and adjacent areas. The green line indicates the 30-year (1981-2010) median sea-ice extent for January. Between 170° E and 170° W, the orange dashed line marks the northern edge where sea ice can reasonably be expected.

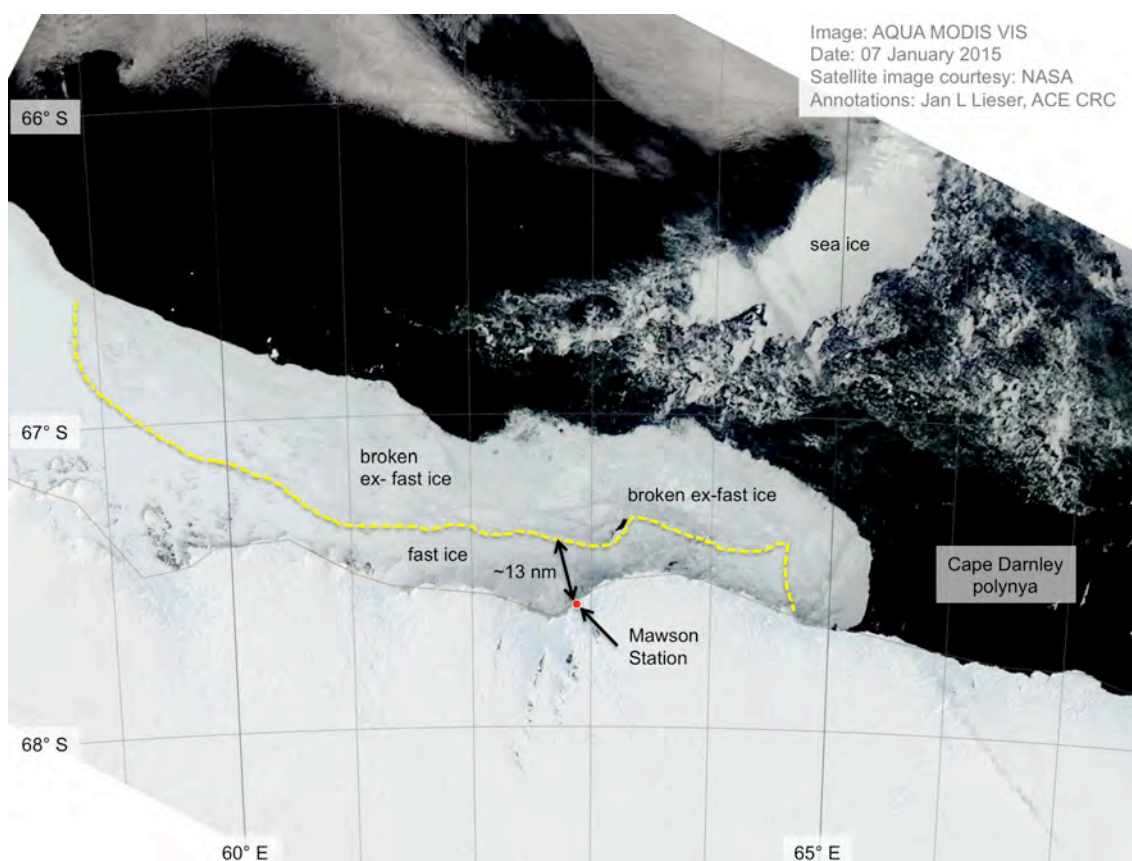
Figure 1: MODIS image, acquired 07/01/2015 and provided by NASA.

At the beginning of this week, fast ice off Mawson Station snapped and broke into many pieces. The current edge of the fast ice is approximated by the yellow dashed line in Figure 1. Even though the loosened ex-fast ice remains in the vicinity, larger areas of open water start to appear, for example at 63° 15' E and 67° 20' S.

One large area of high concentration sea ice remains north of the (ex-)fast ice, centred at about 65° E and 66° 25' S.
