Sea ice reports for the Antarctic shipping season 2014 - 2015

Prepared by: Dr Jan L Lieser (Jan.Lieser@acecrc.org.au), Dr Robert A Massom (Rob.Massom@acecrc.org.au) & Dr Petra Heil (Petra.Heil@acecrc.org.au)
Antarctic Climate & Ecosystems Cooperative Research Centre, May 2015

The sea ice reports compiled in this document are weekly reports on sea-ice conditions for East Antarctica, including sub-weekly updates. They were prepared to support ship operations in East Antarctica during the 2014/2015 shipping season. These reports were primarily used to guide the Australian Antarctic program, but were partly provided to other Antarctic operators. In particular, we assisted Chinese National Antarctic Research Expeditions (RSV *Xue Long*), the Royal New Zealand Navy, the New Zealand National Institute of Water and Atmospheric Research (RV *Tangaroa* Voyage 2), the Australian Marine National Facility (RV *Investigator*) and the US Antarctic Program (RVIB *Nathaniel B. Palmer* Voyage 15-03). During the season, these reports informed eight voyages, all of which returned within schedule or early due to navigational choices made by the ships' captains based on sea-ice reports.

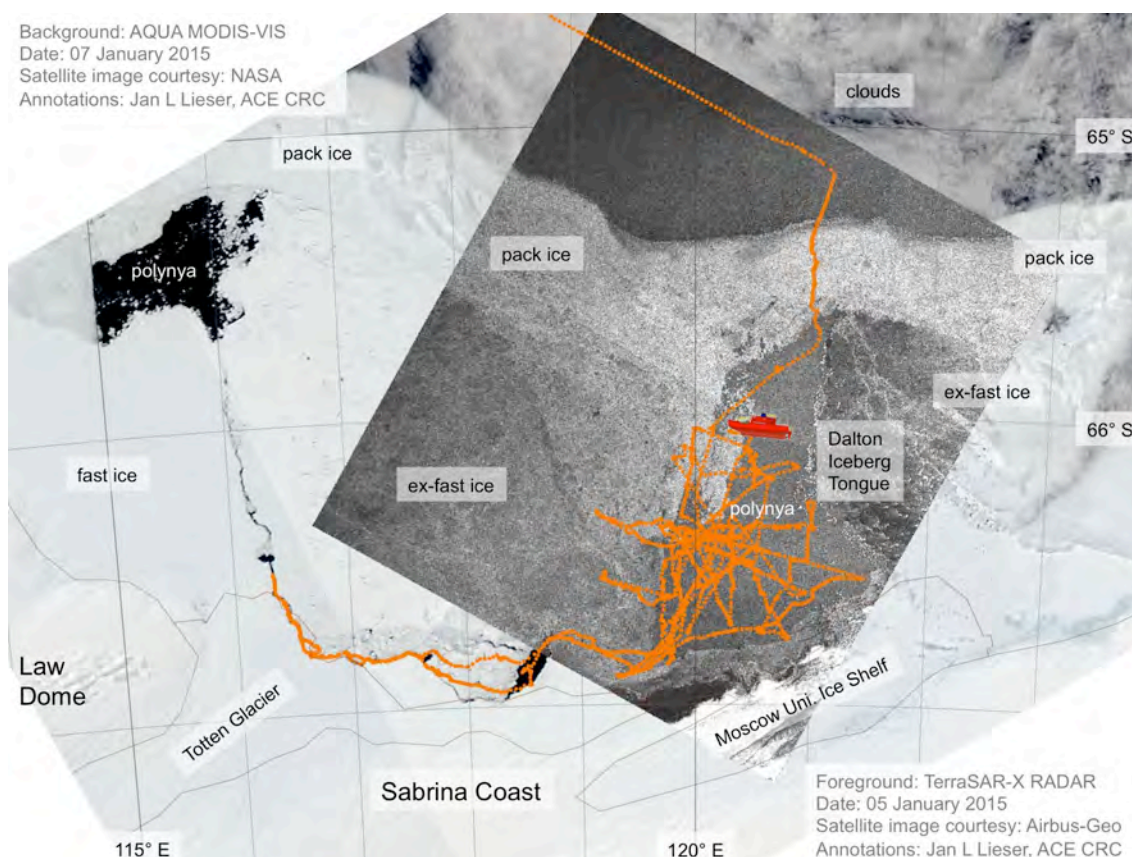
Figure 2: Foreground: TerraSAR-X image, acquired 05/01/2015 and provided by Airbus-Geo; Background: MODIS image, acquired 07/01/2015 and provided by NASA.

Figure 2 shows a RADAR image of sea-ice conditions off Sabrina Coast. It is superimposed over a visible image from MODIS sensor, that is obscured by clouds only in the northeastern part of the figure. The orange dotted line denotes the recent cruise track of RSV *Aurora Australis* in the region (up until 08/01/2015 00:00 UT).

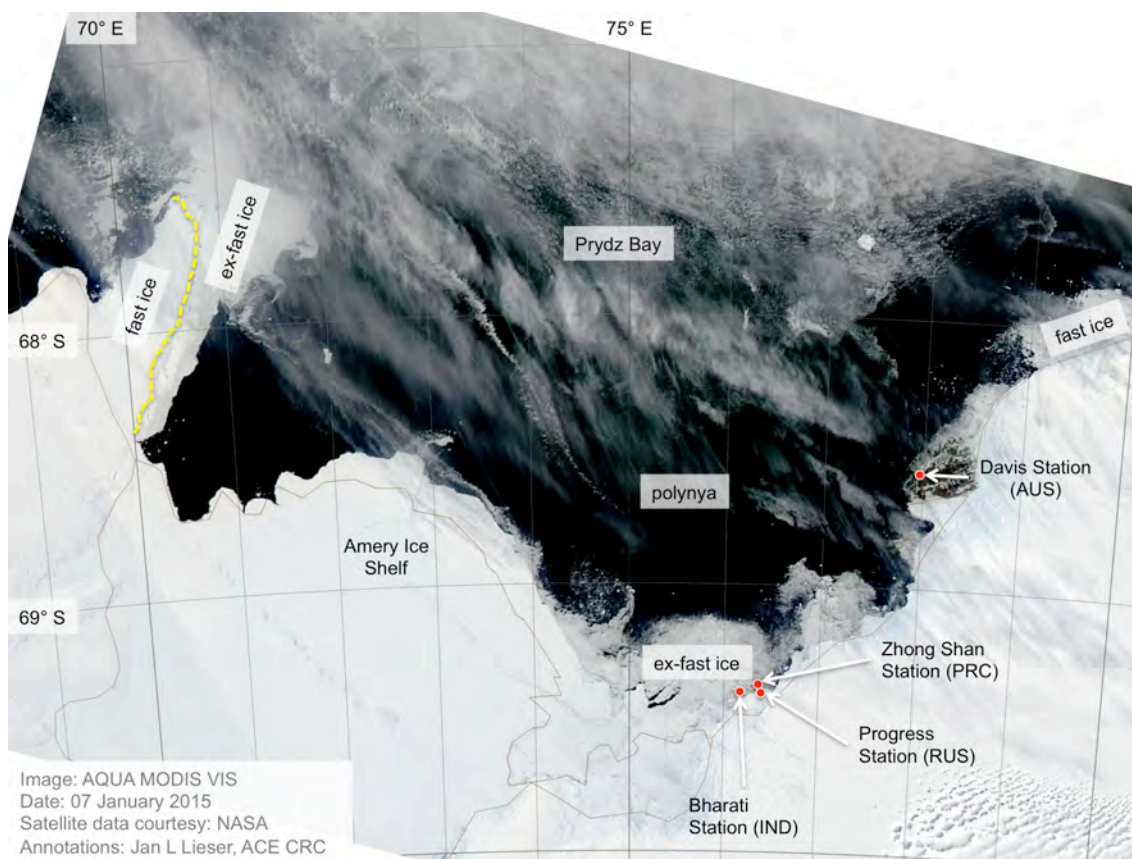
Figure 1: MODIS image, acquired 07/01/2015 and provided by NASA.

Since the beginning of this week, around the coastline of Prydz Bay, remaining fast ice has started to break up. Figure 1 shows shattered ex-fast ice to the north and west of the Larsemann Hills (Zhong Shan Station) and further north along the coast, up to 80° E as well. Also on the eastern side of Cape Darnley (northwest of the Amery Ice Shelf), fast ice is breaking up from the eastern edge of the fast ice attached to the coast. There, the approximate transition between fast ice and ex-fast ice is indicated by a yellow dashed line in Figure 1.

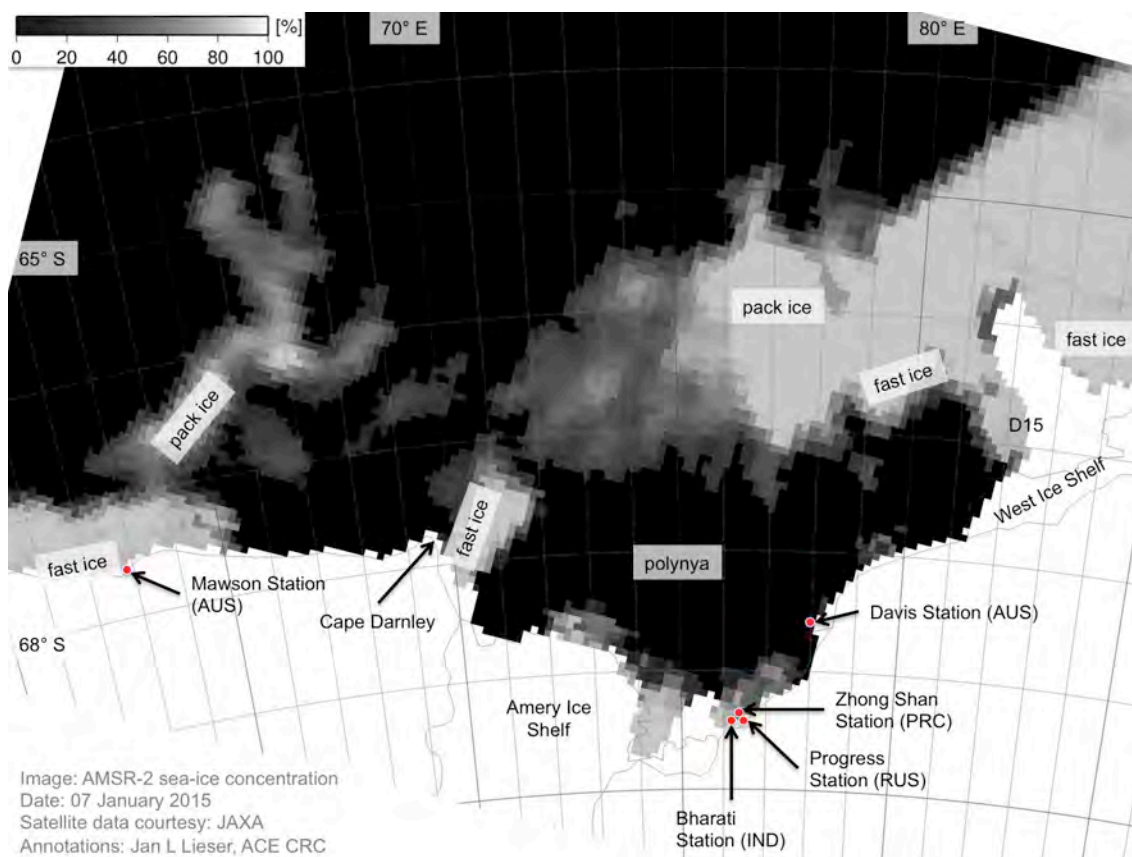
Figure 2: AMSR-2 image, acquired 07/01/2015 and provided by Drift & Noise Polar Services.

Northern Prydz Bay (see Figure 2) still holds some sea ice. Between 65° 30' S and 67° S and west of 80° E, very high sea-ice concentration

is present, consisting of both, pack ice and fast ice. The latter – even though reducing in extent – remains attached to iceberg D15 (grounded north of the West Ice Shelf) and surrounding multi-year fast ice. Further between 65° 30' S and 67° S and between 62° E and 66° E, an area of combined pack ice and ex-fast ice is reducing gradually in concentration, from the very high (up to 100%) east of 65° E down to about 20% at its western margin.

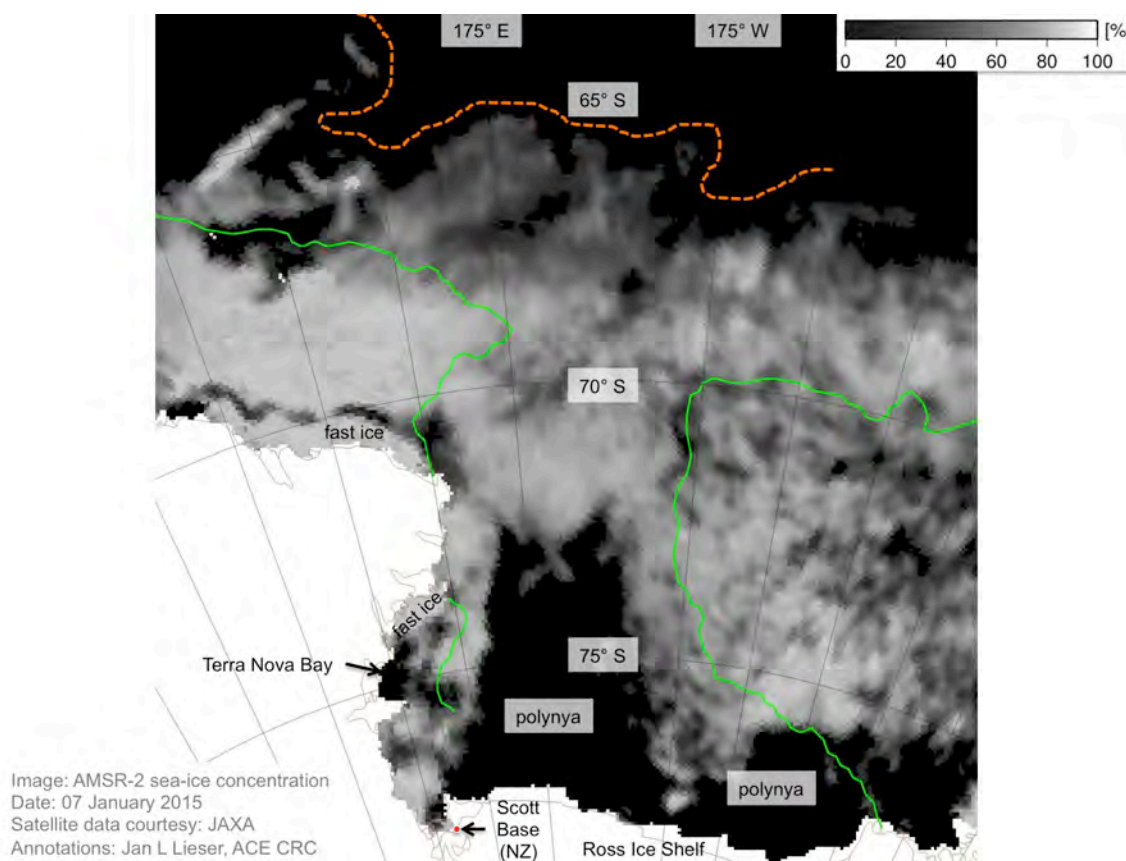
Figure 1: AMSR-2 image, acquired 07/01/2015 and provided by Drift & Noise Polar Services.

Figure 1 shows a map of sea-ice concentration for the Ross Sea and adjacent areas. The green line indicates the 30-year (1981-2010) median sea-ice extent for January. Between 170° E and 170° W, the orange dashed line marks the northern edge where sea ice can reasonably be expected.

Summer trend continues in the Ross Sea region, with sea-ice concentration reducing and large floes breaking into smaller ones.

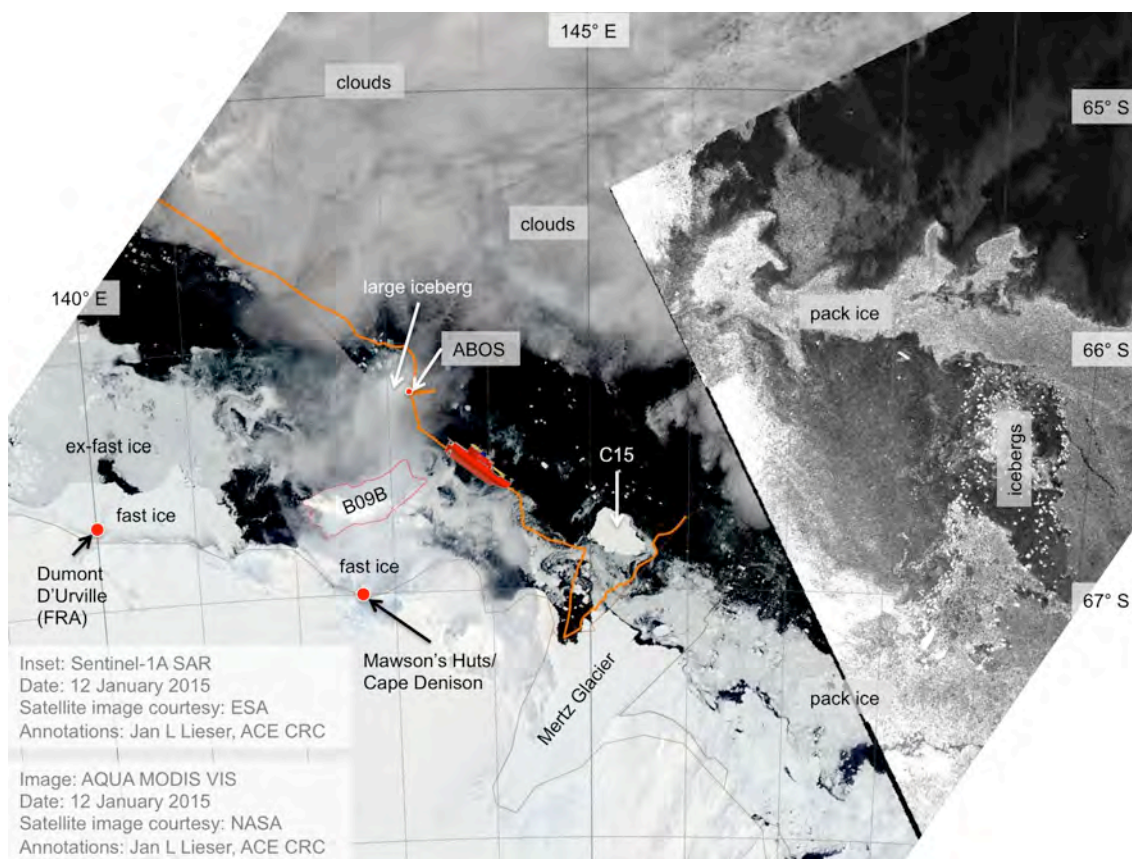
Figure 1: MODIS image, acquired 12/01/2015 and provided by NASA. Inset: SAR image, acquired 12/01/2015 and provided by PolarView.

Figure 1 shows a combination of images from two different sensors, visible MODIS (background) and Synthetic Aperture Radar (SAR) (inset). The orange line denotes the cruise track of RSV *Aurora Australis* in the region (up to 13/01/2015 00:00 UT). The inset provides a view on the sea ice where the MODIS image is obscured by clouds.

Since 01/01/15, iceberg C15 has travelled about 17 nautical miles in northwest direction, across the face of Mertz Glacier.

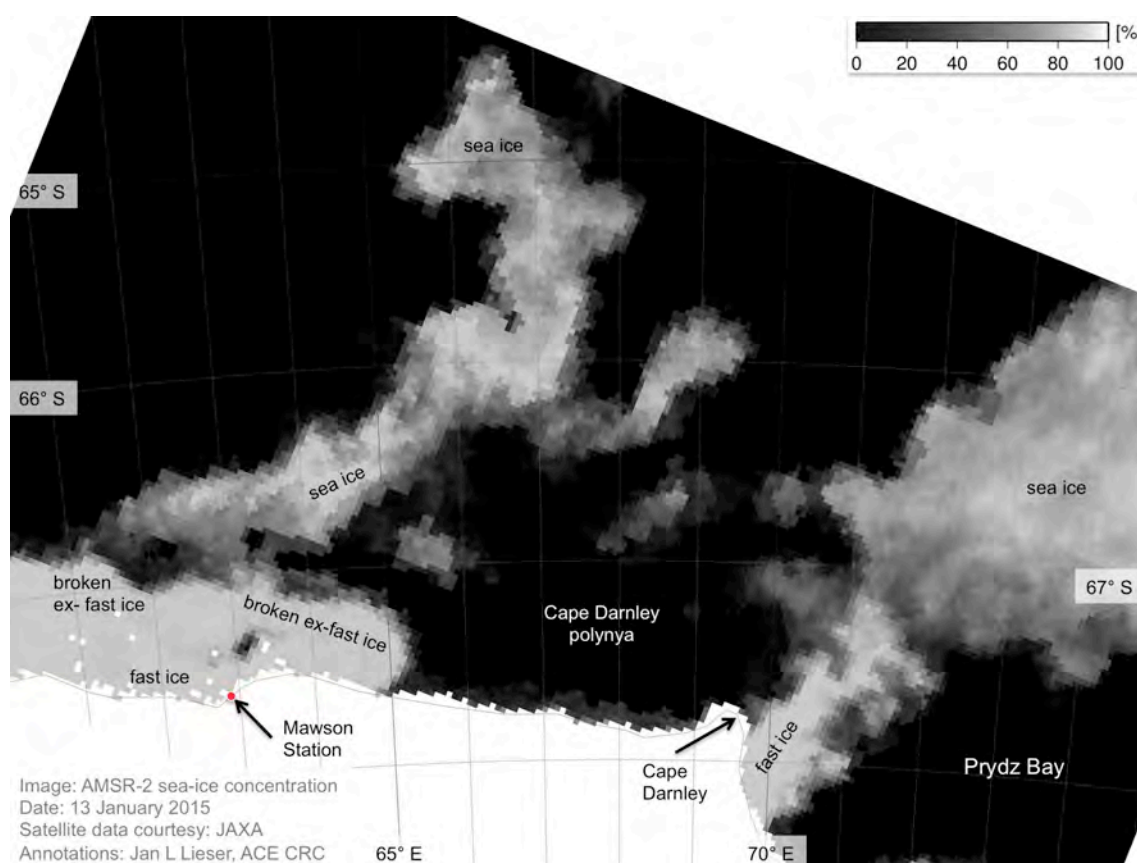
Figure 1: AMSR-2 image, acquired 13/01/2015 and provided by Universität Hamburg.

Even though a detailed view is prevented due to cloud cover, today, sea-ice conditions appear by and large unchanged off Mawson Station. The fast ice edge can not be approximated from the microwave data (Figure 1).

The plume-like pattern of sea ice described in Sea Ice Report #02d/2015 remains in the region and appears highly mobile.

West of 73° 30' E, northern Prydz Bay is covered by medium high to high concentration of sea ice, which is also highly mobile and consists of predominantly small floes. Within this pack, one large iceberg is

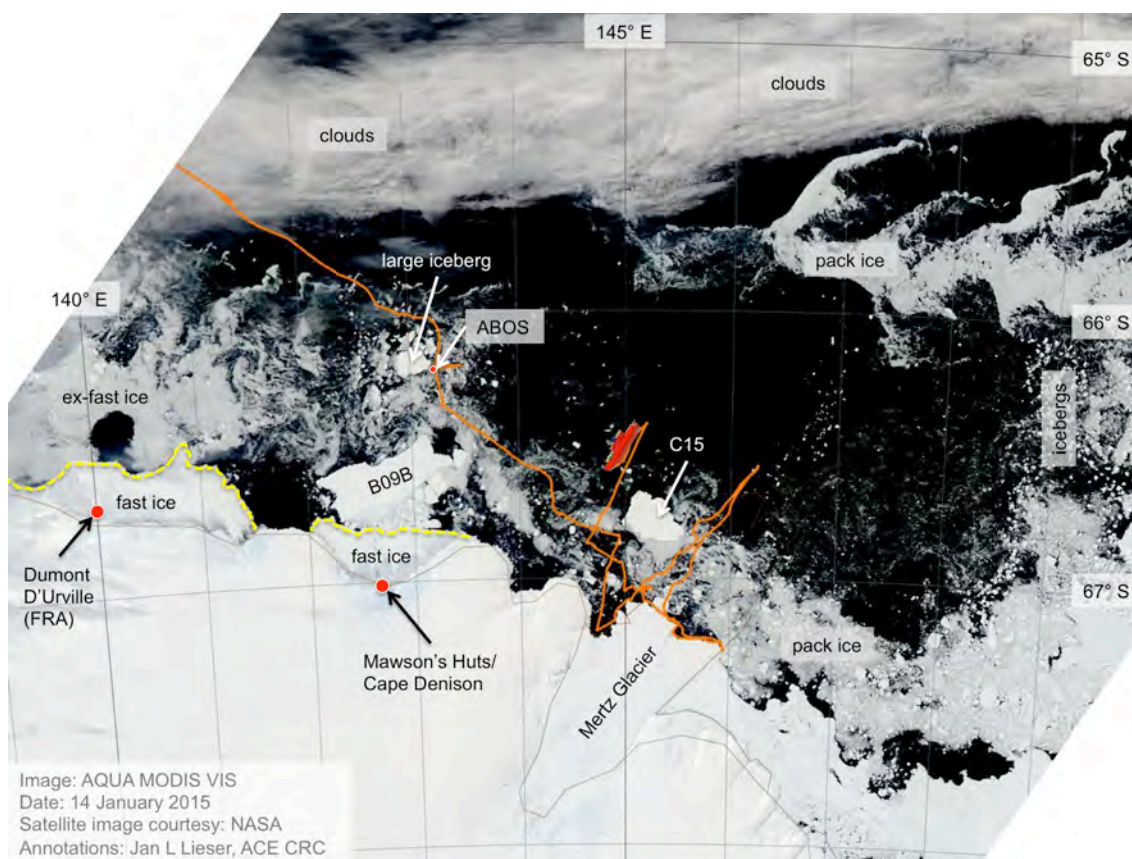
Figure 2: MODIS image, acquired 14/01/2015 and provided by NASA.

Figure 2 provides a largely unobscured visible impression of the sea ice between Dumont d'Urville Station and the Mertz Glacier. The thin orange line denotes the recent cruise track of RSV *Aurora Australis* (up to 15/01/2015 00:00UT). The fast ice edge is approximated with a yellow dashed line.

North of Commonwealth Bay, iceberg B09B is not surrounded by fast ice anymore. The sea ice around the berg has broken up, but remains local south of B09B, between the berg and the fast ice of the bay.

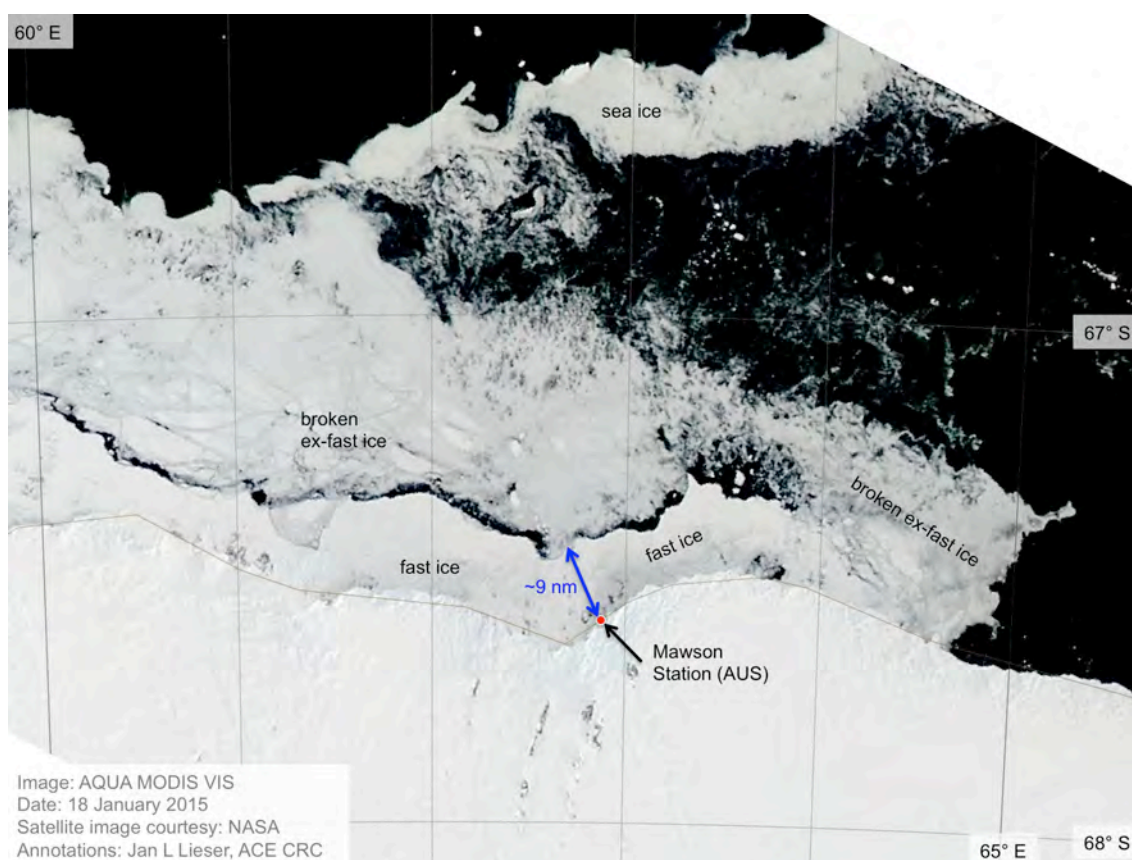
Figure 1: MODIS image, acquired 18/01/2015 and provided by NASA.

Off Mawson Station, the width (north-south extent) of the fast ice remains more or less constant during the past few days. But we notice further east ($63^{\circ} 41' \text{ E}$, $67^{\circ} 30' \text{ S}$) and west ($61^{\circ} 20' \text{ E}$, $67^{\circ} 25' \text{ S}$) the fast ice continues to crumble (see Figure 1).

Close to the coast at Mawson Station, the fast ice is also deteriorating, as can be seen from station's web-cam imagery. A few larger icebergs are drifting freely, north of 67° S .

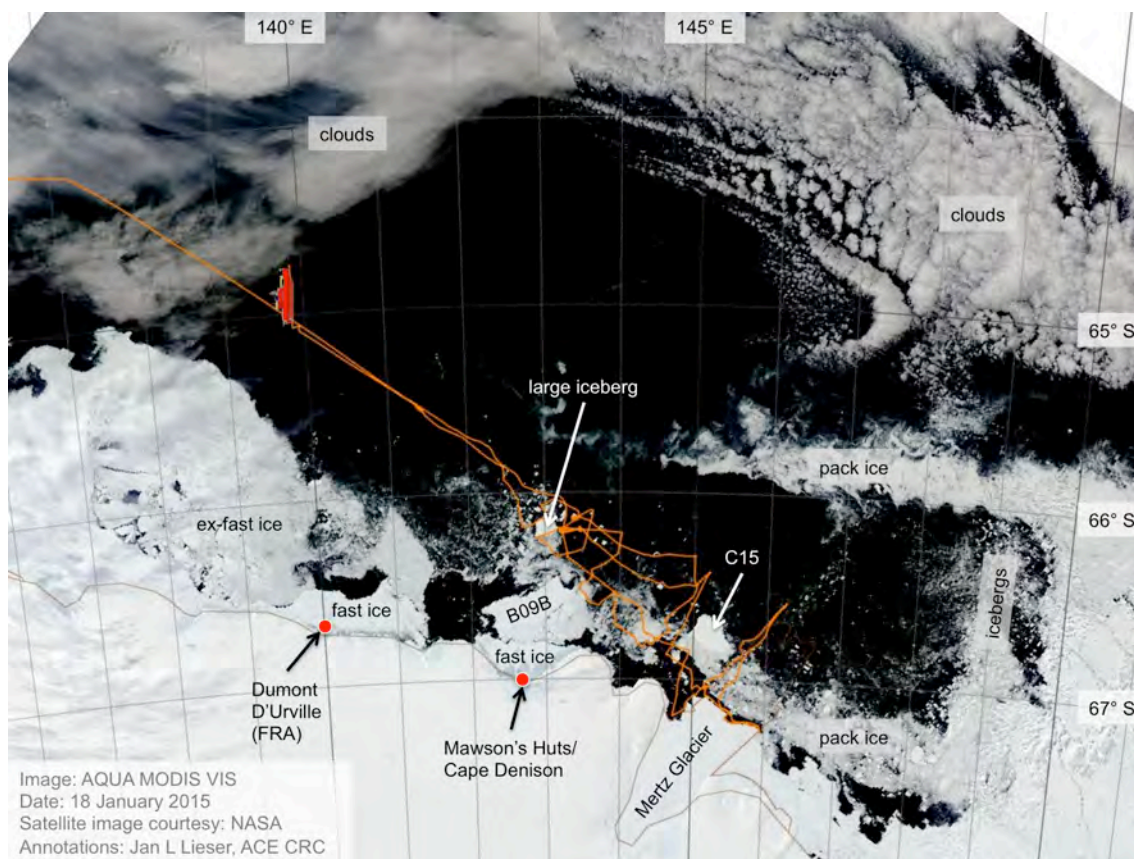
Figure 2: MODIS image, acquired 18/01/2015 and provided by NASA.

orange line denotes the recent cruise track of RSV *Aurora Australis* (up to 19/01/2015 00:00UT).

Sea-ice conditions in the region remain overall unchanged since our last report. Iceberg C15 appears to be on the move again at a rate of about 0.5 nautical miles per day in northerly direction.

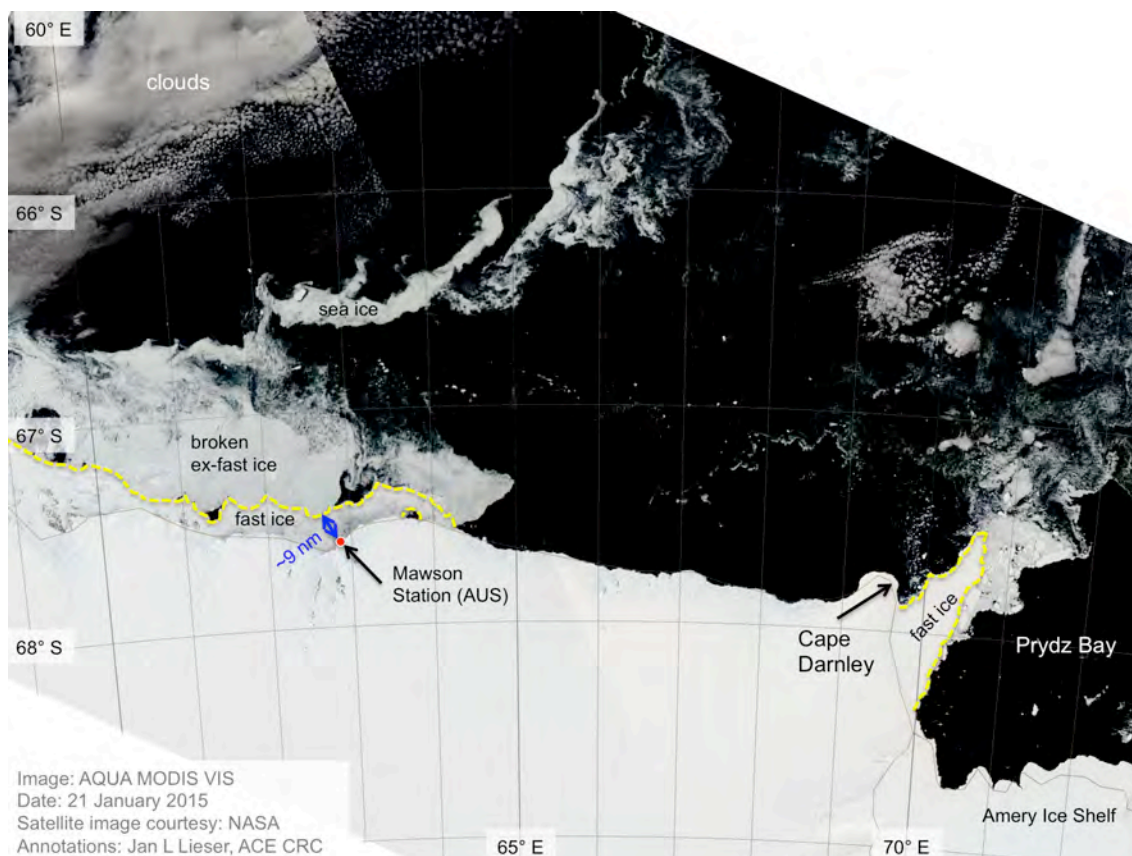
Figure 1: MODIS image, acquired 21/01/2015 and provided by NASA.

Figure 1 shows an almost entirely cloud-free scene of the Mawson Coast and the sea-ice conditions offshore. The fast-ice edge is approximated by a yellow dashed line. The shortest distance between the fast-ice edge and Mawson Station remains steady at about nine nautical miles. The broken ex-fast ice north of the fast ice edge continues to break up further and disperse. The band of sea ice north of the broken ex-fast ice thins and scatters also.

We note an eddy structure of sea ice at about 63° E and 67° 30' S as a visible sign of oceanographic dynamics in the area. Off the eastern side of Cape Darnley, fast ice also continues to break up and spreads northward.

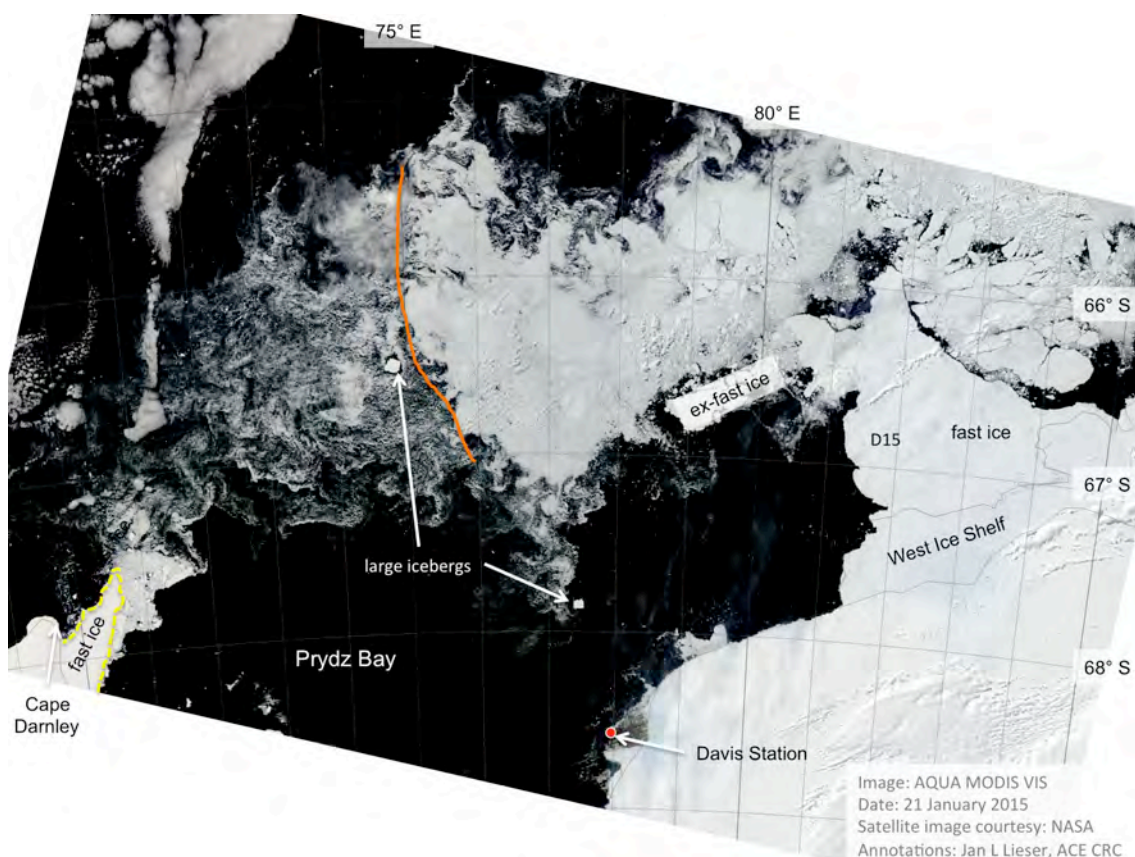
Figure 2: MODIS image, acquired 21/01/2015 and provided by NASA.

In northern Prydz Bay, sea ice can be generally characterised by two different regimes. The transition line is indicated by the orange line in Figure 2. To the west of this line, sea ice is scattered far and wide and some ocean eddy structures can be seen in the swirls of the sea ice. East of the transition line, sea ice remains at higher concentration, but consists mostly of relatively small floes. This eastern regime shows also swirling structures at the edges.

The long protruding fast-ice tongue that was attached to a large body of fast ice to the north and east around iceberg D15 has broken into many pieces. However, the westernmost end of this fast-ice tongue remains local, centred at about 79° E and 66° 42' S.

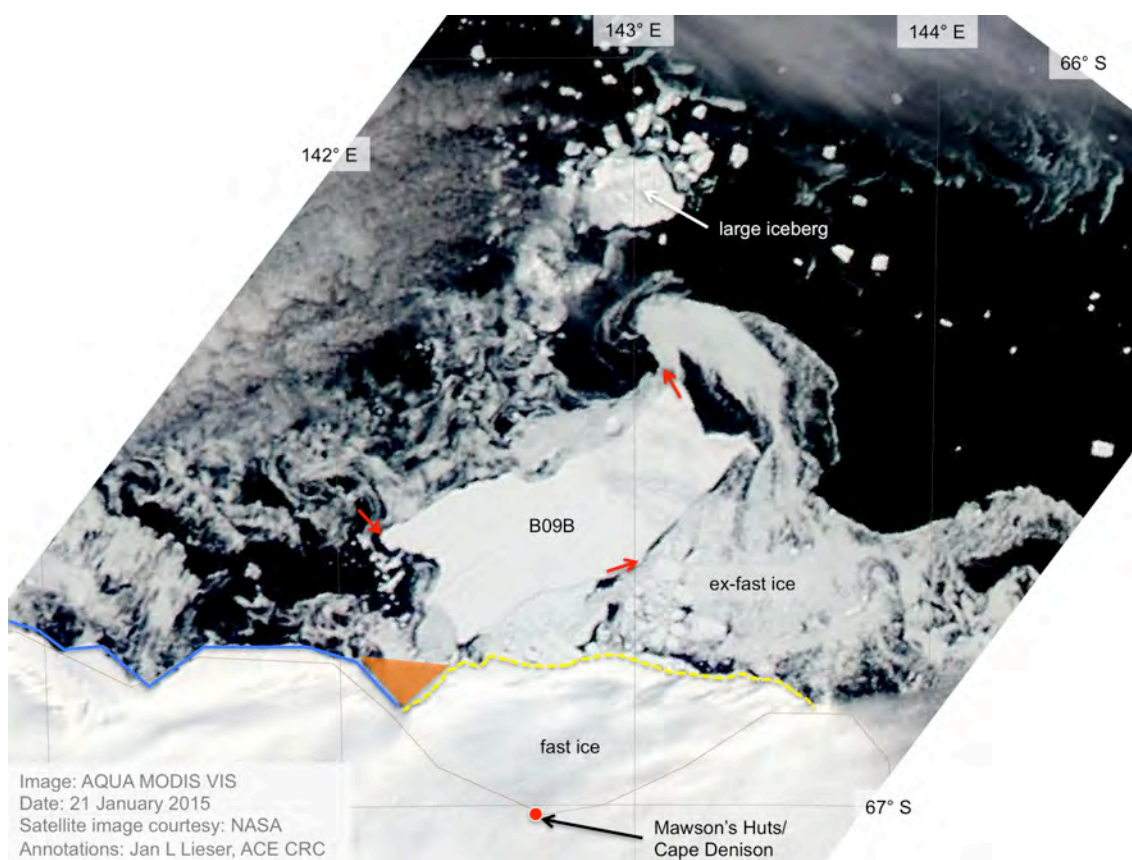
Figure 3: MODIS image, acquired 21/01/2015 and provided by NASA.

Figure 3 shows a detailed view of Commonwealth Bay and iceberg B09B. The fast ice edge is approximated with the yellow dashed line. At the western end of the bay, fast ice is breaking out as indicated by the orange triangle in the figure. Heading west towards Dumont

d'Urville Station, about 37 nautical miles of coast are now exposed to the ocean as indicated by the blue line.

Since the beginning of the year, the large tabular iceberg B09B started to shift its position slightly. This movement appears to coincide with the break up of fast ice at the eastern and southern side of the berg. The onset of this fast ice break-up was between 21/12/2014 and 23/12/2014. We detect an anti-clockwise rotational movement of about seven degrees. Note: the red arrows in Figure 3 indicate the displacement direction of feature points of the berg and are not to scale. The long axis of the berg has shifted about two nautical miles in northeasterly direction.

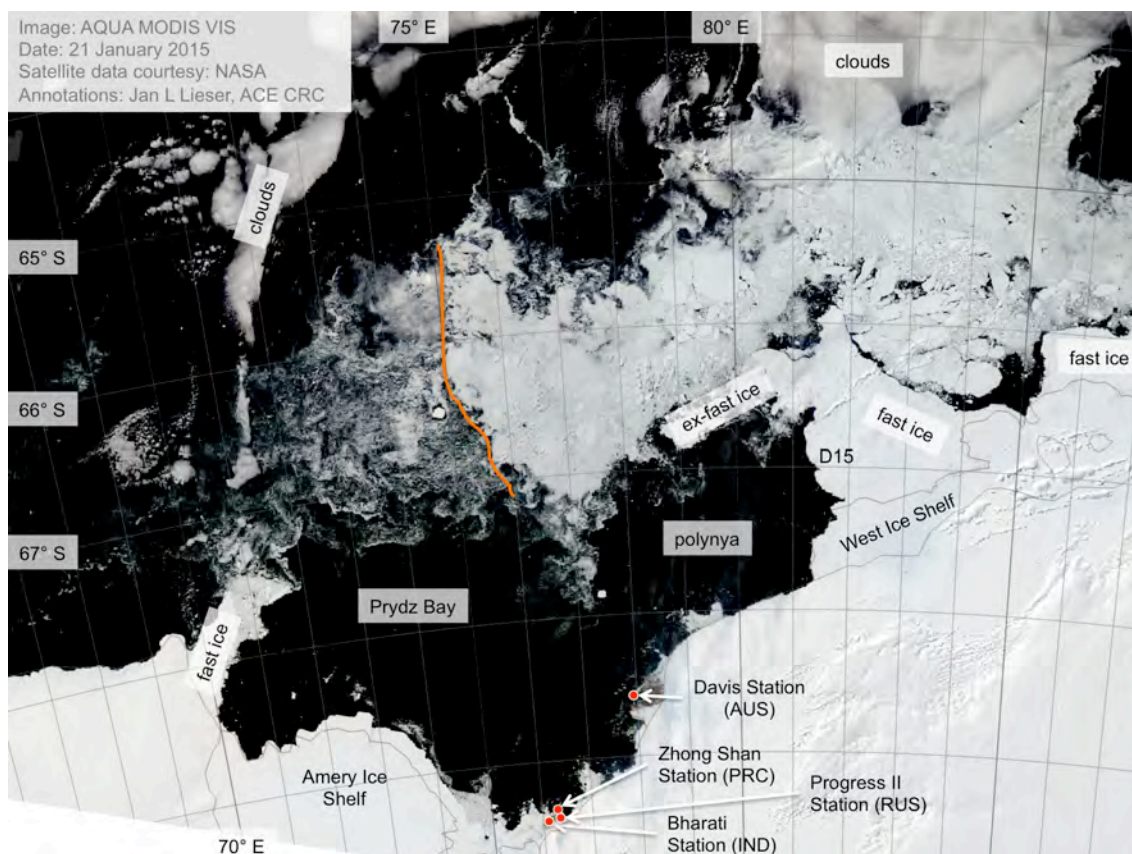
Figure 1: MODIS image, acquired 21/01/2015 and provided by NASA.

In northern Prydz Bay, sea ice can be generally characterised by two different regimes. The transition line is indicated by the orange line in Figure 1. To the west of this line, sea ice is scattered far and wide and some ocean eddy structures can be seen in the swirls of the sea ice. East of the transition line, sea ice remains at higher concentration, but consists mostly of relatively small floes. This eastern regime shows also swirling structures at the edges.

The long protruding fast-ice tongue that was attached to a large body of fast ice to the north and east around iceberg D15 has broken into many pieces. However, the westernmost end of this fast ice tongue remains local, centred at about 79° E and 66° 42' S.

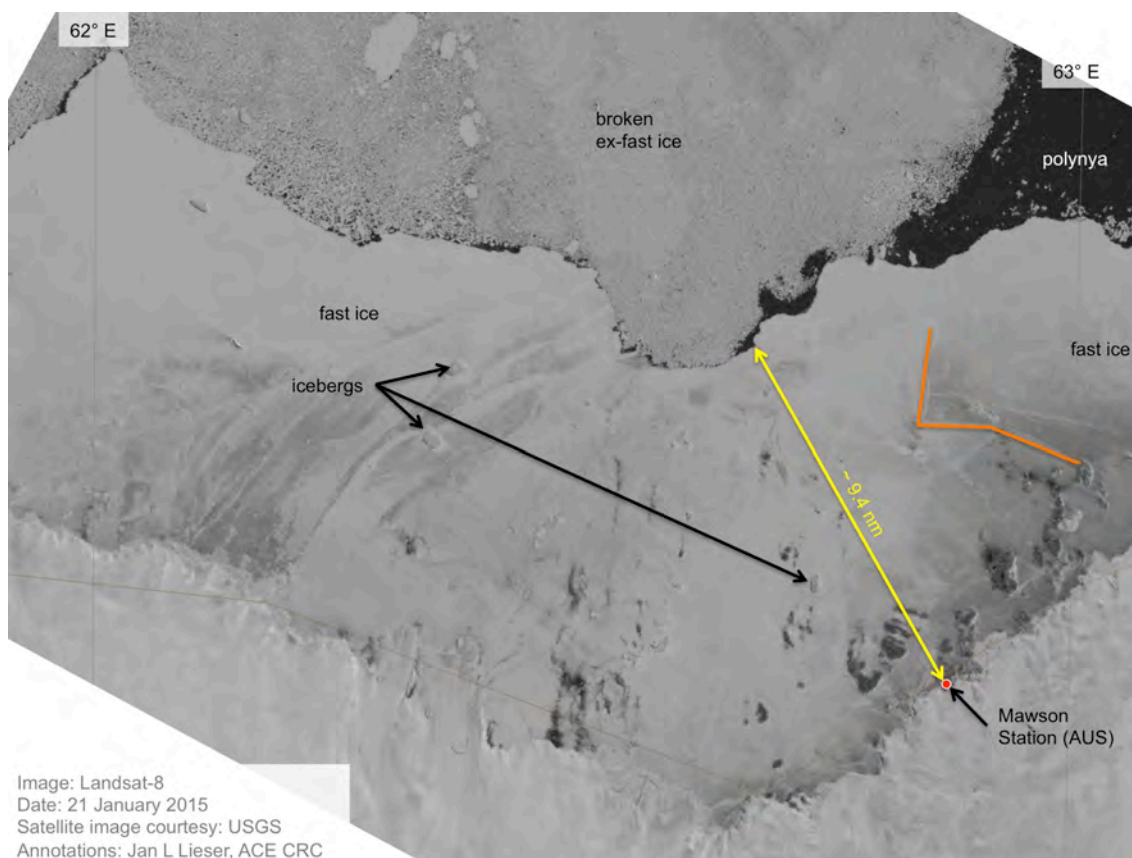
Figure 1: Landsat-8 image, acquired 21/01/2015 and provided by USGS.

Figure 1 shows a very high-resolution (about 30 m spatial resolution) visible image of the fast ice off Mawson Station. The fast-ice edge is clearly visible. The majority of ex-fast ice has broken into small floes, typically of about 100 m diameter. Only occasional very large floes remain in the mix.

Wind scouring on the surface of the fast ice can be seen west of the station, and immediately east of the station, close to the coast. The surface of the fast ice shows some old break-out lines (as indicated by the orange line) that are potential weak points.

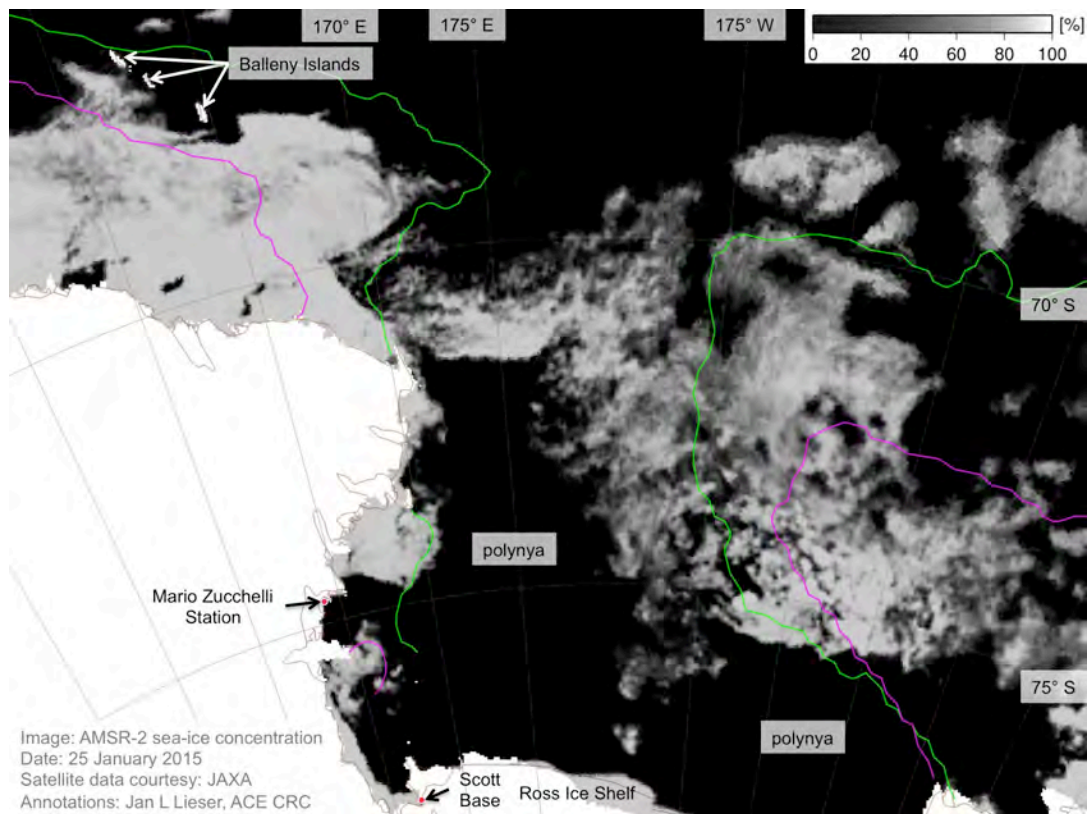
This summer season had a slow start towards melting conditions, which resulted in above average sea-ice concentration in the region. But during the second half of January, sea-ice concentration reduced markedly along 175° E and further east from there. While west of 175° E and north of 70° S, sea-ice extent appears to be well below (south) of the median, some sea ice remains north of the current distinctive sea-ice edge in that area, but below the detection limits of the AMSR-2 instrument. North of Balleny Islands, two patches of sea ice are seen in Figure 1, and can be confirmed through the cloud cover as a spit-like feature (connected patches) in the visible imagery of Figure 2. The inset of Figure 2 provides a very high resolution Synthetic Aperture RADAR look onto the sea ice through the clouds. From this it is verified that there is more sea ice than is resolved by the microwave (AMSR-2) data, for example in the region around 176° E and 69° S. and further east from there.

Figure 1: AMSR-2 sea ice concentration, acquired 25/01/2015 and provided by Universität Hamburg.

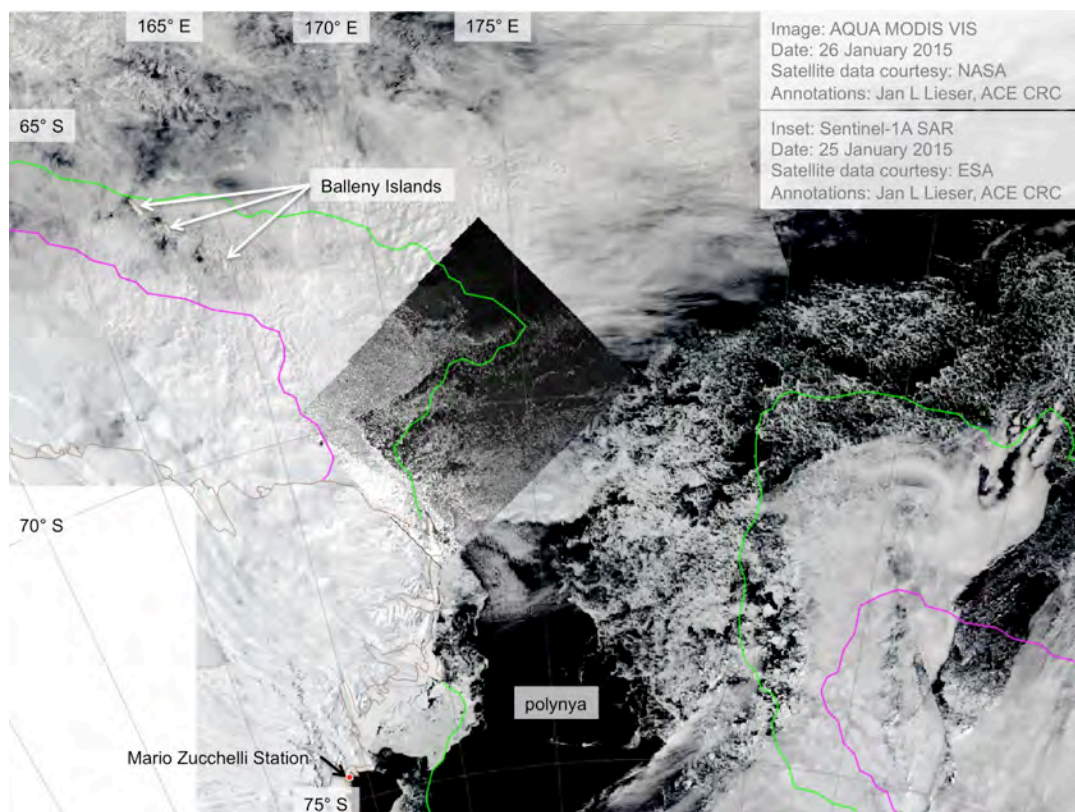
Figure 2: MODIS image, acquired 26/01/2015 and provided by NASA; inset: Sentinel-1a SAR, acquired 25/01/2015 and provided by PolarView.

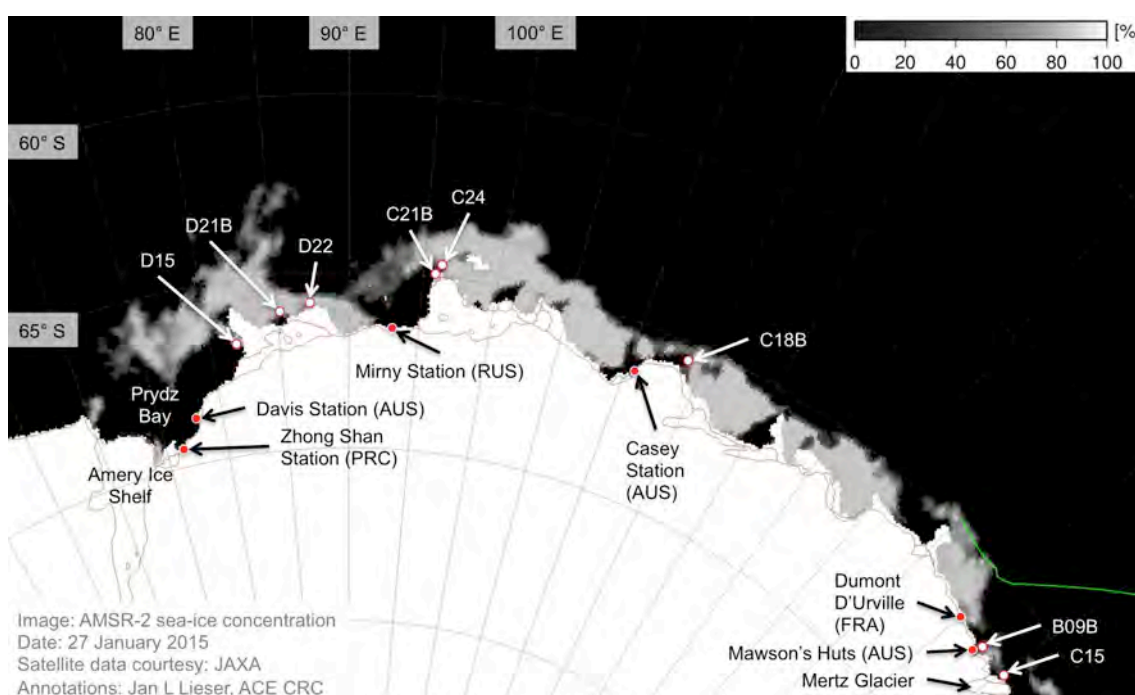
Figure 1 shows a sea-ice concentration chart for East Antarctica, between the Amery Ice Shelf and Mertz Glacier. The thin green line denotes the recent cruise track of RSV *Xue Long* (up to 28/01/2015 03:00 UT). Major tabular iceberg locations are marked with red-rimmed white dots.

Figure 1: AMSR-2 sea ice concentration, acquired 27/01/2015 and provided by Universität Hamburg.

In general, sea-ice concentration is nearing end of summer conditions. Southern Prydz Bay is largely free of sea ice. Around the Larsemann Hills (home of Zhongshan Station) some fast ice still remains, but the eastern edge of the hills (Dålkøys Bay) and Nella Fjord appeared to be sea ice free in recent visible imagery.

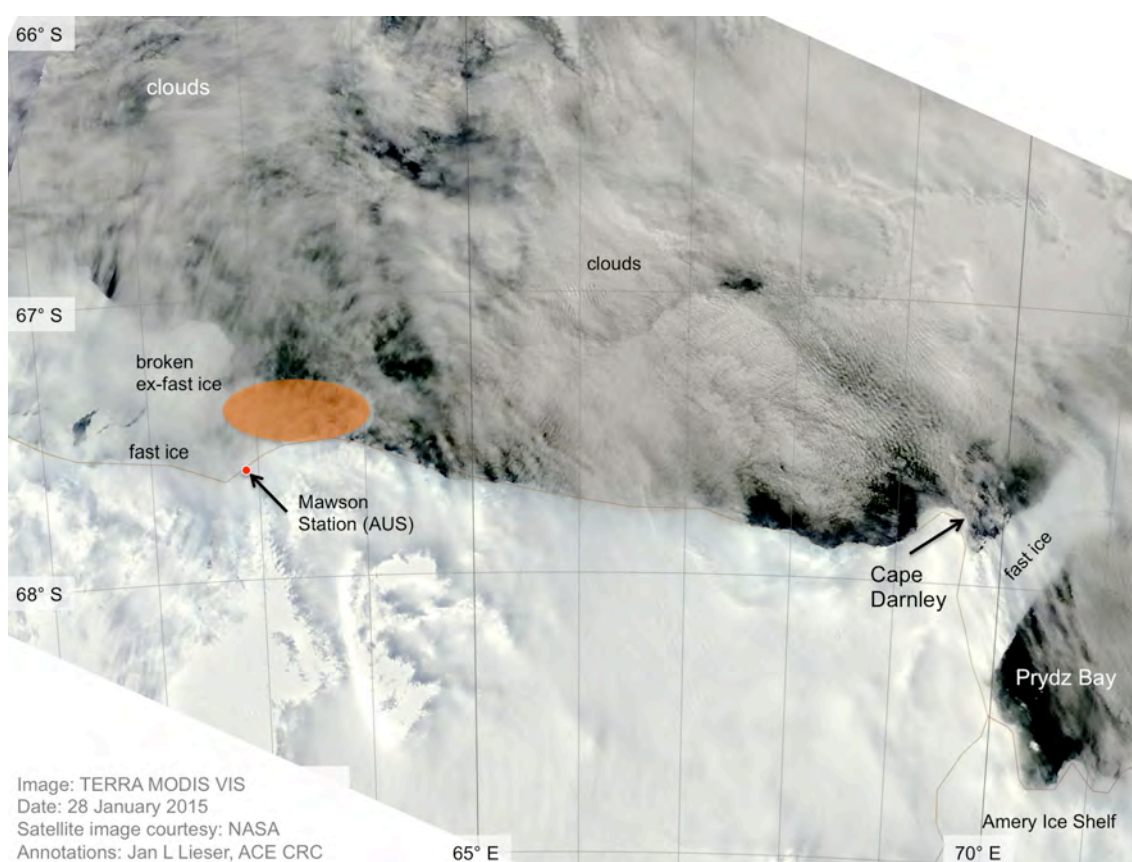
During the past week, visible imagery of Mawson Coast was largely obscured by clouds. After a few days of higher wind speeds recently, yesterday's visible image (Figure 1) suggests a further break up of fast ice, particularly between 63° E and 64° E, but potentially also north of the station (as marked by the orange shape in the figure). The new fast-ice edge could be as close to the shore as 3 nautical miles.

Figure 1: MODIS image, acquired 28/01/2015 and provided by NASA.

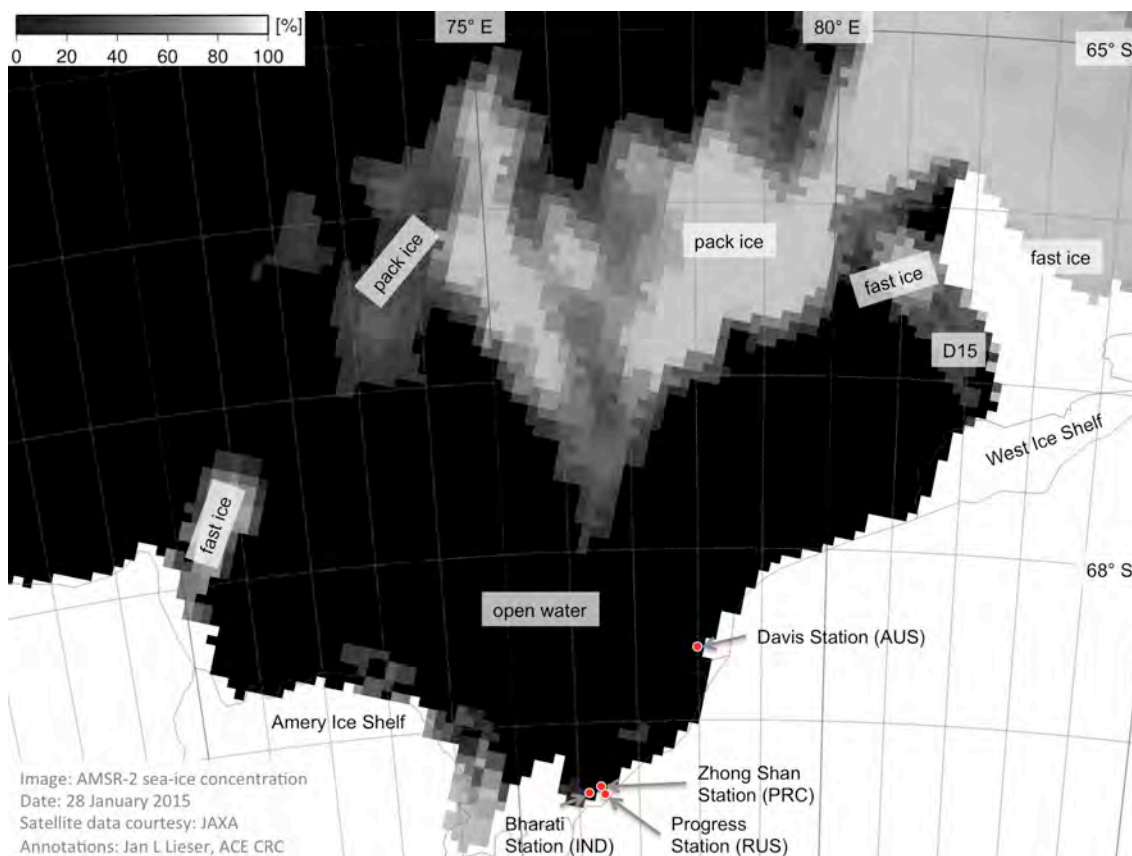
The entire region between 63° E and 72° E appears generally free of sea ice in the microwave data based sea-ice concentration charts (see also Figure 2), except for the fast ice off the eastern side of Cape Darnley, and bits of ice breaking off it. But some isolated patches of sea ice might remain in the region.

The southern part of Prydz Bay is largely sea ice free (Figure 2). North of about 67° S, some high concentration pack ice continues to exist but it appears to be mostly confined to longitudes east of 74° E. Off the West Ice Shelf, the conglomerate of iceberg D15 and old fast ice remains local and has a confused signature in the AMSR-2 sea-ice concentration data.

Figure 2: AMSR-2 image, acquired 28/01/2015 and provided by Drift & Noise Polar Services.

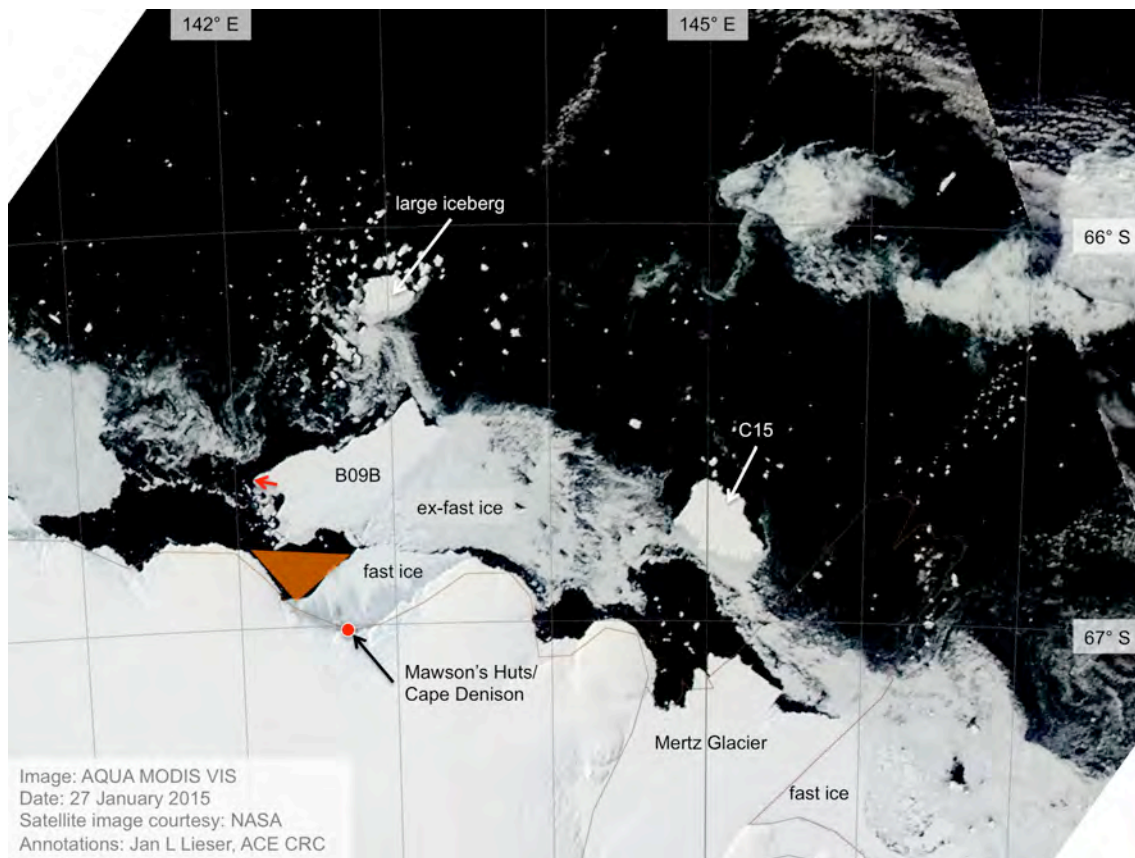
There are numerous smaller icebergs in the entire region visible in Figure 3. Most of them appear to be accumulating around the large (unnamed) iceberg north of B09B (annotated in Figure 3). But many more are drifting freely in the region or are grounded, for example

along a virtual extension of the long axis of Mertz Glacier with a northern end at about 147° E and 66° 15' S.

Figure 3: MODIS image, acquired 27/01/2015 and provided by NASA.
