Sea ice reports for the Antarctic shipping season 2014 - 2015

Prepared by: Dr Jan L Lieser (Jan.Lieser@acecrc.org.au), Dr Robert A Massom (Rob.Massom@acecrc.org.au) & Dr Petra Heil (Petra.Heil@acecrc.org.au)
Antarctic Climate & Ecosystems Cooperative Research Centre, May 2015

The sea ice reports compiled in this document are weekly reports on sea-ice conditions for East Antarctica, including sub-weekly updates. They were prepared to support ship operations in East Antarctica during the 2014/2015 shipping season. These reports were primarily used to guide the Australian Antarctic program, but were partly provided to other Antarctic operators. In particular, we assisted Chinese National Antarctic Research Expeditions (RSV *Xue Long*), the Royal New Zealand Navy, the New Zealand National Institute of Water and Atmospheric Research (RV *Tangaroa* Voyage 2), the Australian Marine National Facility (RV *Investigator*) and the US Antarctic Program (RVIB *Nathaniel B. Palmer* Voyage 15-03). During the season, these reports informed eight voyages, all of which returned within schedule or early due to navigational choices made by the ships' captains based on sea-ice reports.

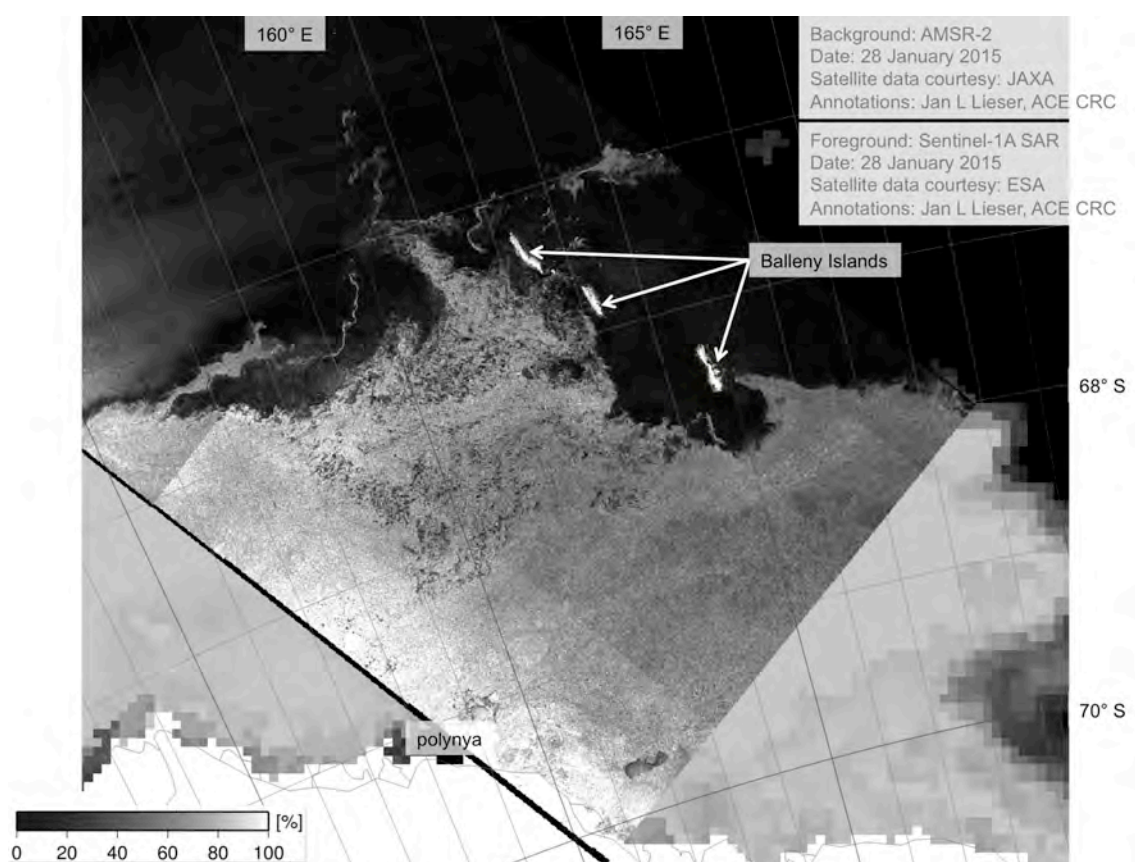
Figure 1 shows a very high resolution Synthetic Aperture RADAR (SAR) image of the sea-ice zone around the Balleny Islands. It is overlain on a background showing a sea-ice concentration chart based on AMSR-2 data.

Figure 1: Foreground: Sentinel-1a SAR, acquired 28/01/2015 and provided by PolarView; Background: AMSR-2 sea-ice concentration, acquired 25/01/2015 and provided by Drift & Noise Polar Services.

The coastlines of the islands appear to be mostly free of sea ice, but to the west and south of the group of islands, small sea-ice floes are abundant in high to very high concentration. The spit-like patch of sea ice along 66° S is still visible (see Sea Ice Report #5.1/2015 for

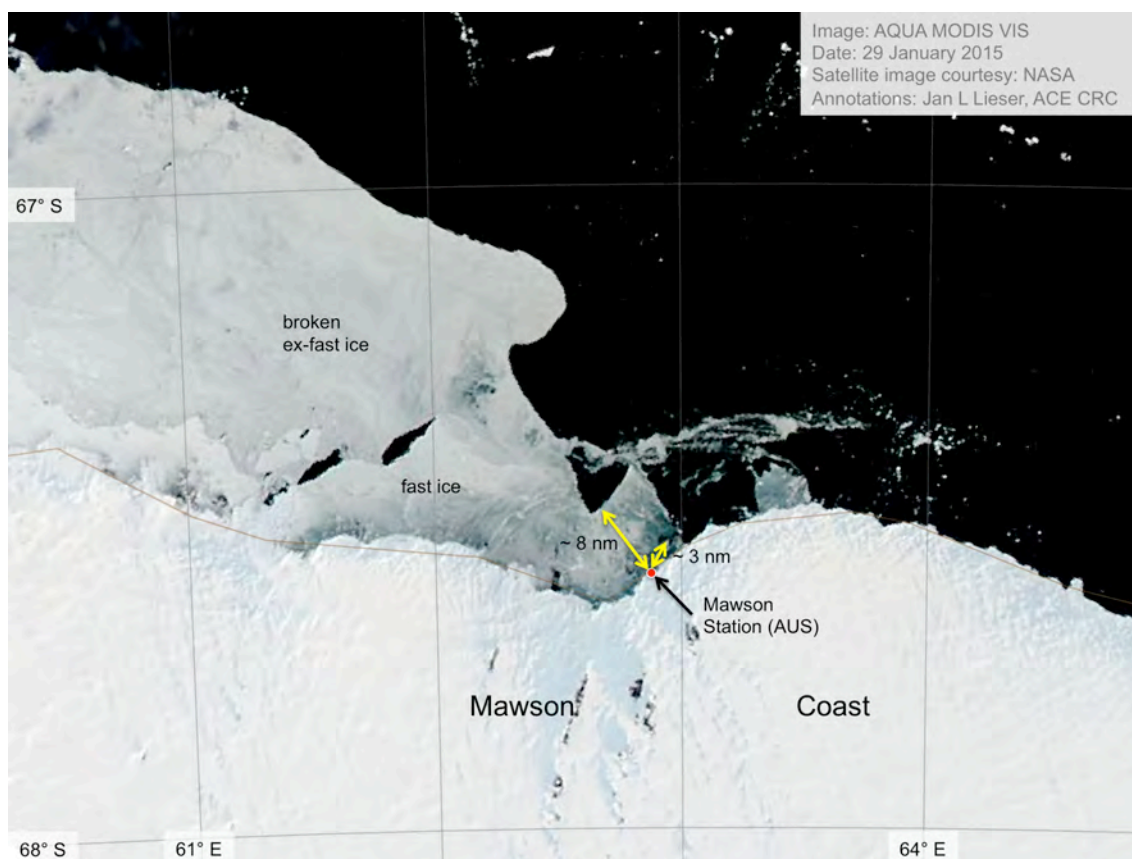
Further to Sea Ice Report #5.3/2015, Figure 1 offers a cloud free view of Mawson Coast and the sea ice off shore. A large portion of fast ice to the east of 63° E has disintegrated. Close to the shore, the new fast-ice edge is not a straight line, but shows a harbour-like structure with the nearest open water about three nautical miles away from the station in northeasterly direction (at about 62° 55' E and 67° 30' S).

Figure 1: MODIS image, acquired 29/01/2015 and provided by NASA.

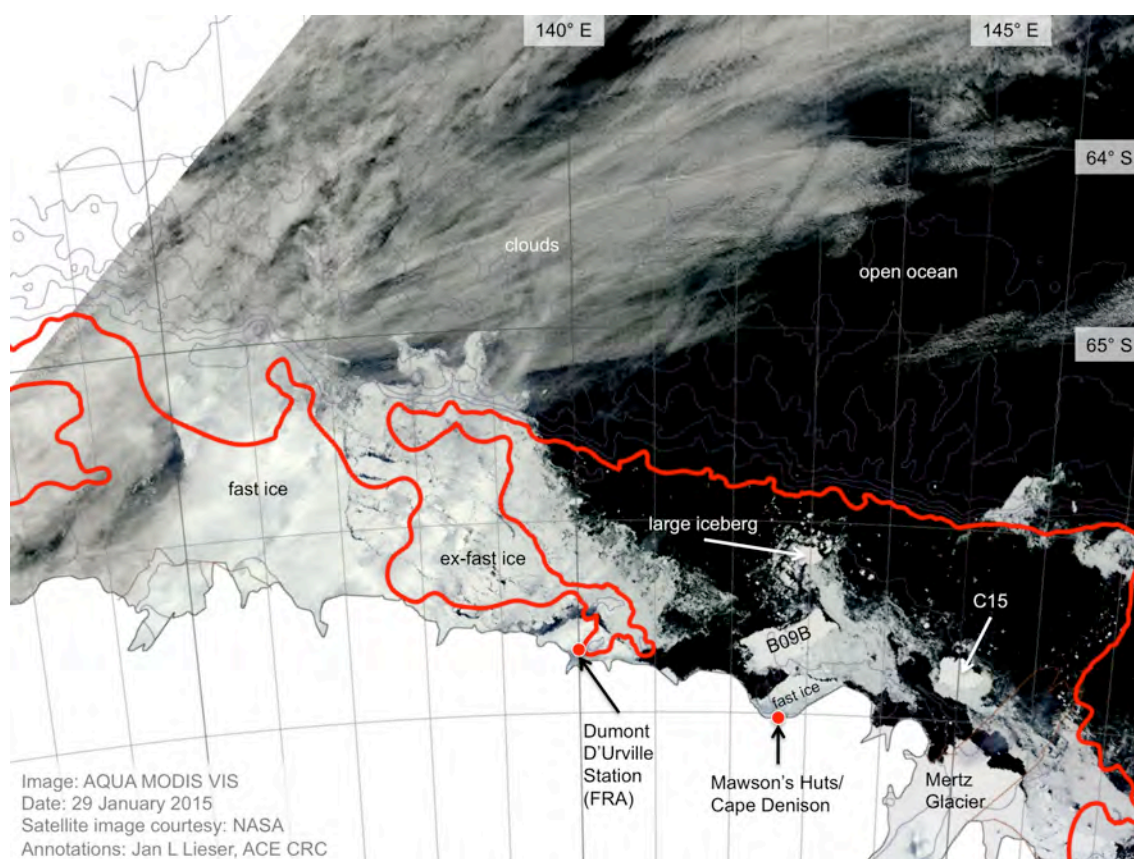
The northern and western part of Figure 1 is covered by thin clouds but the southern and eastern part provides an unobscured view on the sea-ice zone. East of 140° E and between of 65° S and 66° S, only very little sea ice can be seen in the visible imagery of Figure 1. West of the large tabular iceberg B09B is an area of about 40 nautical miles of exposed coast, but north of that region remains a band of low sea-ice concentration, centred at about 66° 25' S.

Figure 1: MODIS image, acquired 29/01/2015 and provided by NASA.

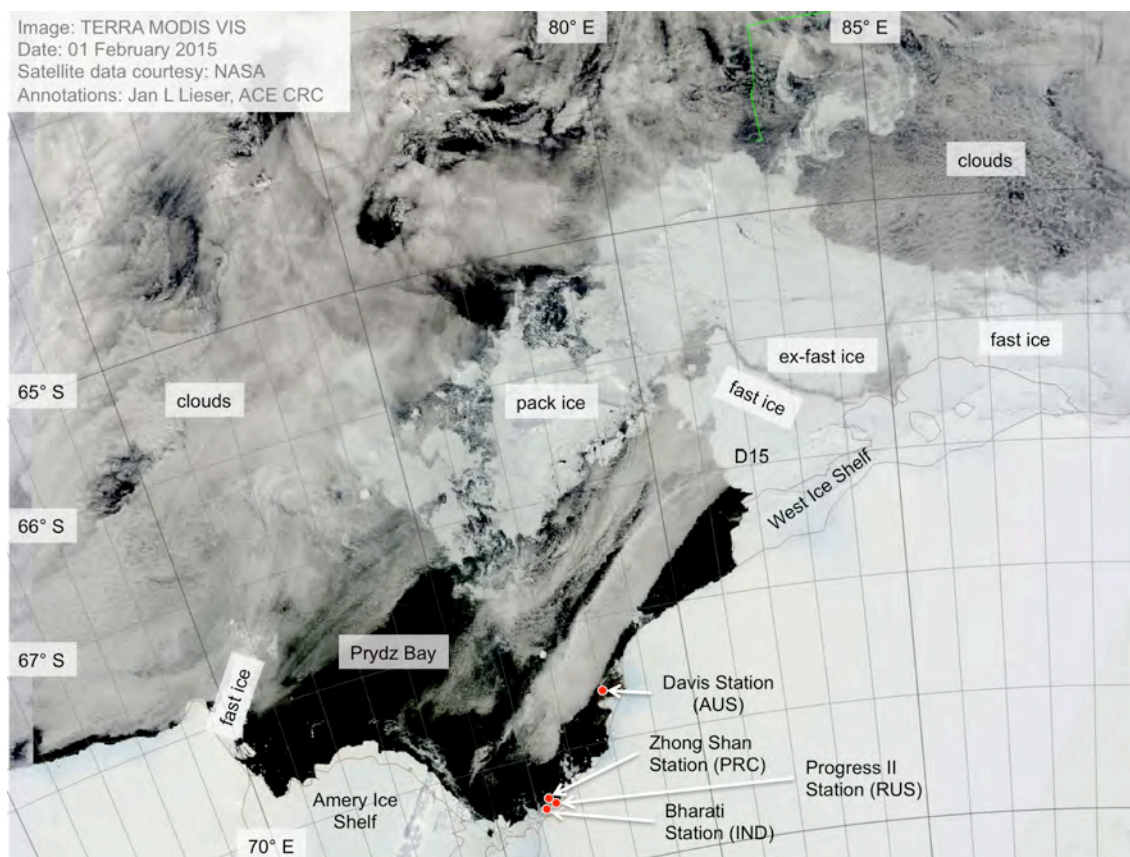
Figure 1 shows a visible MODIS image of Prydz Bay. The thin green line denotes the cruise track of RSV *Xue Long*, up until 02/02/2015 00:00UT. Most of the sea-ice zone is obscured by thin clouds, but the pack ice in eastern Prydz Bay can be clearly identified.

Figure 1: MODIS image, acquired 01/02/2015 and provided by NASA.

Medium high to high concentration sea-ice extents as far west as 73° 30' E, but a winding channel of low sea-ice concentration stretches between 76° E and 77° E, from about 66° S to 67° S. The southern part of Prydz Bay is largely free of sea ice, but at least one large tabular iceberg is drifting in the area, currently located at 76° 55' E and 68° 11' S.

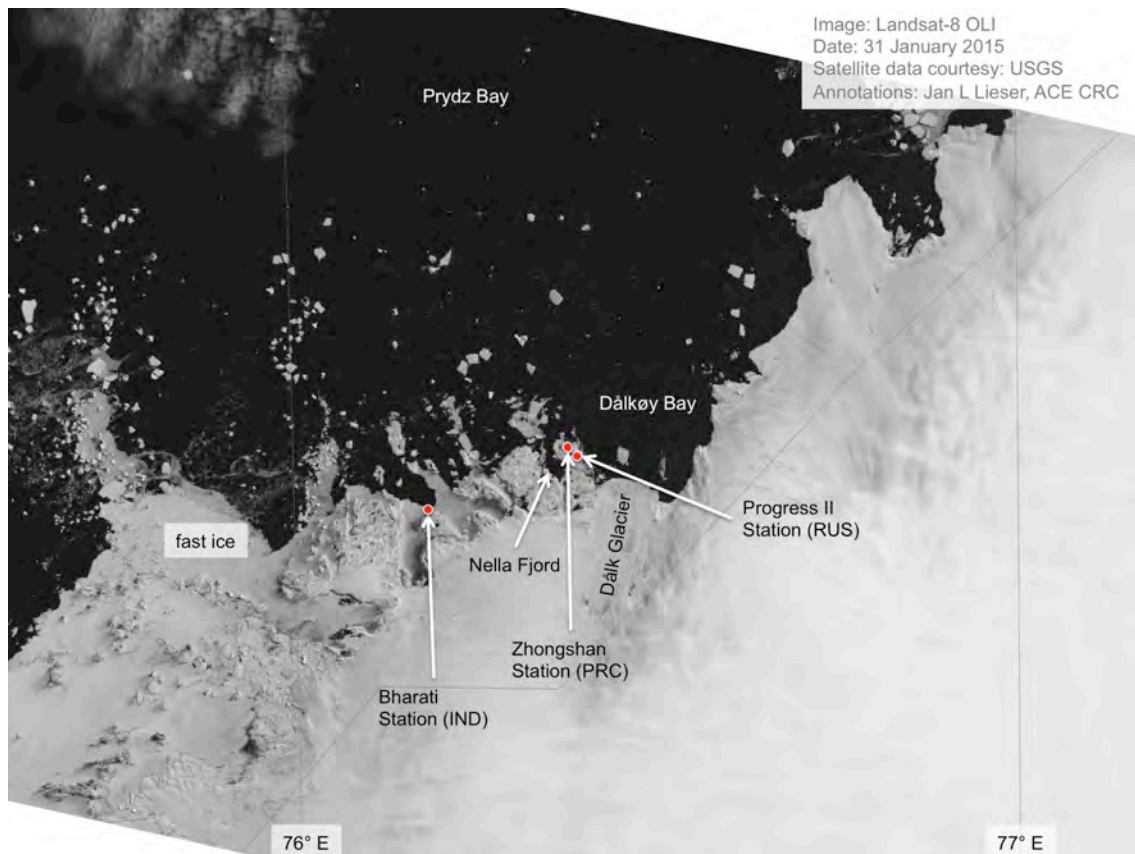
Figure 2: Landsat-8 Operational Land Imager (OLI) image, acquired 31/01/2015 and provided by US Geological Survey.

A very high resolution (30 m horizontal resolution) visible image of the Larsemann Hills is given in Figure 2. It was acquired by Landsat-8 satellite's Operational Land Imager (OLI). Dalkø Bay is mostly free of sea ice, as well as Nella Fjord. North of Larsemann Hills, some icebergs are present and melting ex-fast ice.

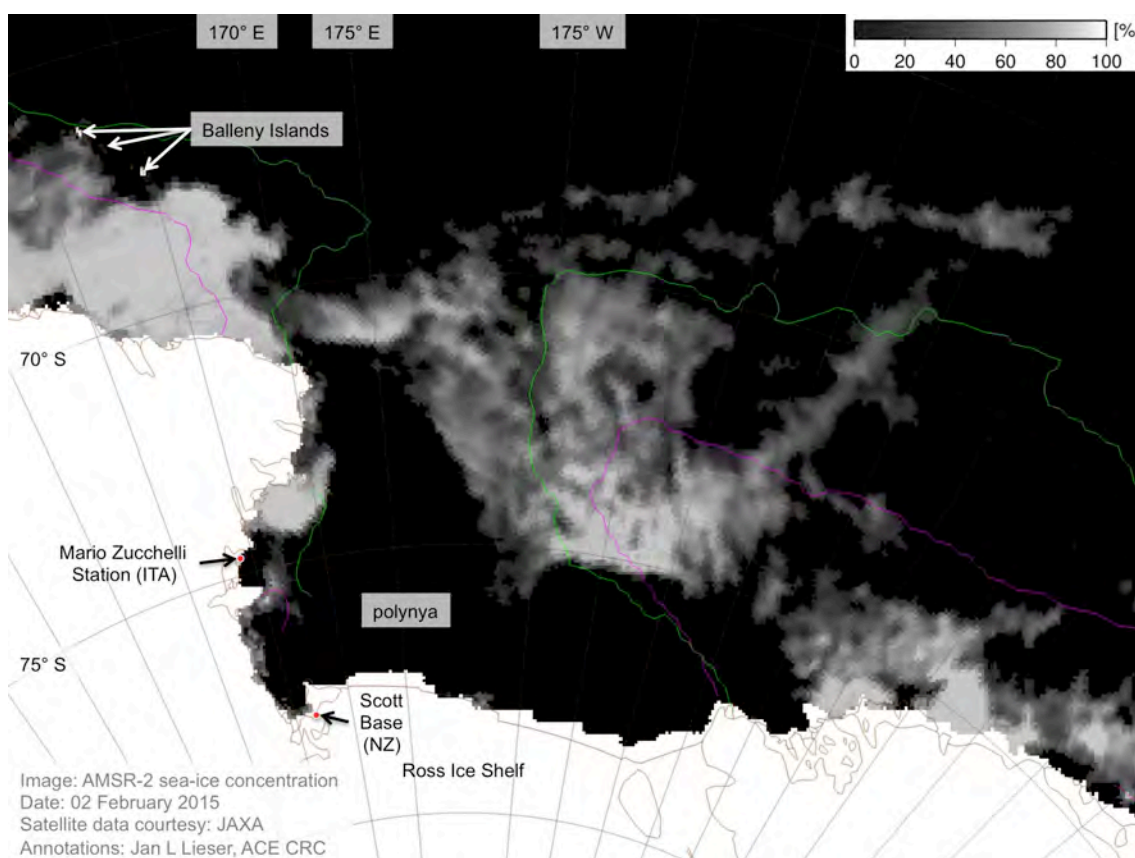
In general, sea ice in the Ross Sea and adjacent areas still shows signs of summer retreat. However, overall more sea ice (higher concentration) remains in the region when compared to the 30-year (1981-2010) median of sea-ice extent. In Figure 1, the January and February median sea-ice extent is indicated by the thin green and magenta lines, respectively.

Figure 1: AMSR-2 image, acquired 02/02/2015 and provided by JAXA.

The central southern and western part of the Ross Sea is largely free of sea ice (Figure 1). But one patch of high concentration sea ice, currently centred between 172° E and 177° E at about 71° S, separates the polynya of the Ross Sea from the open ocean north of 69° S. This patch is slowly moving in northerly direction. During the past week, the southern boundary of this patch has migrated about 25 nautical miles north, along 175° E.

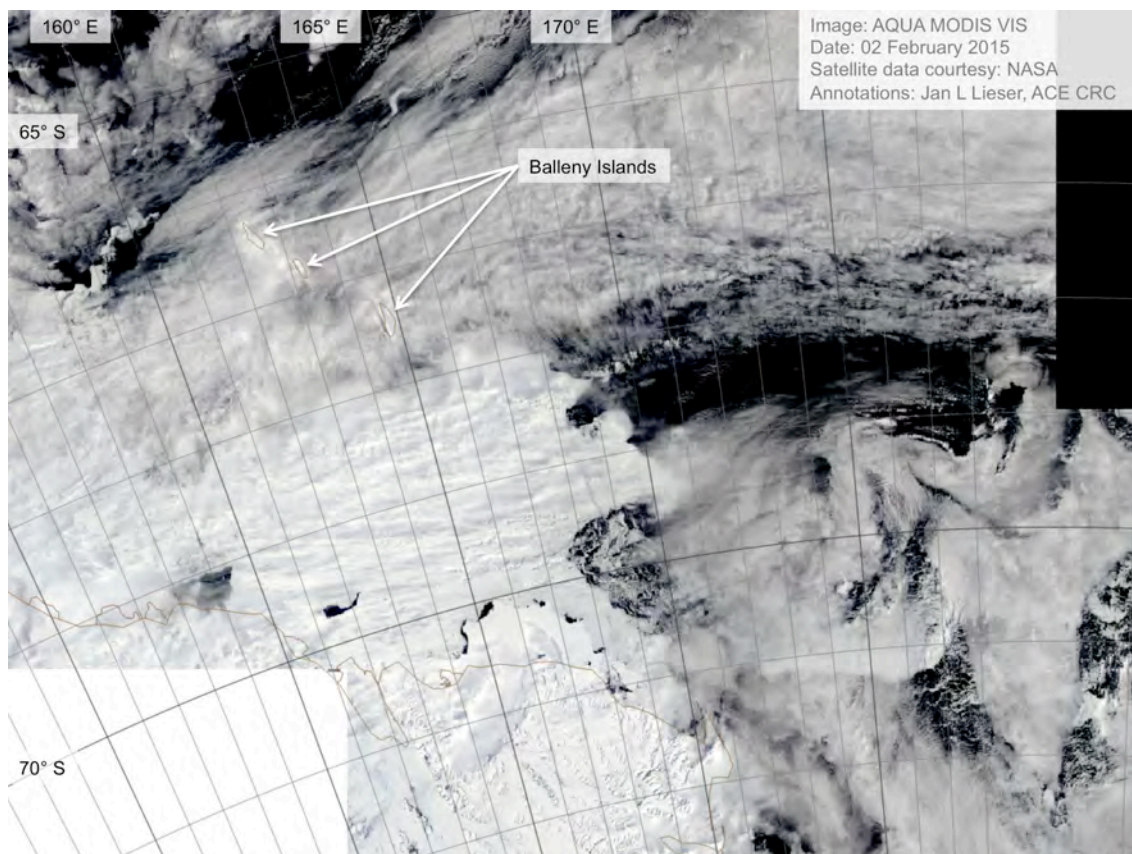
To the north and east of the Balleny Islands, sea ice is below the detection limit of the AMSR-2 instrument and the cloud cover (see Figure 2) does not allow for a visual confirmation.

Figure 2: MODIS image, acquired 02/02/2015 and provided by NASA.

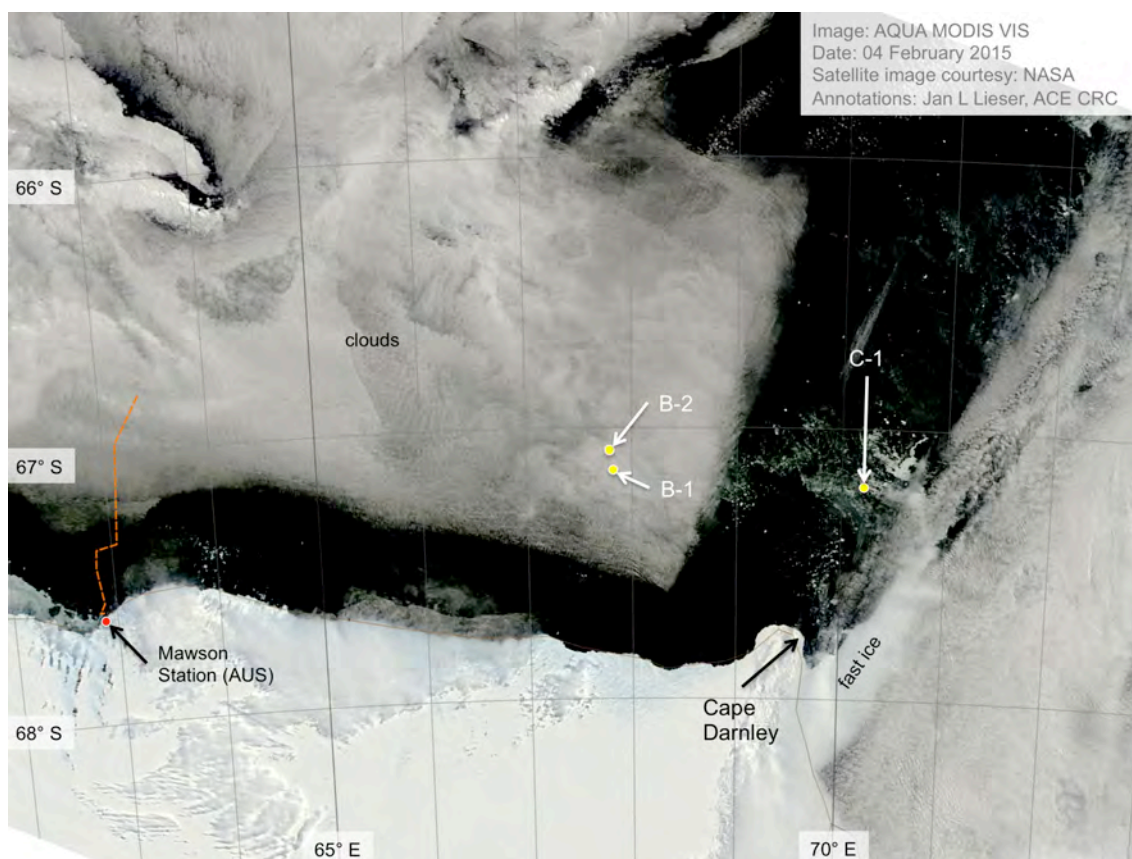
The approach into Mawson Station, as indicated by the orange dashed line in both, Figure 1 and Figure 2, is mostly free of sea ice. Only a thin sheet of old ex-fast ice remains inside Horseshoe Harbour. Three mooring locations off Cape Darnley, as indicated by yellow dots in both figures, are covered by only minimal sea ice, which is below the detection limit of the AMSR-2 sensor (see Figure 2). Fast ice attached to the eastern side of Cape Darnley is still breaking up and sea-ice floes originating from this are drifting westward, across the mooring locations.

Figure 1: MODIS image, acquired 04/02/2015 and provided by NASA.

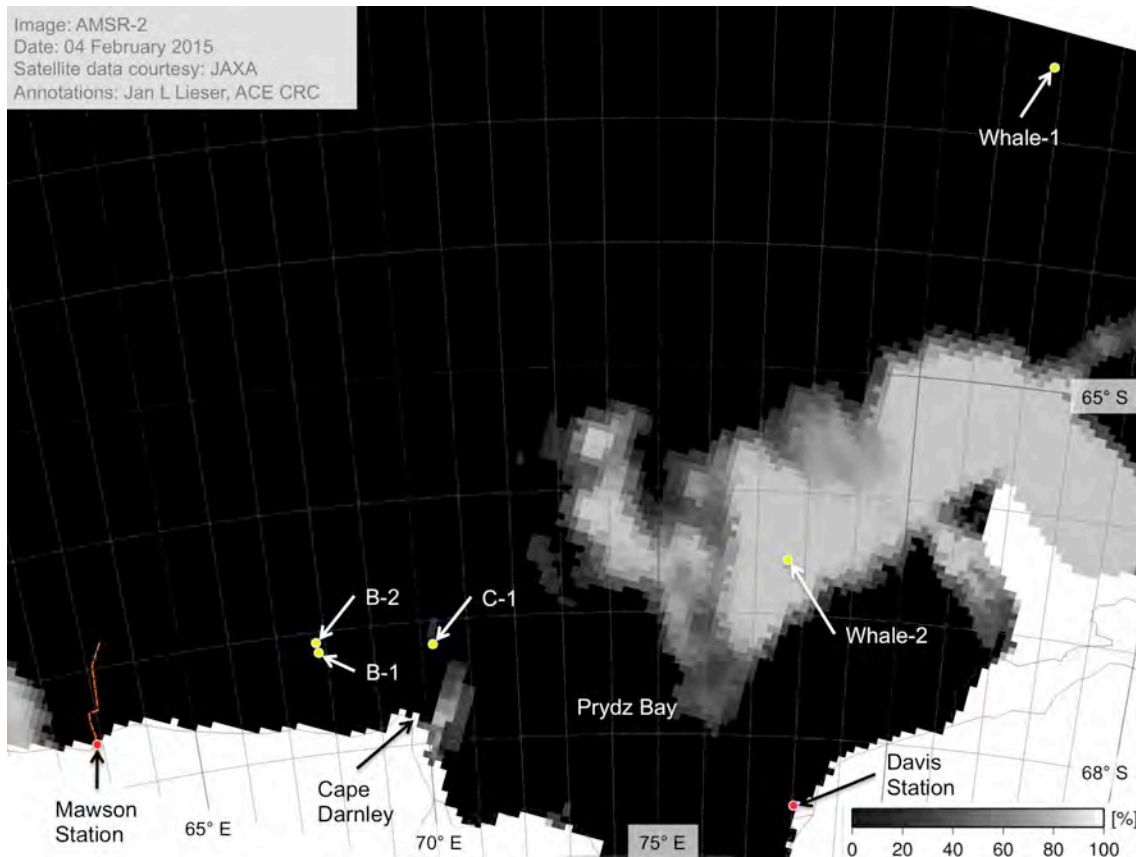
Figure 2 provides a larger-scale overview of sea-ice conditions in Prydz Bay. Whale-1 mooring is located about 140 nautical miles

north of the sea-ice edge. Whale-2 mooring is under a persistent high concentration sea-ice cover.

Figure 2: AMSR-2 image, acquired 04/02/2015 and provided by JAXA.

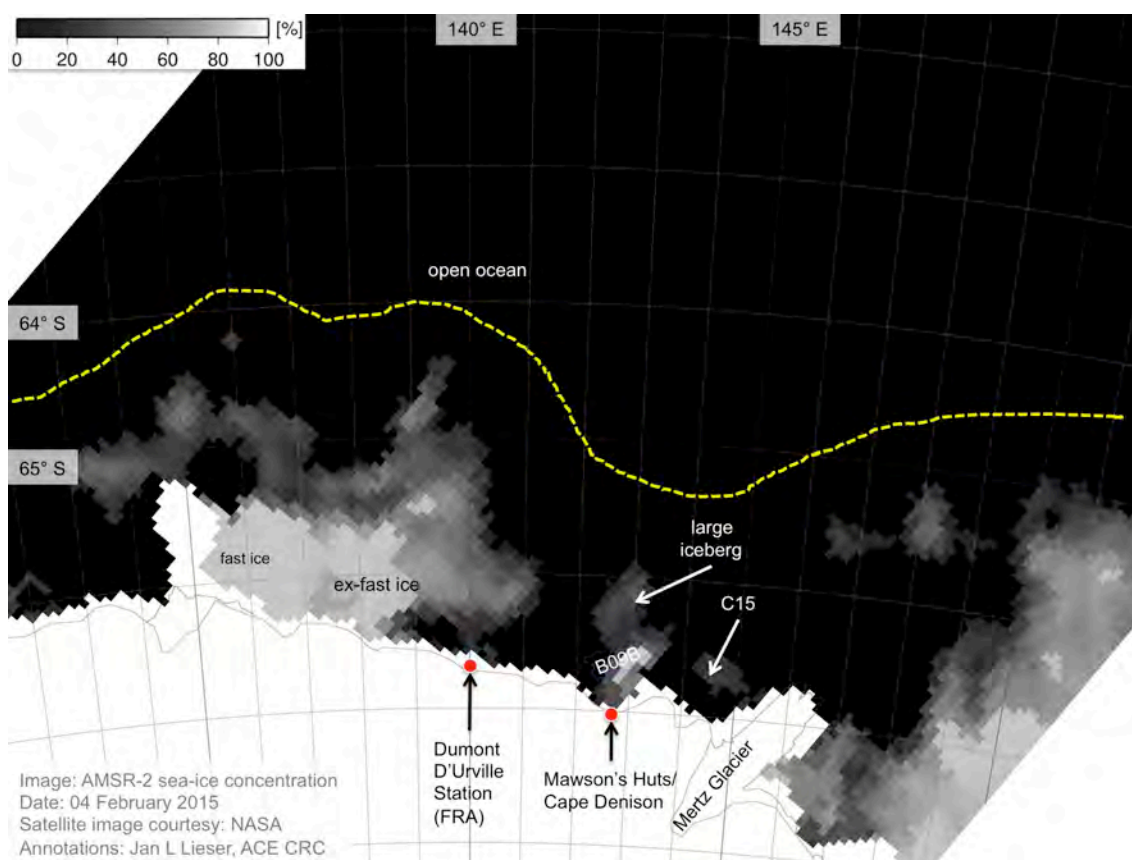
Figures 1 and 2 show the same geographical frame as seen by the AMSR-2 and MODIS instrument, respectively, between 135° E and 150° E. The yellow dashed line in both figures gives the boundary south of which some sea ice can reasonably be expected.

Figure 1: AMSR-2 image, acquired 04/02/2015 and provided by JAXA.

Along 142° E appears to be a relatively ice free passage to the coast in Figure 1, but some sea-ice floes below the detection limit (nominally 15%) of the sea-ice concentration algorithm applied to the AMSR-2 data is still in the area.

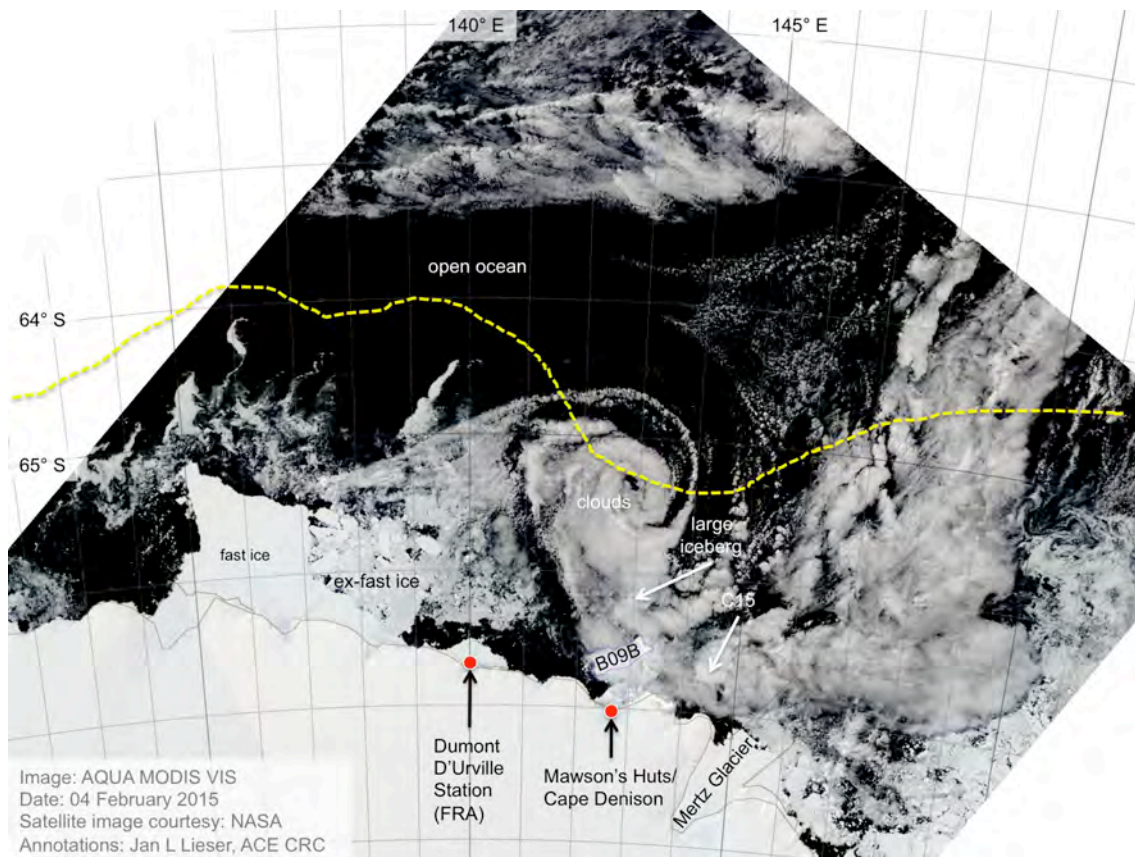
Figure 2: MODIS image, acquired 04/02/2015 and provided by NASA.

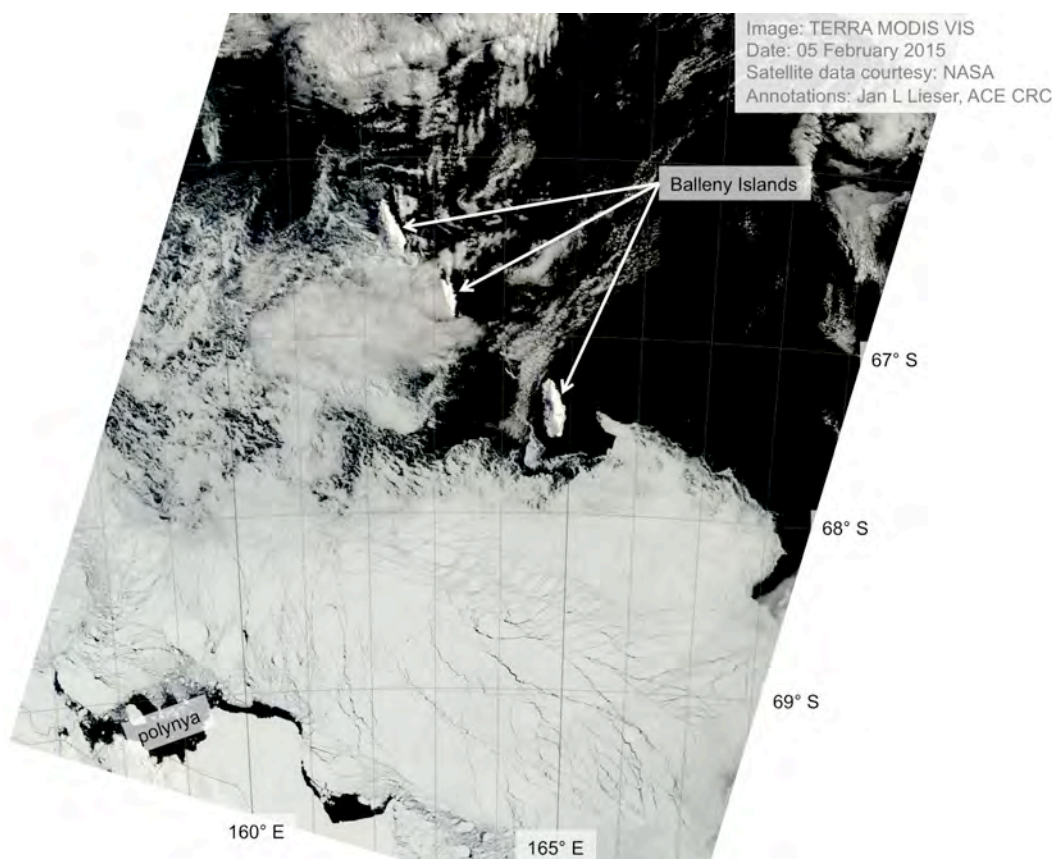
The region east of the Balleny Islands is largely free of sea ice (see Figure 1). East of 165° E, the sea-ice edge is a relatively well defined line. West of Buckle Island (the middle one of the three major islands that make up the Balleny Islands), an opaque cloud patch obscures the view on to the sea ice, but the large-scale sea-ice concentration map based on AMSR-2 data (not shown) suggests medium-high to high concentration in that area.

Figure 1: MODIS image, acquired 05/02/2015 and provided by NASA.

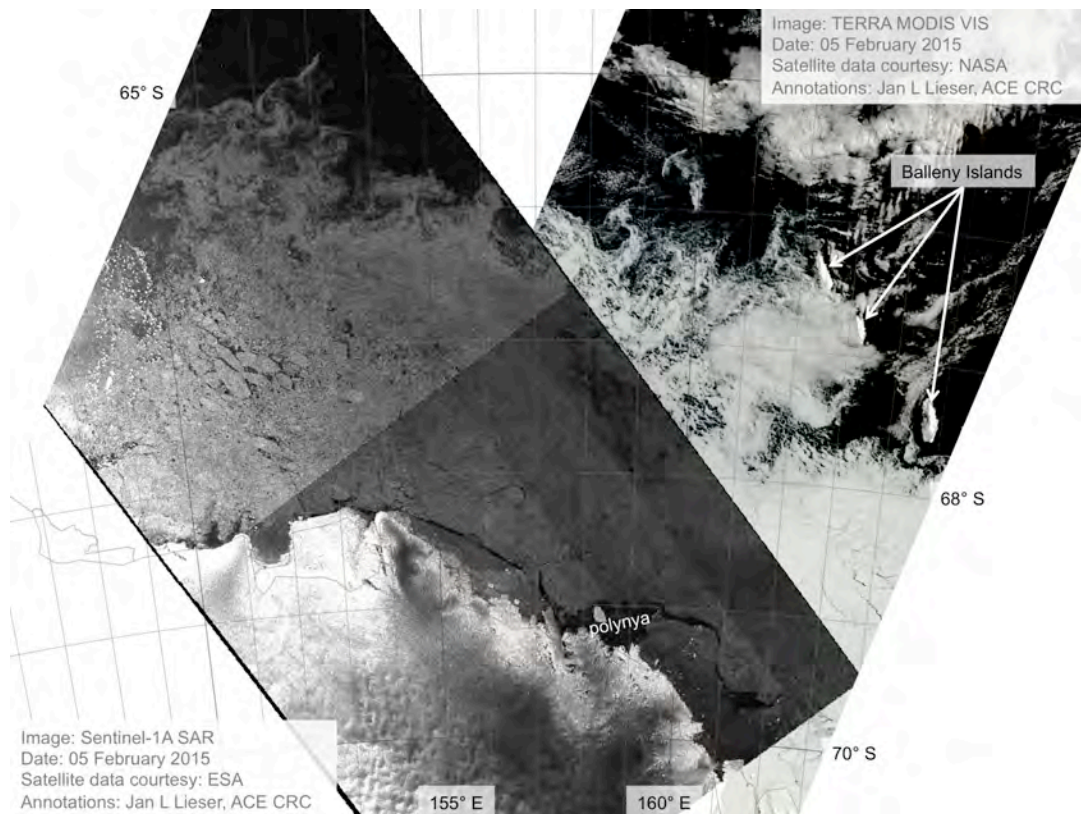
In addition to the image of Figure 1, Figure 2 provides two consecutive SAR scenes illuminating the sea ice to the south and west of the Balleny Islands. Mostly small sea-ice floes can be identified to the east of about 152° E.

Figure 2: Same as Figure1 plus overlain Sentinel-1A SAR images, acquired 05/02/2015 and provided by PolarView.

West of 150° E, a large group of icebergs can be seen as bright spots, between 66° S and 67° 30' S (Figure 2).

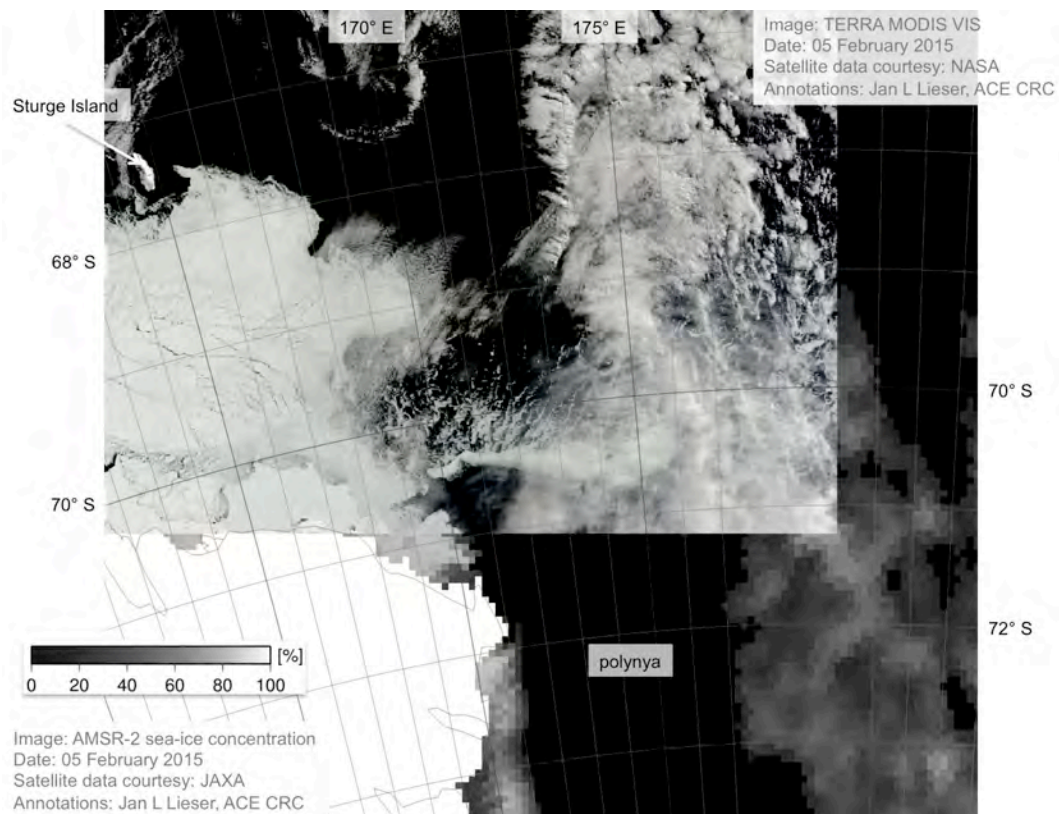
Figure 3: Same as Figure1 plus background of sea-ice concentration map, acquired 05/02/2015 and provided by Drift & Noise Polar Services.

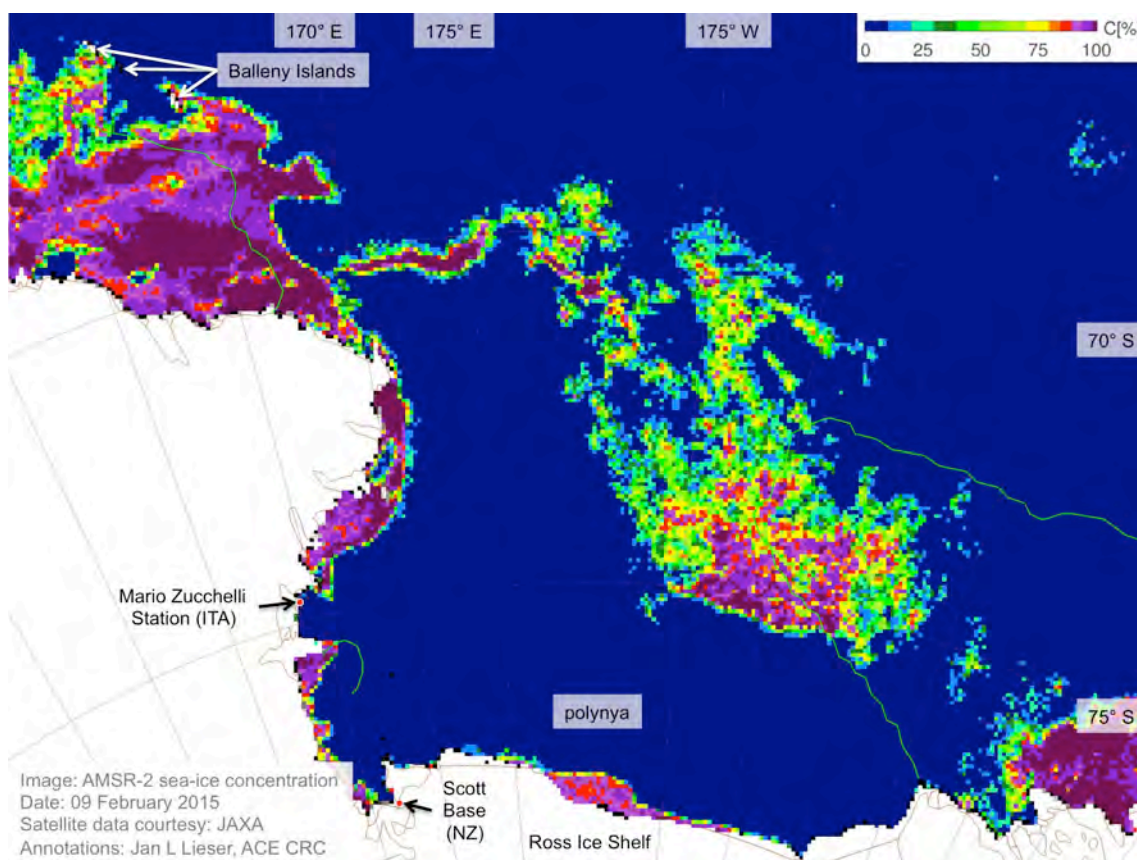
Figure 1 shows a sea-ice concentration chart for the Ross Sea and surrounding areas. The thin green line denotes the long-term (1981-2010) median sea-ice extent for February in the region.

Figure 1: AMSR-2 image, acquired 09/02/2015 and provided by Universität Bremen.

Western Ross Sea is largely free of sea ice, some fast ice remains attached to the coast. Between 170° E and 176° E, a band of very localised high concentration sea ice still separates the southern Ross Sea from the open water of the Southern Ocean. This band has moved about 17 nautical miles northwards during the past five days, has thinned and is currently just south of 70° S.

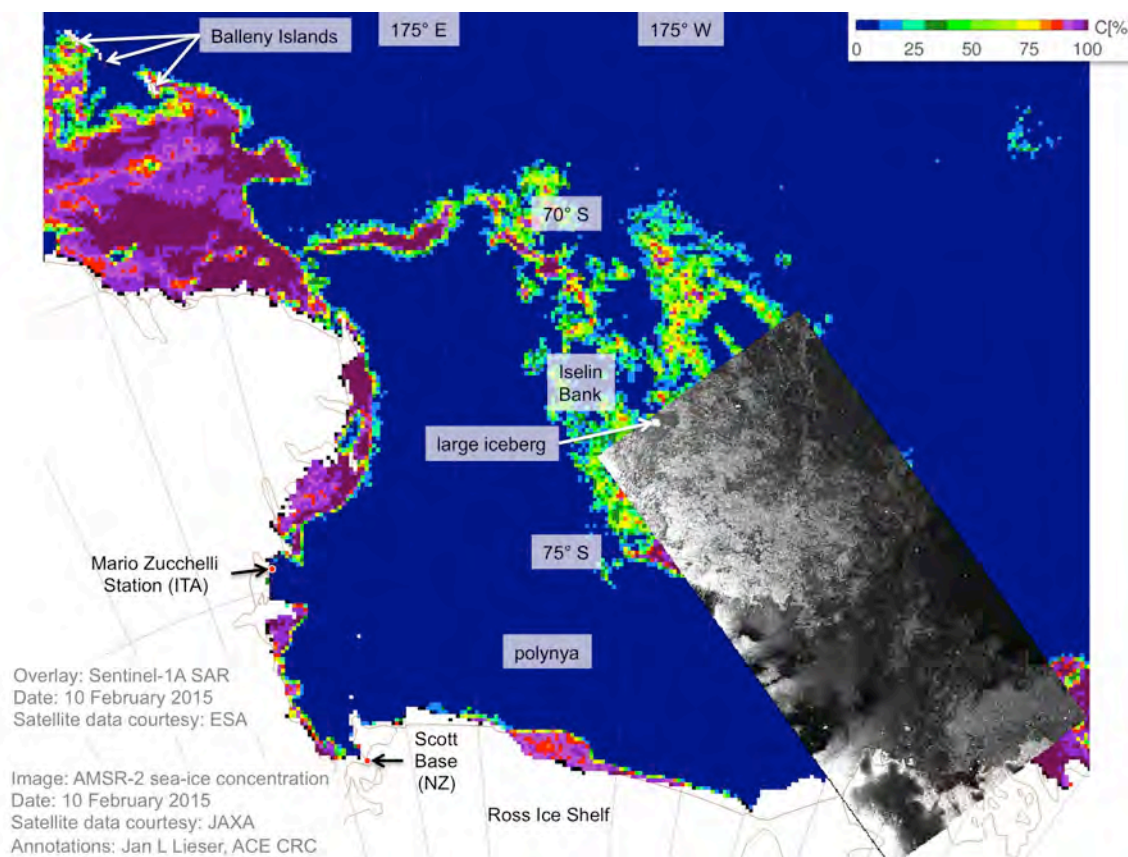
Figure 2 shows the same setup as Figure 1, but for 10/02/15. Two SAR scenes (combined adjacent to each other) were acquired for the eastern Ross Sea.

Figure 2: AMSR-2 image, acquired 10/02/2015 and provided by Universität Bremen; overlay: Sentinel-1A SAR, acquired 10/02/2015 and provided by PolarView.

As for the region southeast of the Balleny Islands, the SAR scenes show mostly small sea-ice floes in the pack, but at lower concentration. The frayed structures can clearly be seen in the high resolution imagery.

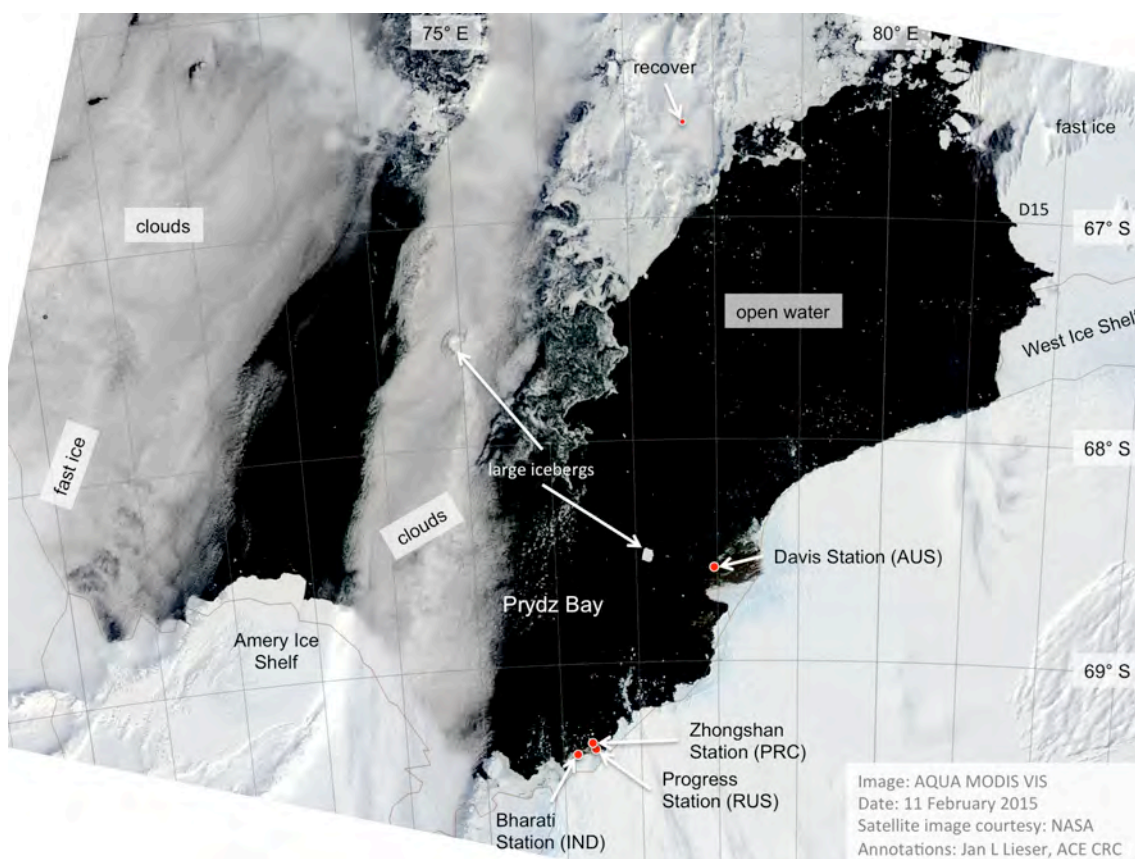
In southern Prydz Bay, only minimal sea ice remains but a large number of free floating icebergs can be identified as white dots on the dark open water in Figure 1. Two particularly large icebergs are annotated in the figure, the one at 77° 7' E and 68° 30' S has a surface area of approximately 10 nautical miles² (~34 km²).

Figure 1: MODIS image, acquired 11/02/2015 and provided by NASA.

West of the Amery Ice Shelf, some fast ice remains attached to the eastern side of Cape Darnley, but is still breaking up. The seaward edges of the Vestfold and Larsemann hills (home of the annotated stations in Figure 1) are free of sea ice. The location of the due to be recovered 'whale mooring' is covered by high concentration sea ice.

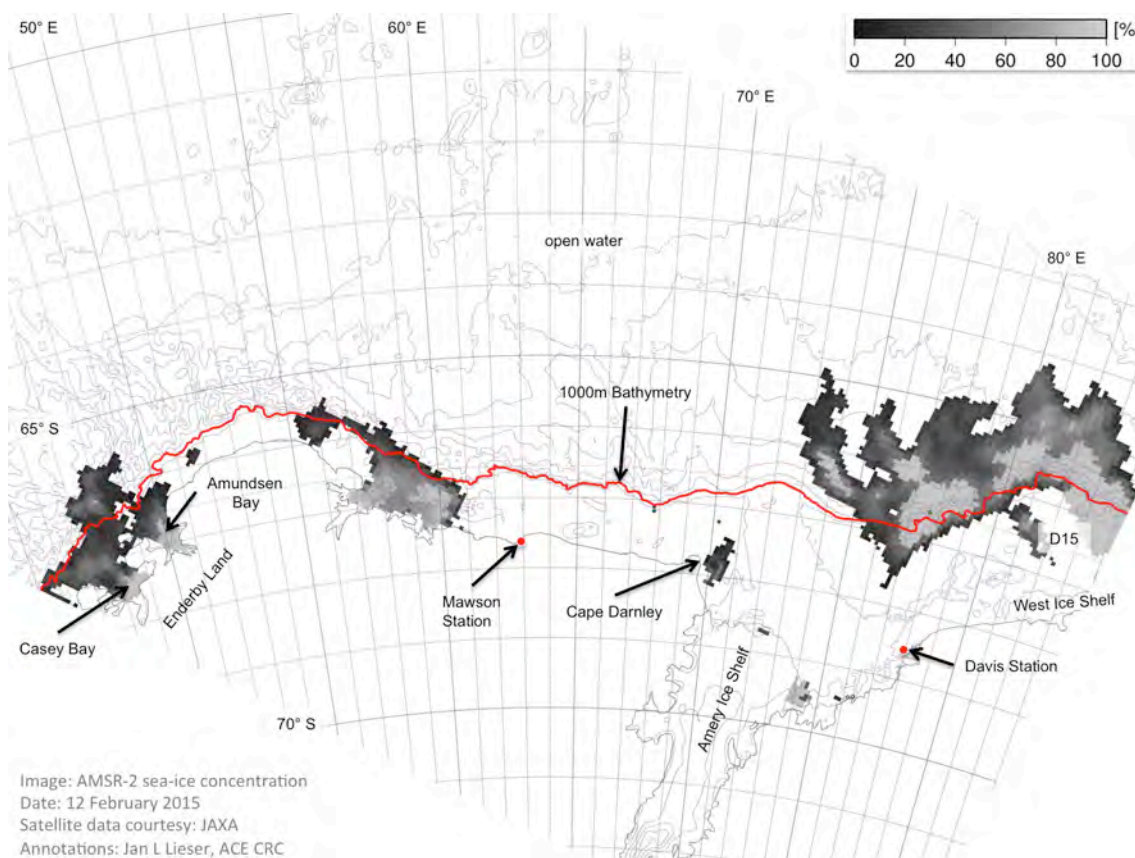
Figure 1 shows a sea-ice concentration chart of the region between Enderby Land and the West Ice Shelf. The contour lines denote ocean bathymetry (at 500 m intervals); the 1000 m bathymetry line is highlighted in red. Small green dots indicate mooring locations of interest during *Aurora Australis*' Voyage 3 in the region.

Figure 1: AMSR-2 image, acquired 12/02/2015 and provided by Drift & Noise Polar Services.

Off Enderby Land, sea ice shows quite variable concentration, during the past week, but generally still summer melting conditions. Fast ice appears to be locked in Casey Bay and Amundsen Bay.

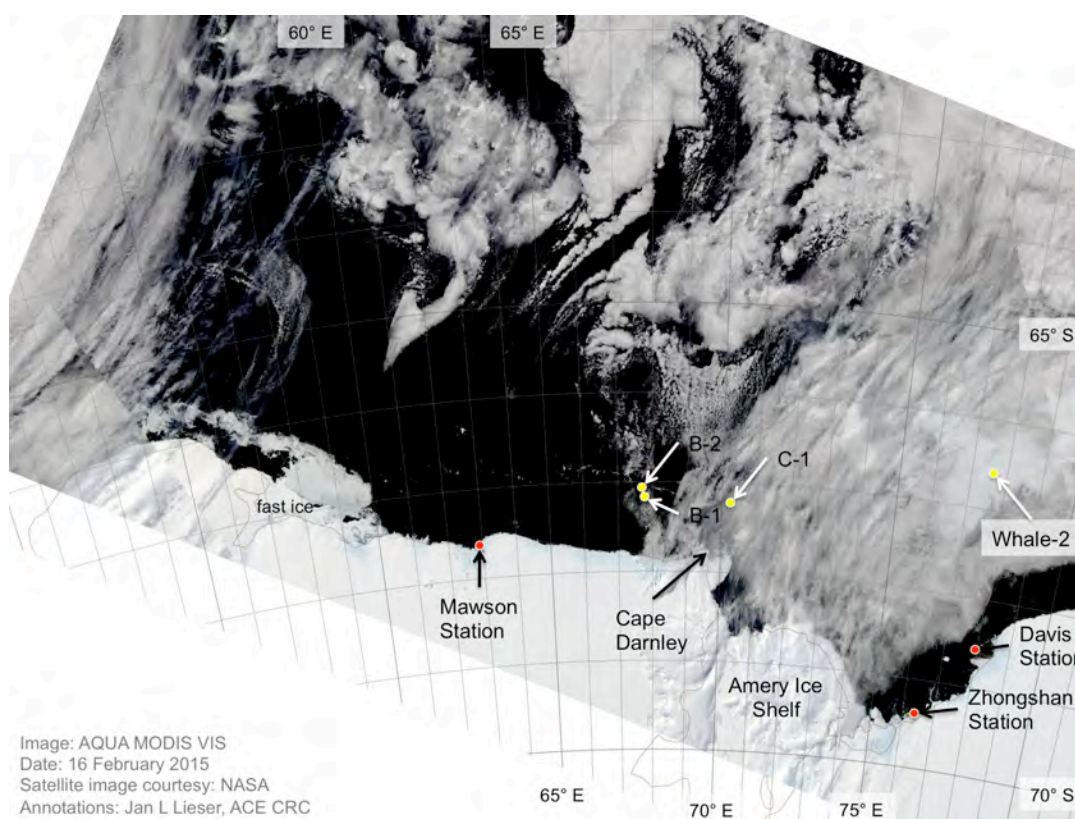
There is no significant sea ice off Mawson Station. However, Figure 1 shows a string of sea-ice floes just north of 67° S, between 60° E and Cape Darnley. These floes originate most likely from the fast-ice body that is still attached to the coast, east of Cape Darnley. These floes are below the detection limit of the AMSR-2 instrument, but can still be of solid thickness as ex-fast ice.

Figure 1: MODIS image, acquired 16/02/2015 and provided by NASA.

The seaward side of the Vestfold and Larsemann hills (home of Davis and Zhongshan stations, respectively) are free of sea ice and fast ice.

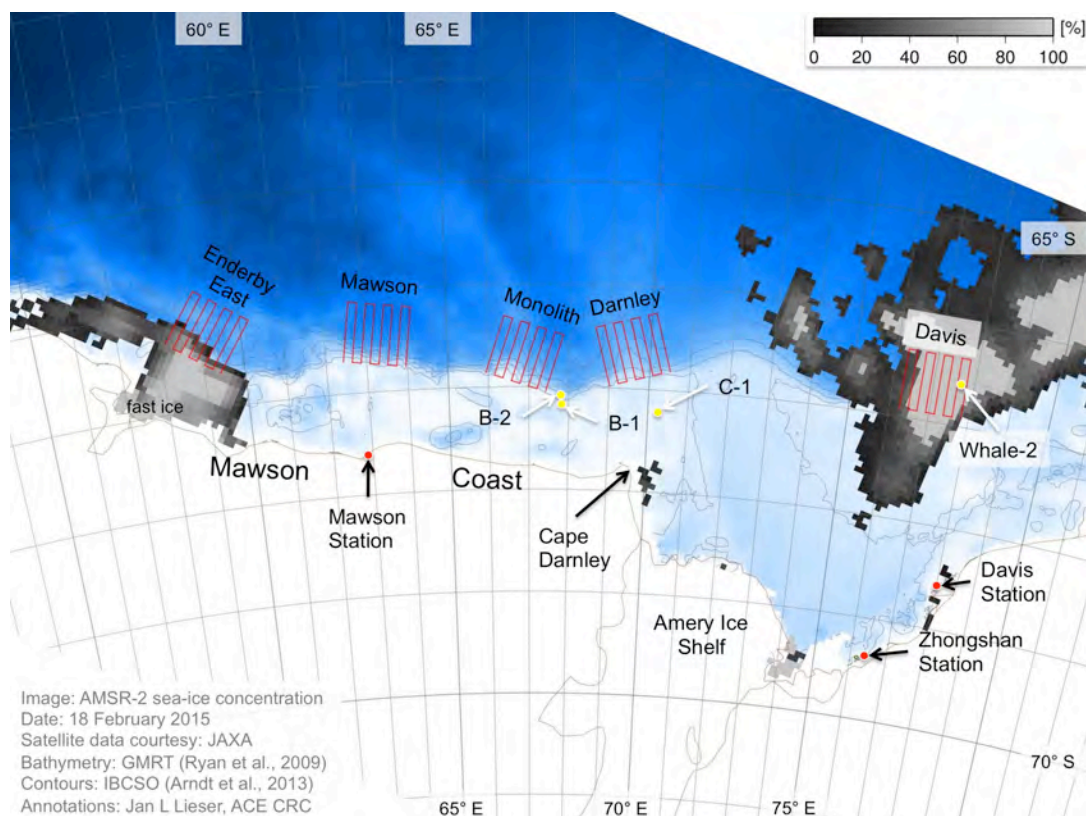
North of Davis Station, the proposed 'Davis' survey area and mooring 'Whale-2' are covered by a very high (up to and including 100%) concentration of sea ice.

Figure 2: AMSR-2 image, acquired 18/02/2015 and provided by Drift & Noise Polar Services.

The seaward side of the Vestfold and Larsemann hills (home of Davis and Zhongshan stations, respectively) are free of sea ice and fast ice.
