Sea ice reports for the Antarctic shipping season 2014 - 2015

Prepared by: Dr Jan L Lieser (Jan.Lieser@acecrc.org.au), Dr Robert A Massom (Rob.Massom@acecrc.org.au) & Dr Petra Heil (Petra.Heil@acecrc.org.au)
Antarctic Climate & Ecosystems Cooperative Research Centre, May 2015

The sea ice reports compiled in this document are weekly reports on sea-ice conditions for East Antarctica, including sub-weekly updates. They were prepared to support ship operations in East Antarctica during the 2014/2015 shipping season. These reports were primarily used to guide the Australian Antarctic program, but were partly provided to other Antarctic operators. In particular, we assisted Chinese National Antarctic Research Expeditions (RSV *Xue Long*), the Royal New Zealand Navy, the New Zealand National Institute of Water and Atmospheric Research (RV *Tangaroa* Voyage 2), the Australian Marine National Facility (RV *Investigator*) and the US Antarctic Program (RVIB *Nathaniel B. Palmer* Voyage 15-03). During the season, these reports informed eight voyages, all of which returned within schedule or early due to navigational choices made by the ships' captains based on sea-ice reports.

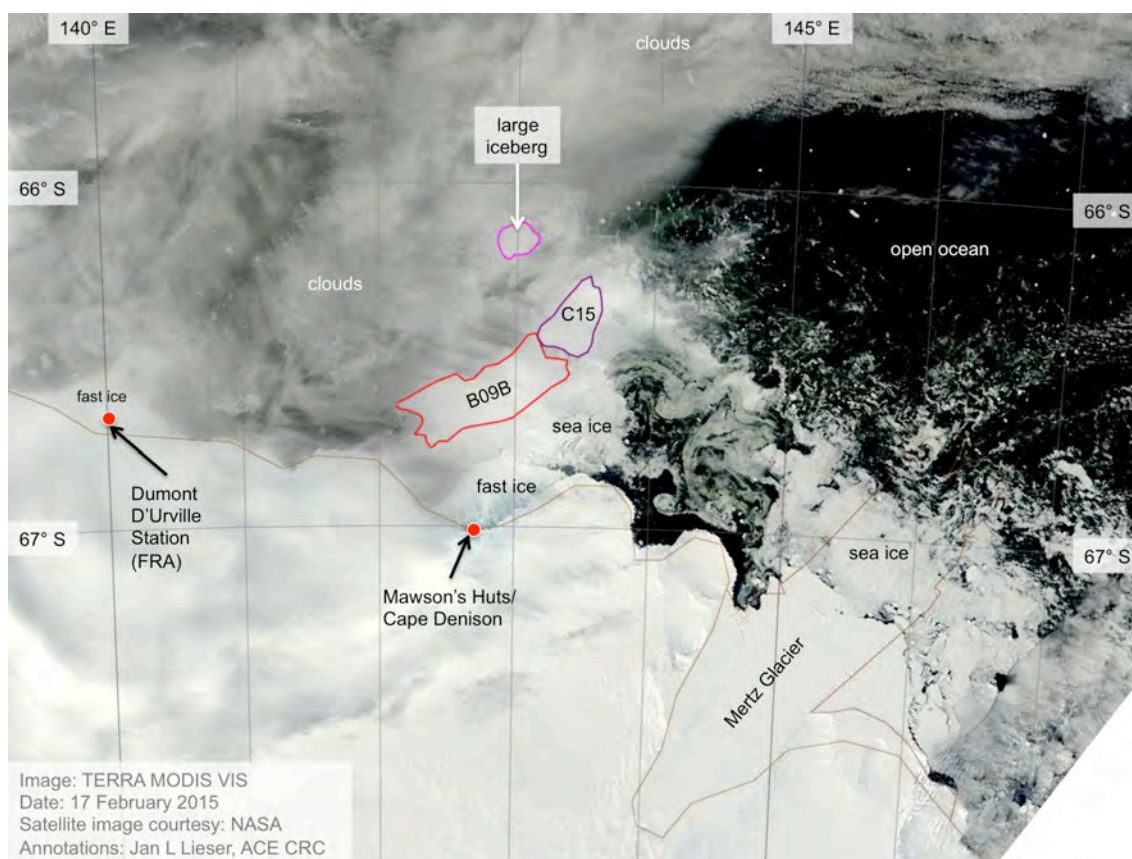
Further to Sea Ice Report #06.4/2015, we note that iceberg C15 (circa 350 km²) has impacted on the eastern edge of iceberg B09B (circa 900 km²), most likely on 16/02/2015 under a blanket of clouds. Figure 1 shows both bergs now roughly aligned along one axis and touching at the northern corner of B09B/western edge of C15. It is estimated that C15 has knocked off approximately 5 km² from the eastern corner of B09B and has rotated about 90 degrees anticlockwise.

Figure 1: MODIS image, acquired 17/02/2015 and provided by NASA.

If iceberg C15 is not resting on the seabed or against iceberg B09B now, it is likely to impact the large iceberg (circa 114 km²; annotated in the figure) as well.

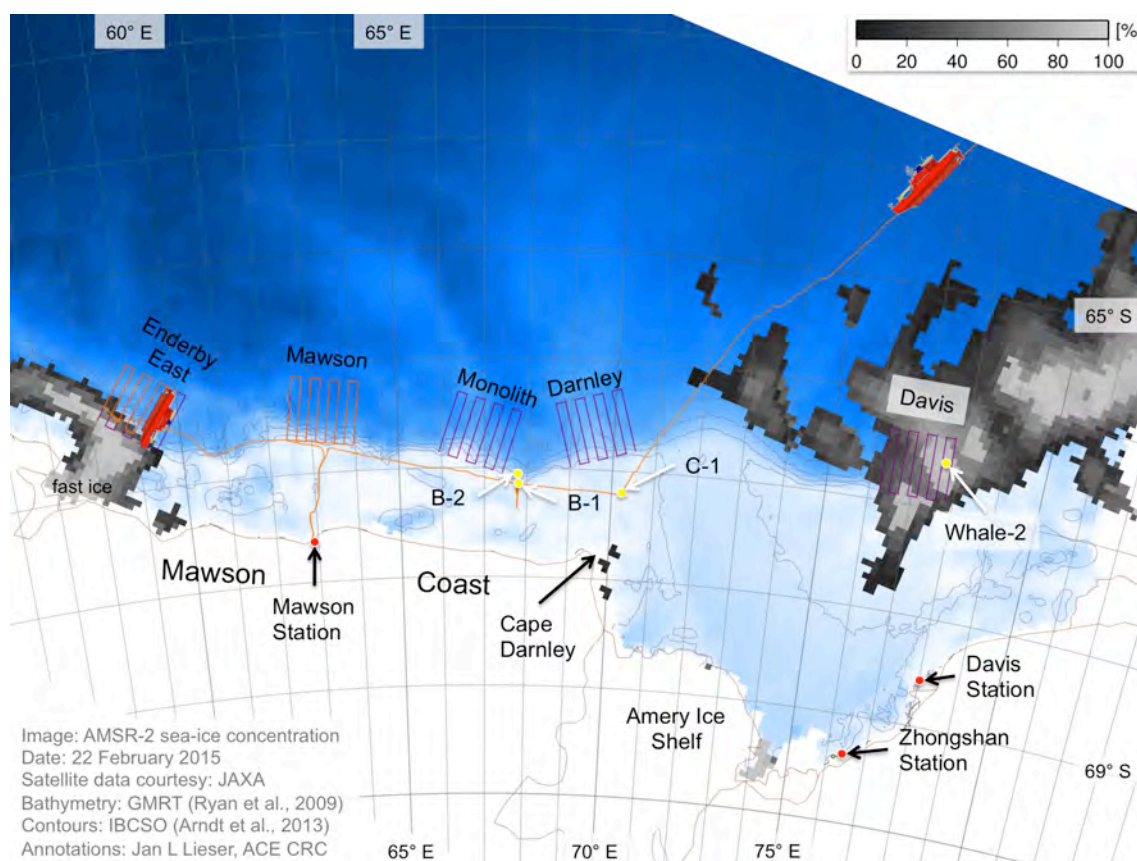
Figure 1 shows the region off Mawson Coast and the Amery Ice Shelf, as seen by the AMSR-2 instrument. Additionally, the figure also shows a colour-shaded bathymetry with depth contours marked at 500 m intervals. Purple survey lines indicate proposed marine science during Voyage 3 of RSV *Aurora Australis* and are named according to geographical region onshore. The orange track indicates the recent cruise track of RSV *Aurora Australis* in the region (up until 23/02/2015 01:00 UT). Also, locations of moorings of interest during that voyage are marked with yellow dots.

Figure 1: AMSR-2 image, acquired 18/02/2015 and provided by Drift & Noise Polar Services.

The 'Enderby East' survey is almost complete. A potential extension

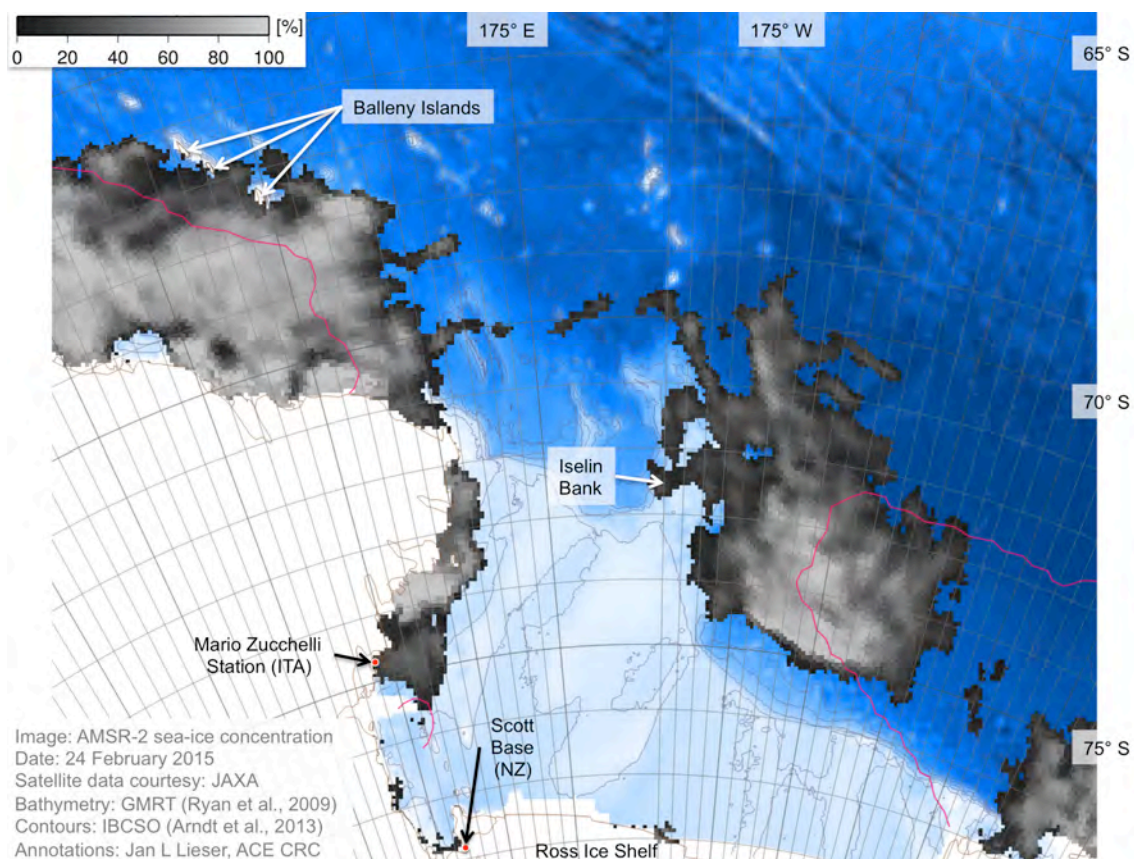
Between 170° E and 179° W, a thin band of scattered, low sea-ice concentration remains, along 70° S (Figure 1). The region of Iselin Bank is still covered by some sea ice, but the western edge of this patch of sea ice is retreating eastward.

Figure 1: AMSR-2 image, acquired 24/02/2015 and provided by Drift & Noise Polar Services.

During the past five days, more sea ice appears to be surrounding the Balleny Islands, arriving there with an eastward drift.

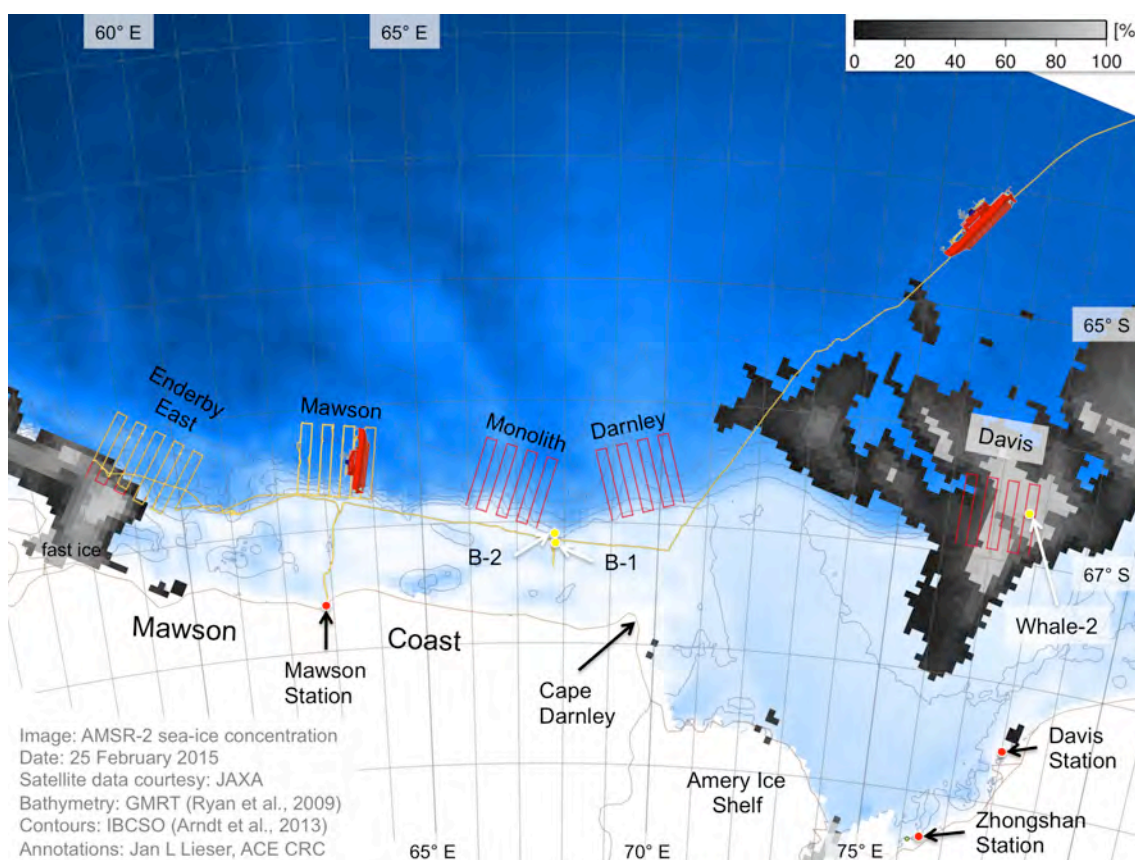
Figure 1 shows a sea-ice concentration map off Mawson Coast and Prydz Bay, with respect to proposed survey grids of RSV *Aurora Australis* given in red. The orange line denoted the cruise track of the vessel, up until 26/02/2015 00:00 UT. The 'Enderby East' survey has been completed and a repeat of the 'Mawson' survey is underway.

Figure 1: AMSR-2 image, acquired 25/02/2015 and provided by Drift & Noise Polar Services.

The 'Monolith' and 'Darnley' survey areas remain largely free of sea ice, as well as the locations of moorings 'B-1' and 'B-2'. The 'Davis' survey area is still largely covered by sea ice, but only the eastern part of the proposed grid is under very high concentration sea ice. The location of 'Whale-2' mooring is also covered by up to 100% of sea ice.

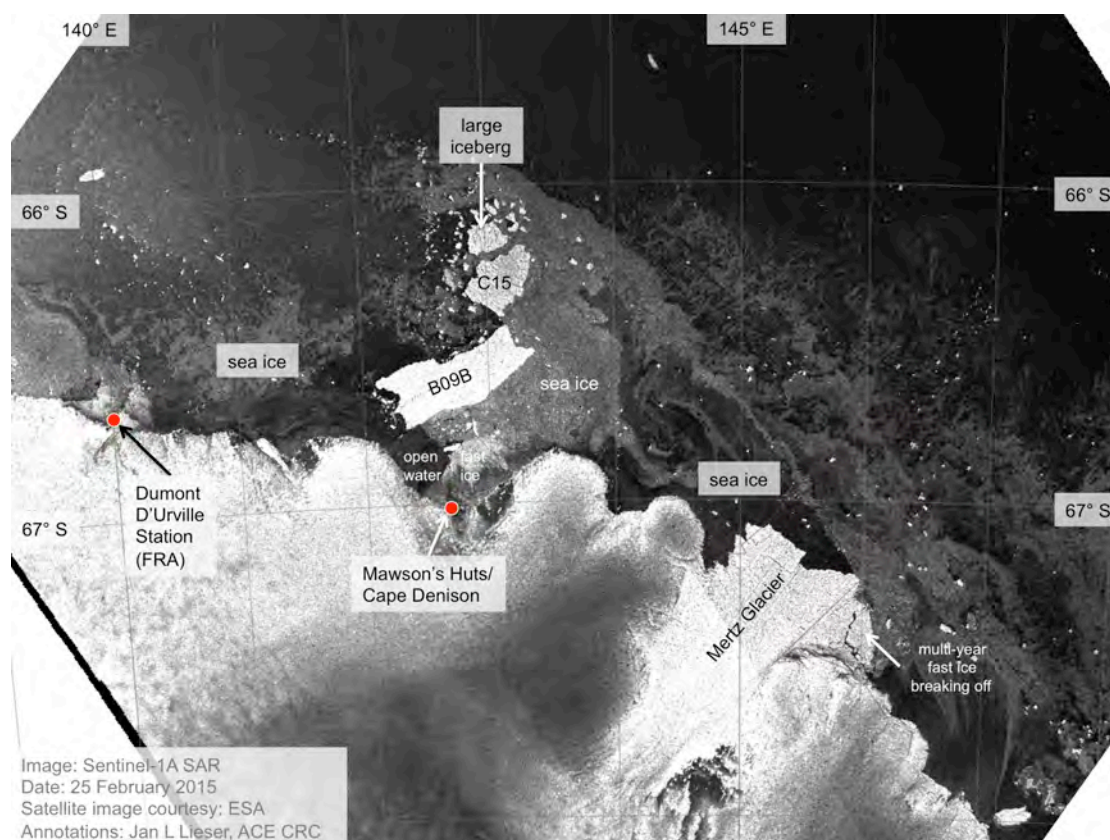
Off Commonwealth Bay, iceberg C15 has spun around about 50 degrees clockwise after it had made contact with iceberg B09B (see Sea Ice Report #08.4/2015), and hit the large (annotated) iceberg to the north, on 23/02/2015. Since then, it has rotated about 30 degrees anticlockwise again and now sits in the middle between B09B and the big berg to the north. The most recent TERRA MODIS acquisition (not shown) confirms C15 has rotated anticlockwise further and is now almost completely closing the gap, leaving less than 3 km wide openings between these three large bergs.

Figure 2: Sentinel-1a image, acquired 25/02/2015 and provided by PolarView.

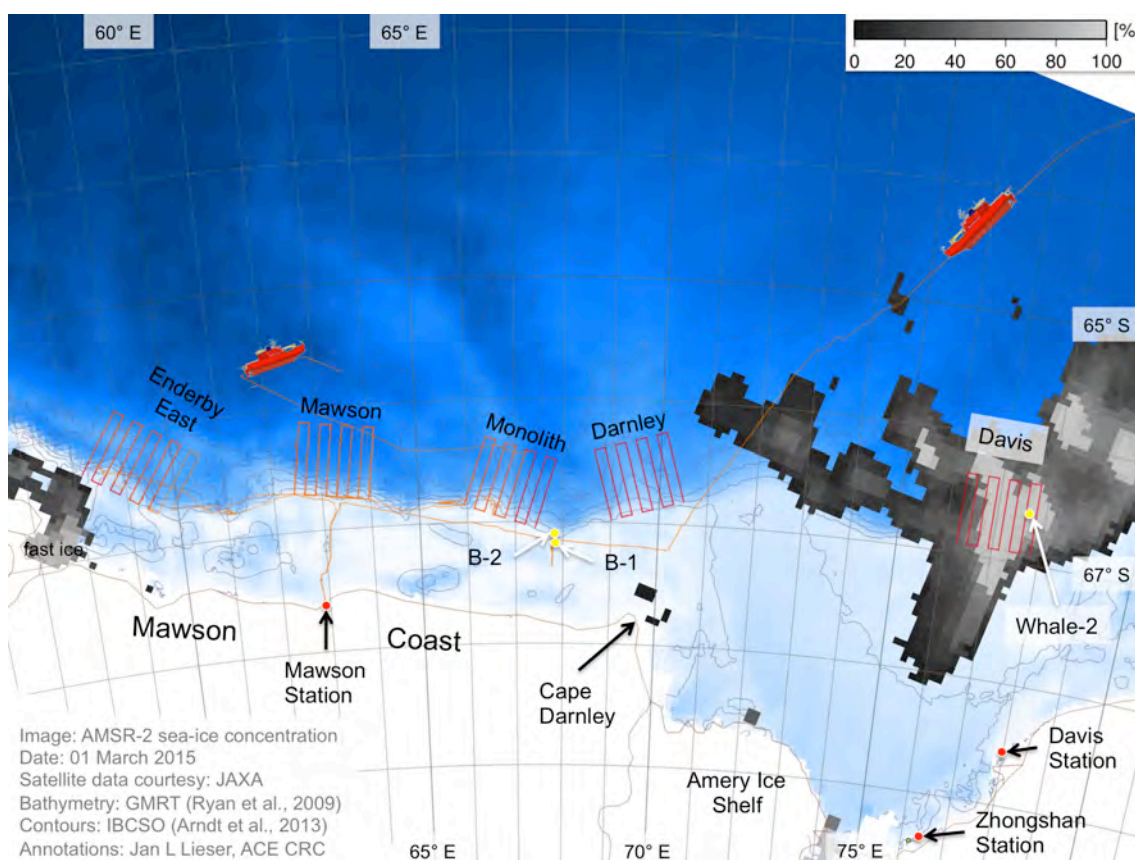
Figure 1 shows a sea-ice concentration map off Mawson Coast and Prydz Bay, with respect to proposed survey grids of RSV *Aurora Australis* given in red. The orange line denotes the cruise track of the vessel, up until 02/03/2015 01:00 UT.

Figure 1: AMSR-2 image, acquired 01/03/2015 and provided by Drift & Noise Polar Services.

The remaining part of the 'Monolith' survey and the 'Darnley' survey area remain largely free of sea ice, as well as the locations of moorings 'B-1' and 'B-2'. The 'Davis' survey area is increasingly covered by very high sea-ice concentration.

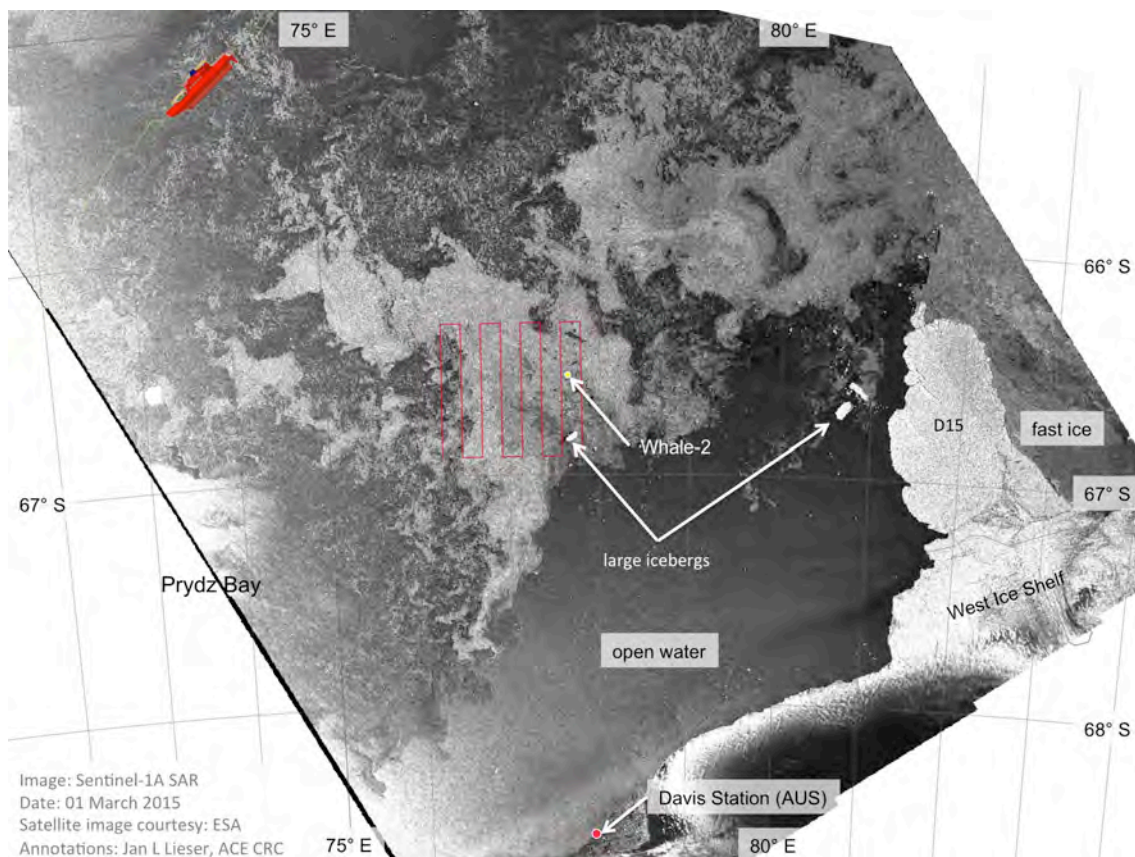
Figure 2 shows a high resolution (50 m by 100 m) SAR image of the sea ice, north of Davis Station. The proposed 'Davis' survey (see Figure 1) is given in red. The location of the 'Whale-2' mooring is indicated by a yellow dot.

Figure 2: Sentinel-1a SAR image, acquired 01/03/2015 and provided by PolarView.

As already stated in the previous section, the survey area and the 'Whale-2' mooring are covered by very high concentration of sea ice. This pack consists mostly of small to medium sized floes with a few icebergs in the mix. Two particularly large icebergs are pointed out by arrows.

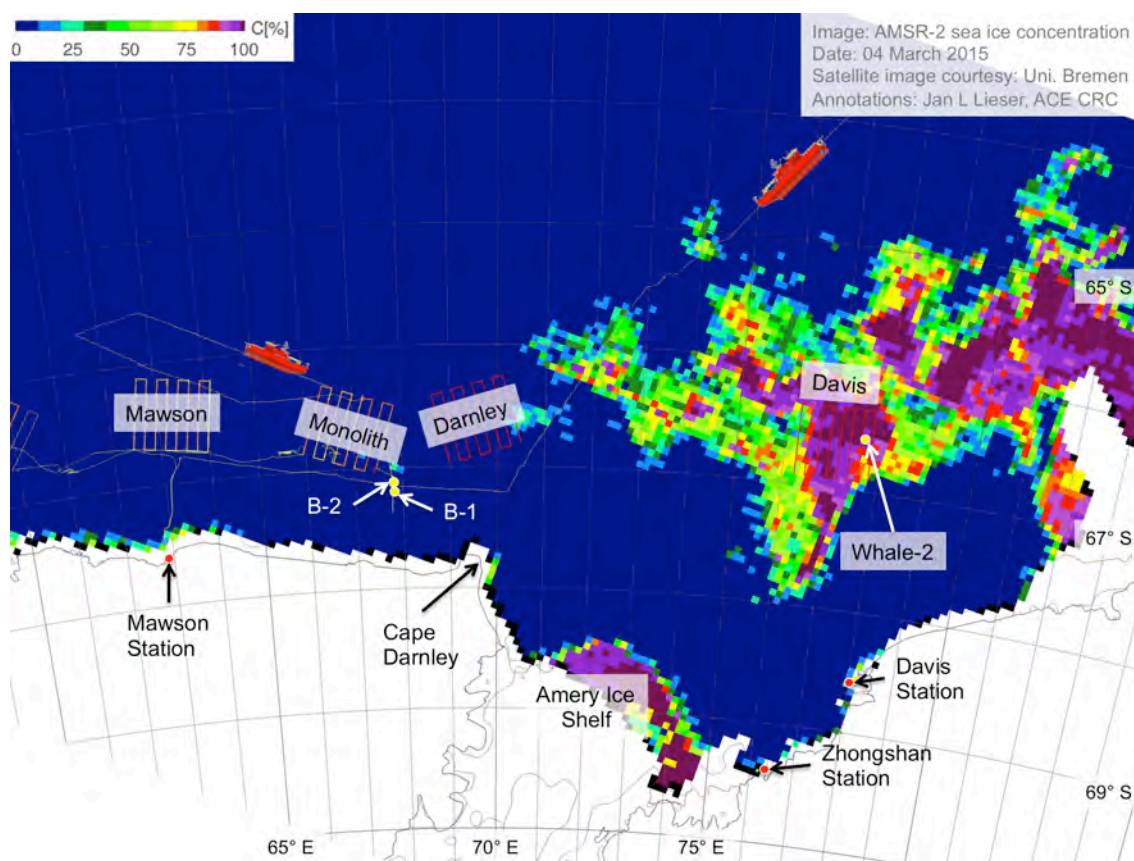
Figure 1 shows a sea-ice concentration map with respect to proposed (red) and completed (orange) marine science survey lines of RSV *Aurora Australis*' Voyage 3 (cruise track given in yellow). Three mooring locations are indicated by yellow dots.

The algorithms calculating sea-ice concentration in near-real time from AMSR-2 data are currently affected by less-than-optimal atmospheric corrections. This results in an overestimation of sea-ice cover, particularly west of 75° E. The lack of cloud-free visible images or RADAR data precludes confirmation of concentration estimates.

Figure 1: AMSR-2 image, acquired 04/03/2015 and provided by PolarView.

Now that the beginning of autumn has set in, the 'Davis' survey area is covered by increasing sea ice. The 'Whale-2' mooring remains under a very high (up to and including 100%) concentration of sea ice.

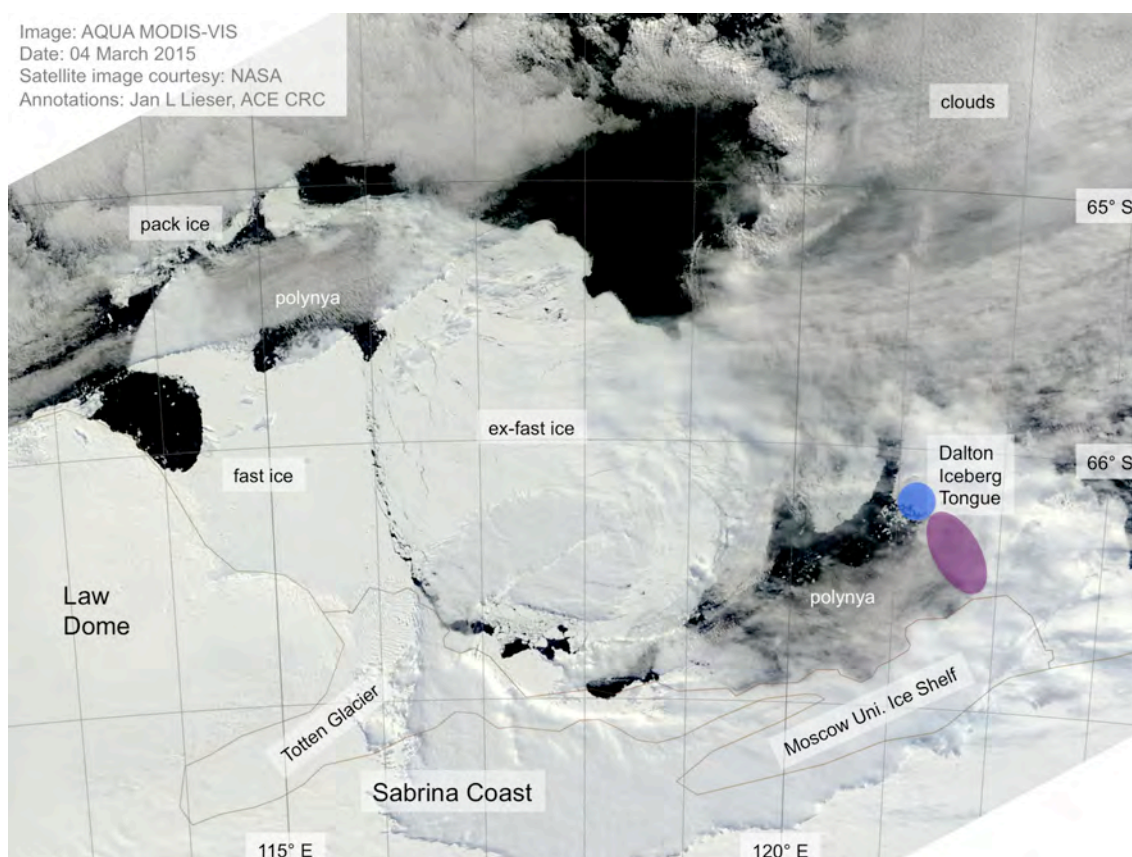
The region between Law Dome and the Dalton Iceberg Tongue is shown in Figure 2. Off the Totten Glacier, the ex-fast ice is still mobile and a lead of variable width (both, in space and time) is separating the large ex-fast ice body from the continent/shelf front. North of the Moscow University Ice Shelf, a polynya is largely maintained, but a few larger sea-ice floes and smaller icebergs are drifting freely there.

Figure 2: MODIS image, acquired 04/03/2015 and provided by NASA.

Since early February 2015, we note two events regarding the fast ice of the Dalton Iceberg Tongue, which consists of a large number of icebergs enclosed by fast ice. Between 04/02/2015 and 08/02/2015, a suspected large swell event snapped the fast ice in-between the icebergs that make up the tongue. While the majority of fast ice remains trapped between the icebergs, approximately 800 km² of fast ice broke free from the southern side of the Dalton Iceberg Tongue (indicated by the purple shade in Figure 2), releasing ex-fast ice floes into the polynya. Between 02/03/2015 and 04/03/2015, an additional 230 km² (indicated by the blue shade in Figure 2) of fast ice broke free, to the north of the above mentioned breakout.

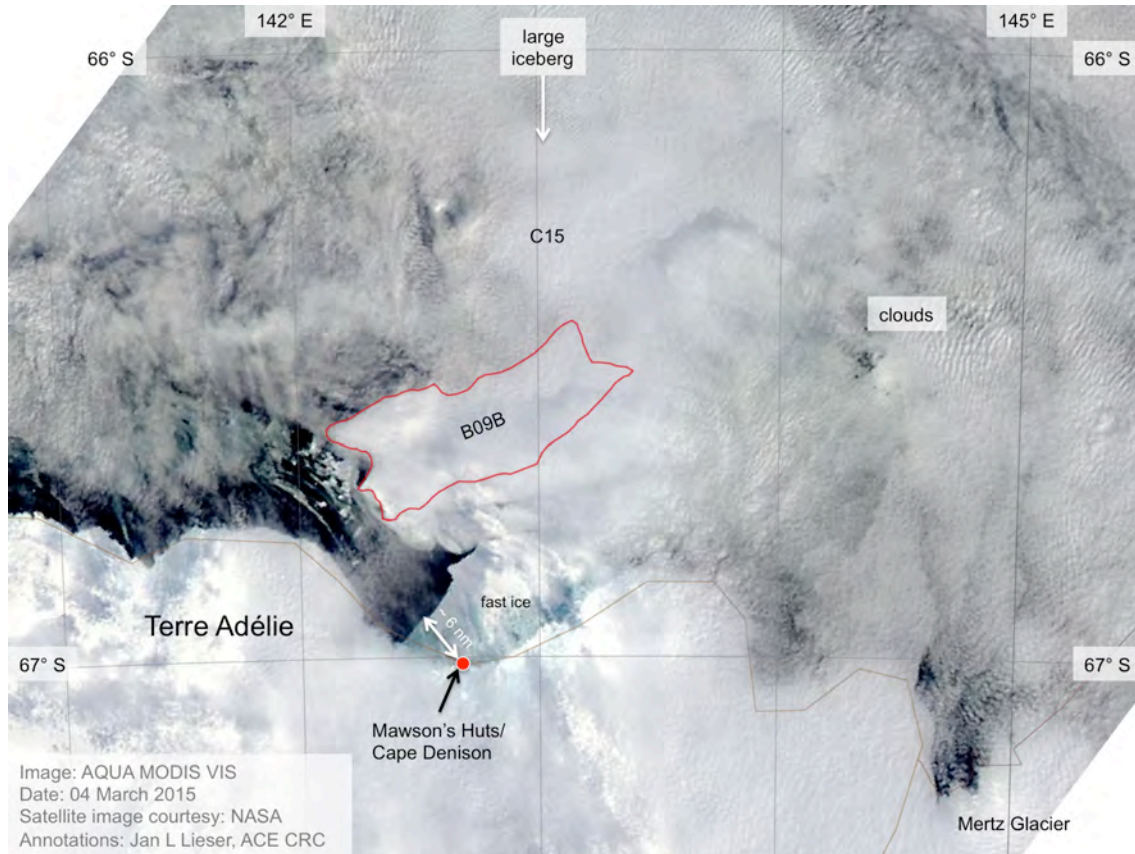
still unsettled between B09B in the south and an unnamed berg in the north, some fast ice is still breaking up inside the bay (Figure 3). One third of the bay is ice free and the shortest distance between the fast ice edge and Mawson's Huts is just under 6 nautical miles.

Figure 3: MODIS image, acquired 04/03/2015 and provided by NASA.

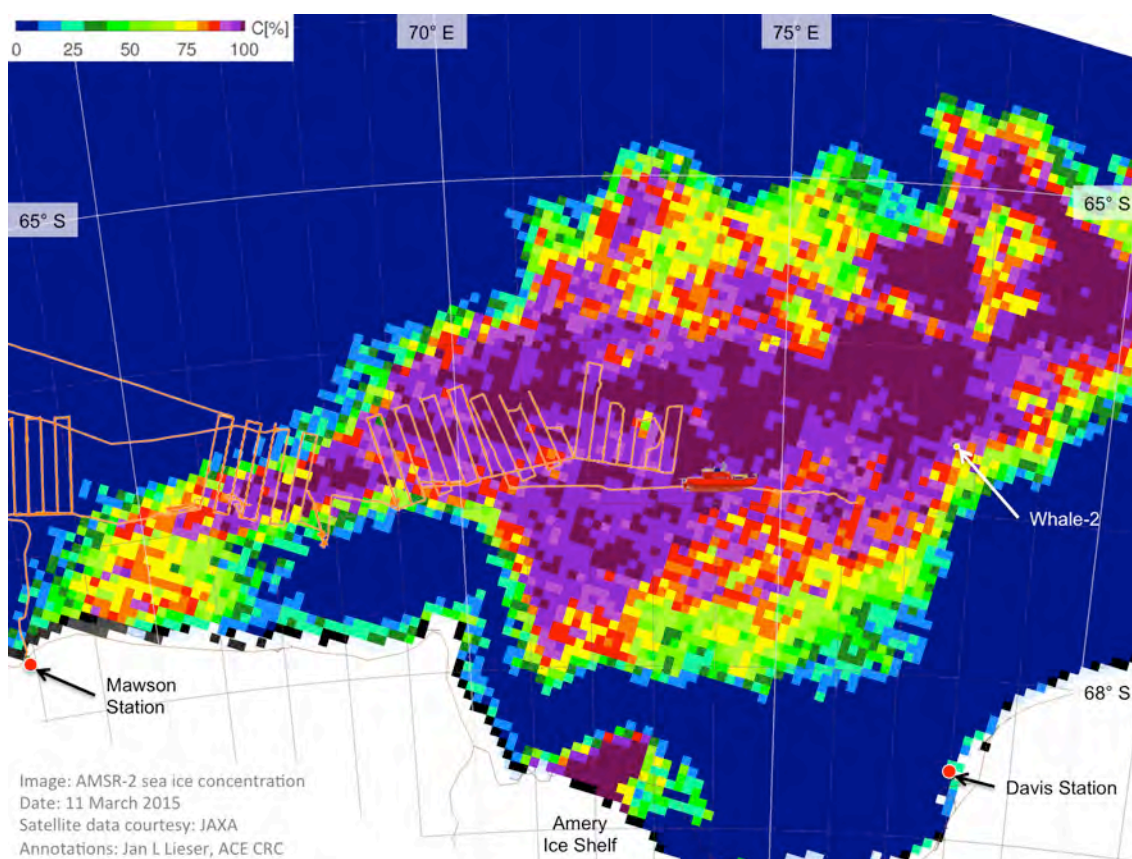
Figure 1 shows a sea-ice concentration map and the recent cruise track of RSV *Aurora Australis* in the region (up to 12/03/2015 00:00 UT). The lack of cloud-free visible images or RADAR data precludes confirmation of sea-ice concentration estimates, as the algorithm still might overestimate the sea-ice concentration. However, the general pattern of sea ice presence appears to be consistent between different algorithms.

Of note regarding Figure 1 is the outdated land-mask applied to the Amery Ice Shelf, which results in wrong sea-ice concentration estimates off the face of the shelf.

Figure 1: AMSR-2 image, acquired 11/03/2015 and provided by PolarView.

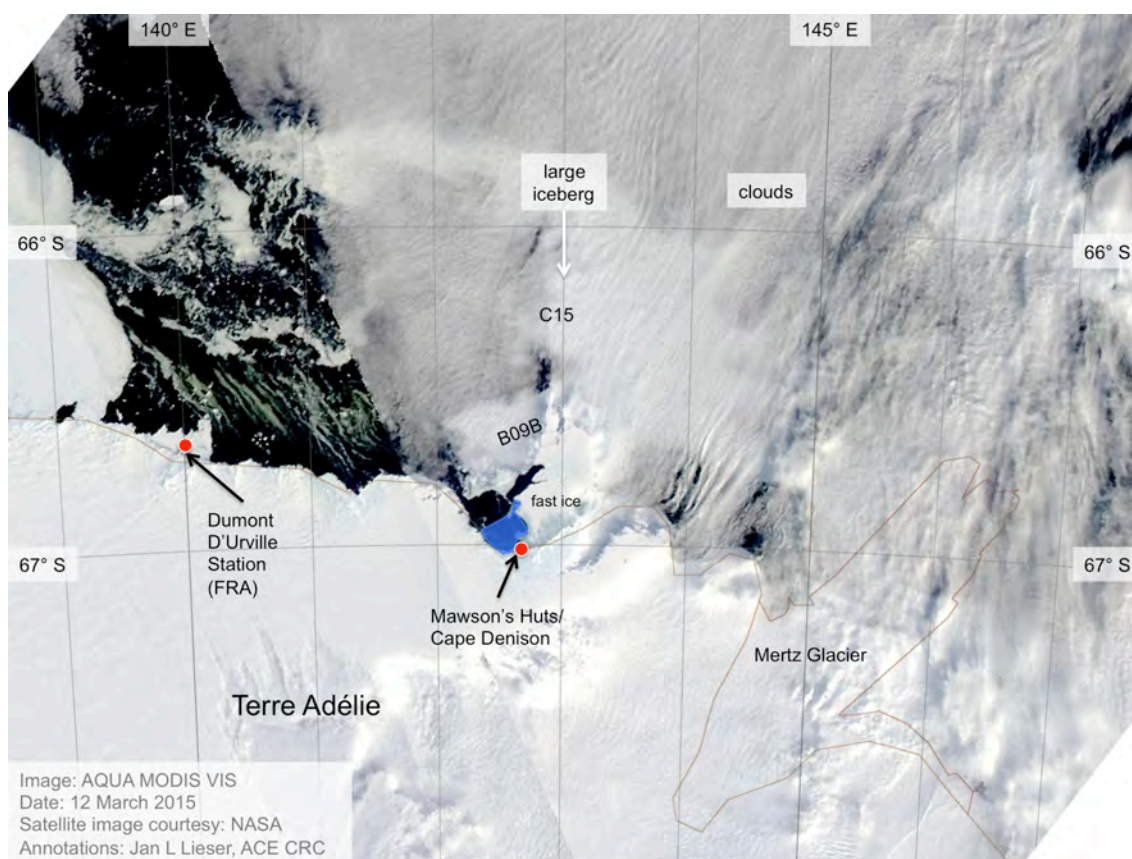
Further to our Sea Ice Report #10.3/2015, an additional 125 km² of fast ice have broken away from inside Commonwealth Bay, as indicated by the blue shaded shape in Figure 1. This leaves less than half of the bay covered by fast ice. It is expected that no fast ice is currently in front of Mawson's Huts.

Figure 1: MODIS image, acquired 12/03/2015 and provided by NASA.

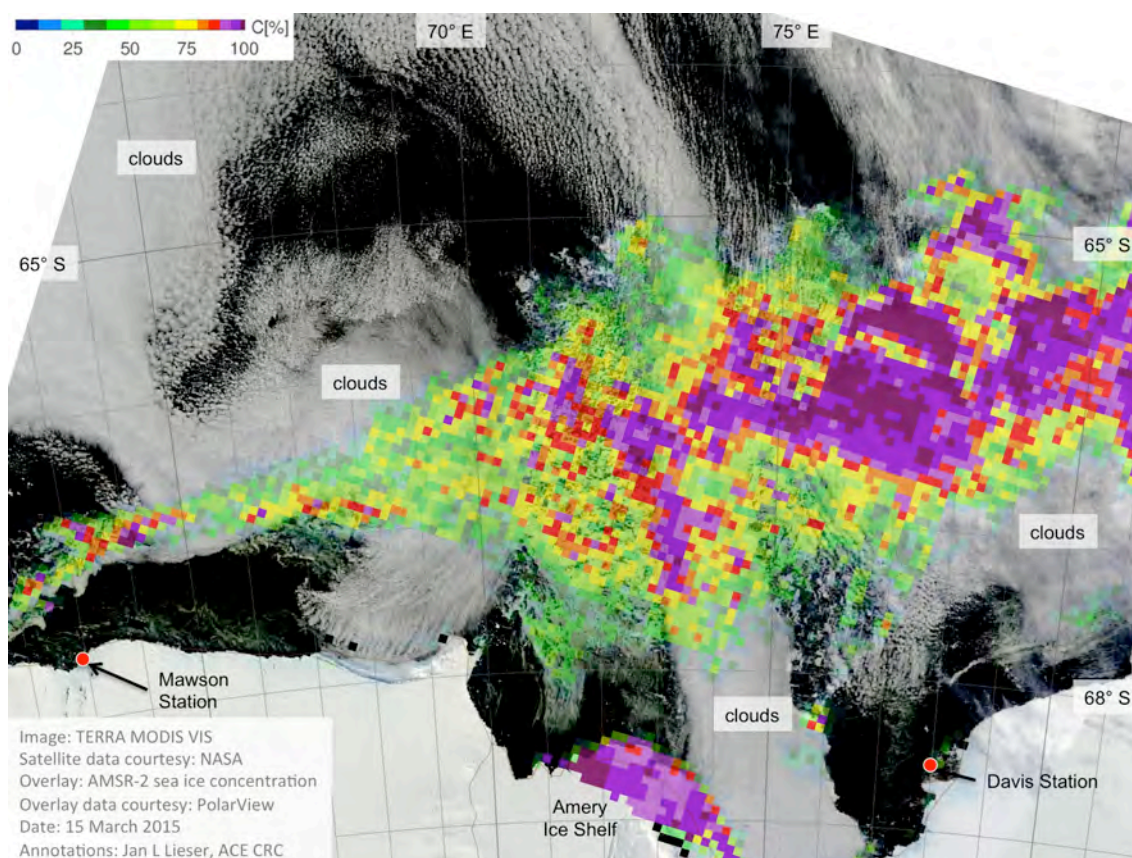
Figure 1: MODIS image, acquired 15/03/2015 and provided by NASA; overlay: AMSR-2 sea-ice concentration, acquired 15/03/2015 and provided by PolarView.

The sea-ice growth season has well and truly started in Antarctica. Figure 1 shows a combination of visible MODIS data with an overlay of sea-ice concentration derived from AMSR-2 data. Both data sets compare well, except for low concentration areas and the Amery Ice Shelf, which is incorrectly classified as very high concentration sea ice.

The central part of the pack ice in Prydz Bay, north of Davis Station, which is classified as very high concentration with purple colours, is most likely consisting for the most part of sea ice that has survived the recent summer melt.

As a side note, Figure 2 shows the same frame as Figure 1, except without the sea-ice concentration overlay, to illustrate the 'last hurrah' of biological primary productivity, for this season, that can be seen from space. The greenish tint discolouration in the sea-ice zone between 20 nautical miles and 60 nautical miles offshore, particularly west of 73° E (in western Prydz Bay and off Mawson Coast), is caused primarily by ice associated algae. Between 62° E and 67° E, another patch of darker green in-between new sea ice can be seen, hugging the coastline.

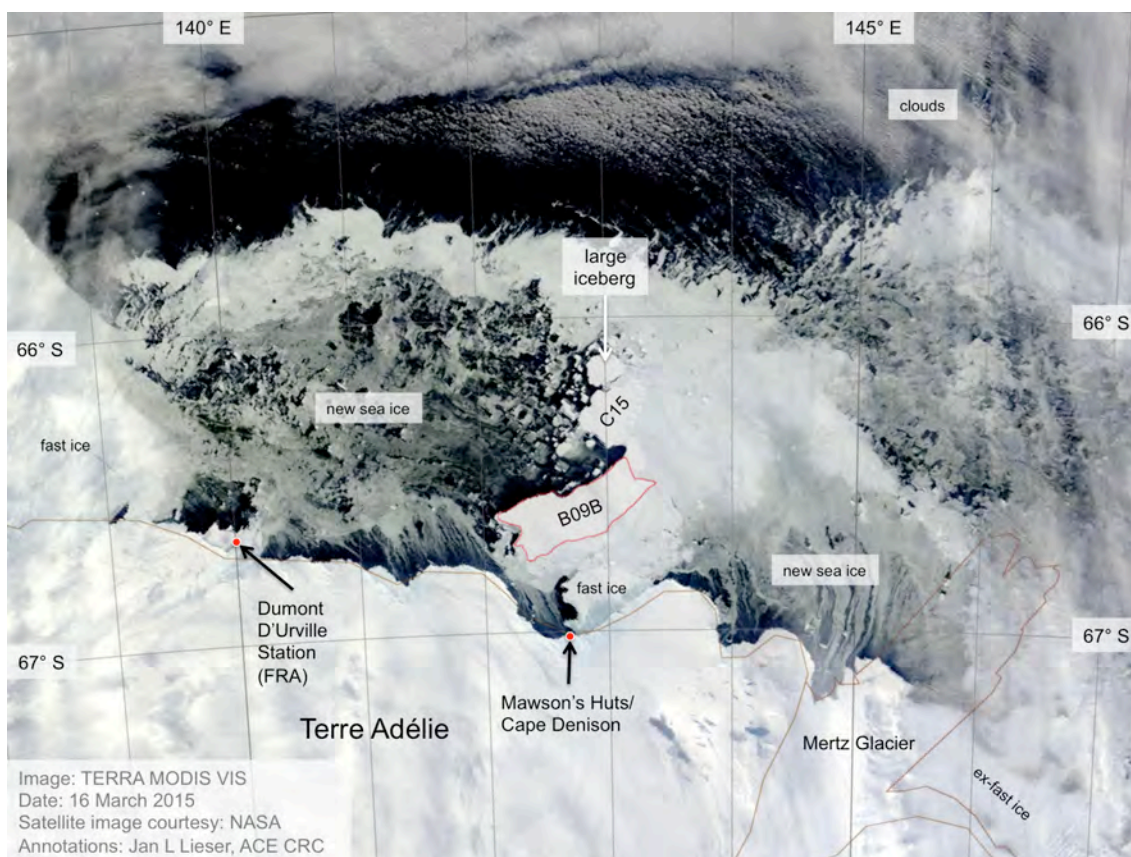
Figure 1: MODIS image, acquired 16/03/2015 and provided by NASA.

A cloud-free scene of the region between Dumont d'Urville Station and the Mertz Glacier is given in Figure 1. The troika of icebergs B09B, C15 and the large berg to the north of the two can clearly be seen. They are arranged as a north-south oriented barrier to the general westward sea-ice drift close to the coast.

The smallest gap between C15 and the large northern berg is only 0.7 nautical miles. South of C15, the gap towards B09B appears to be sealed by a large piece of ex-fast ice. The open water half of Commonwealth Bay is now backfilling with newly forming sea ice, as is to be expected at this time of year.

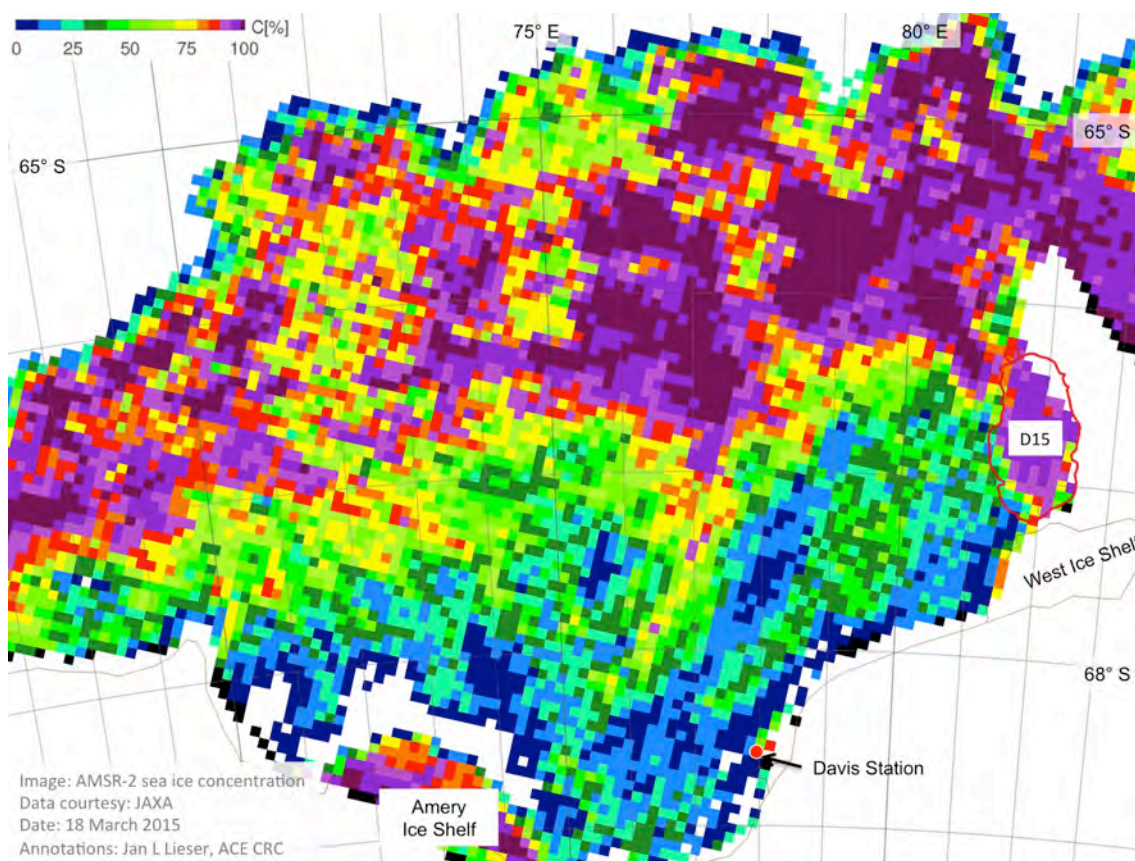
Figure 1: AMSR-2 image, acquired 18/03/2015 and provided by PolarView.

Sea-ice concentration is increasing in Prydz Bay. The entire bay is steadily filling with newly forming sea ice, but off the face of the Amery Ice Shelf, a polynya is currently still maintained. North of Davis Station is a wide band of dense sea ice between 65° S and 67° S. The highest concentration sea ice (represented in purple colours in Figure 1) is largely expected to consist of sea ice that has survived the summer melt season. Through this band are some areas of lower concentration, roughly north-south oriented, for example at 75° E and meandering around 78° E.

The passage of a large atmospheric low pressure system in the north is likely to spread the sea-ice cover further north, but can at the same time be assisting in easing pressure on the sea-ice cover temporarily.

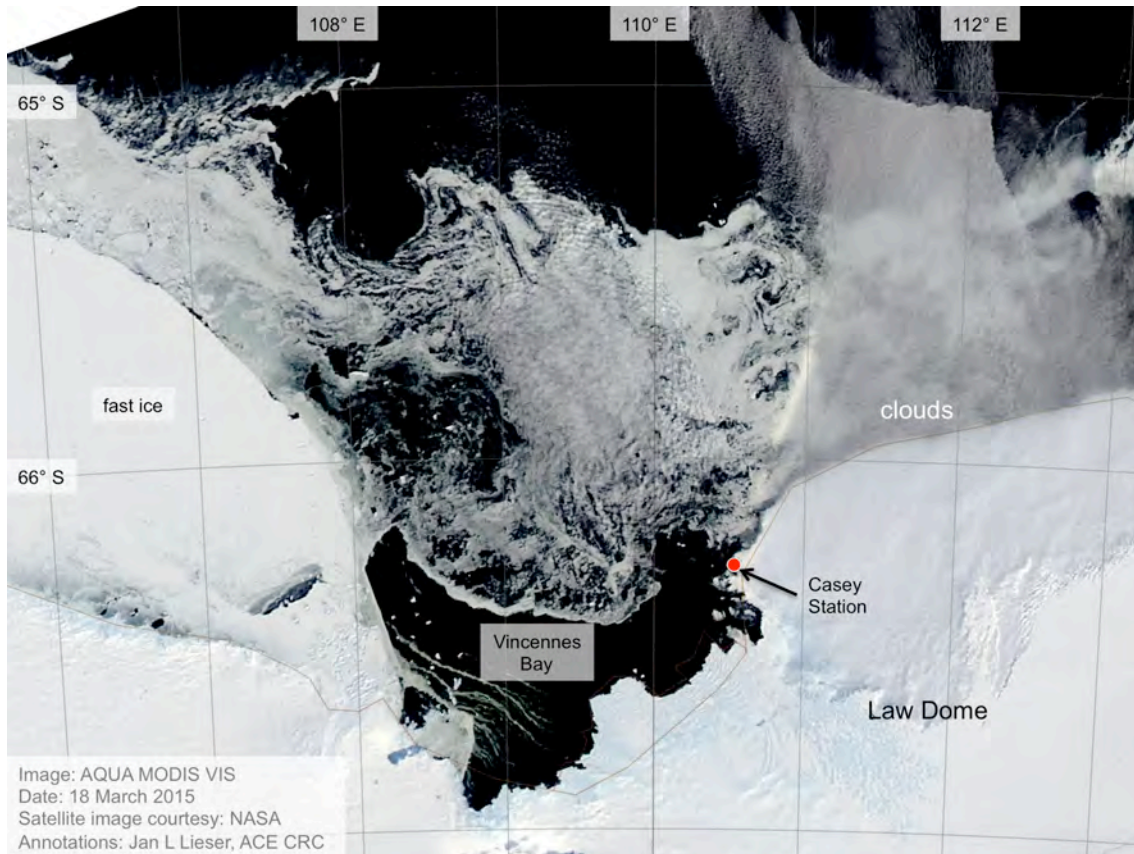
Figure 2: MODIS image, acquired 18/03/2015 and provided by NASA.

Off Casey Station, sea ice is also growing but most of Vincennes Bay is covered by only very light ice conditions at the moment. East of 110° E and north of 66° S, higher sea-ice concentration can be seen in Figure 2, which contains older sea ice that has been exported from ex-fast ice from the eastern side of Law Dome (outside the figure).

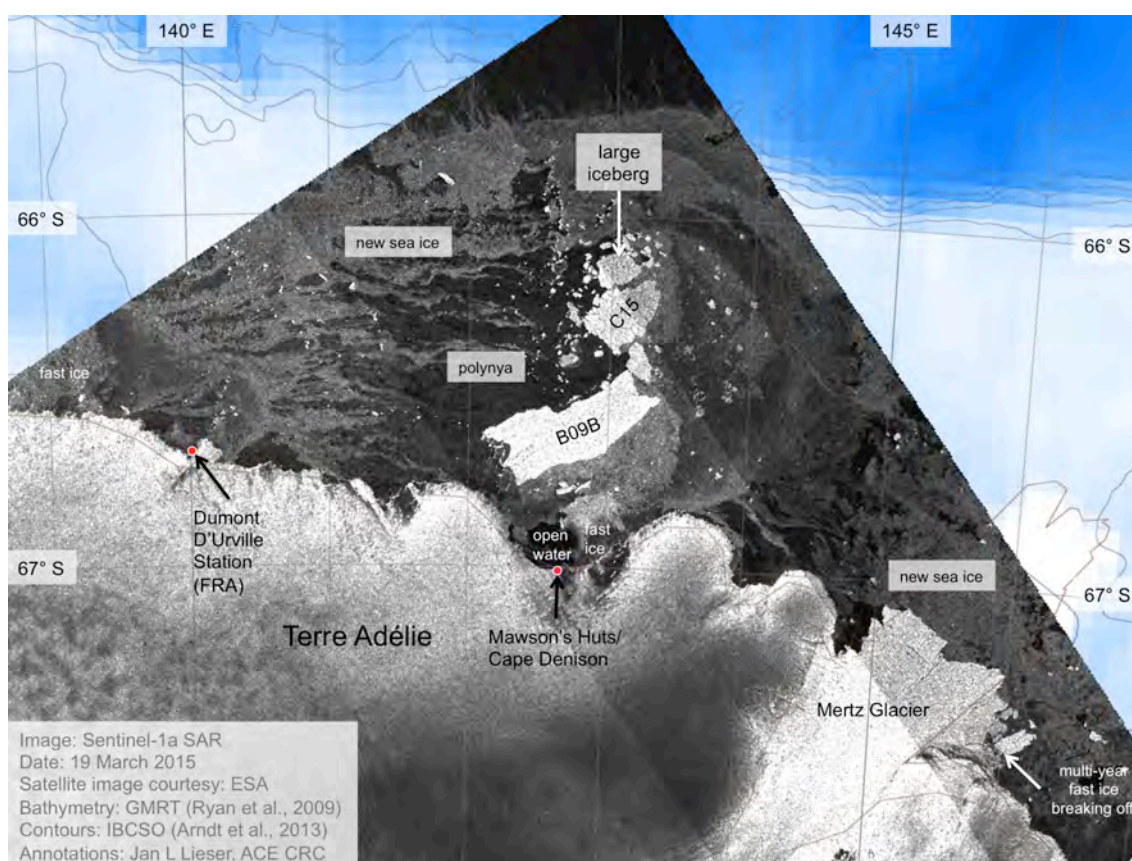
Figure 1: Sentinel-1a SAR scene, acquired 19/03/2015 and provided by PolarView.

Further to our Sea Ice Report #12.2/2015, Figure 1 shows a Synthetic Aperture RADAR (SAR) scene of Commonwealth Bay.

From this it becomes clear that the previously mentioned troika of icebergs is now in fact a quadriga, as a fourth piece of ice joined in between iceberg B09B and C15. This fourth piece displays the same surface signature as other icebergs around, but bits breaking off from the fast ice east of the remaining Mertz Glacier Tongue, which accumulated during many years, show similar surface signatures.

This iceberg quadriga mimics the effect that the Mertz Glacier Tongue

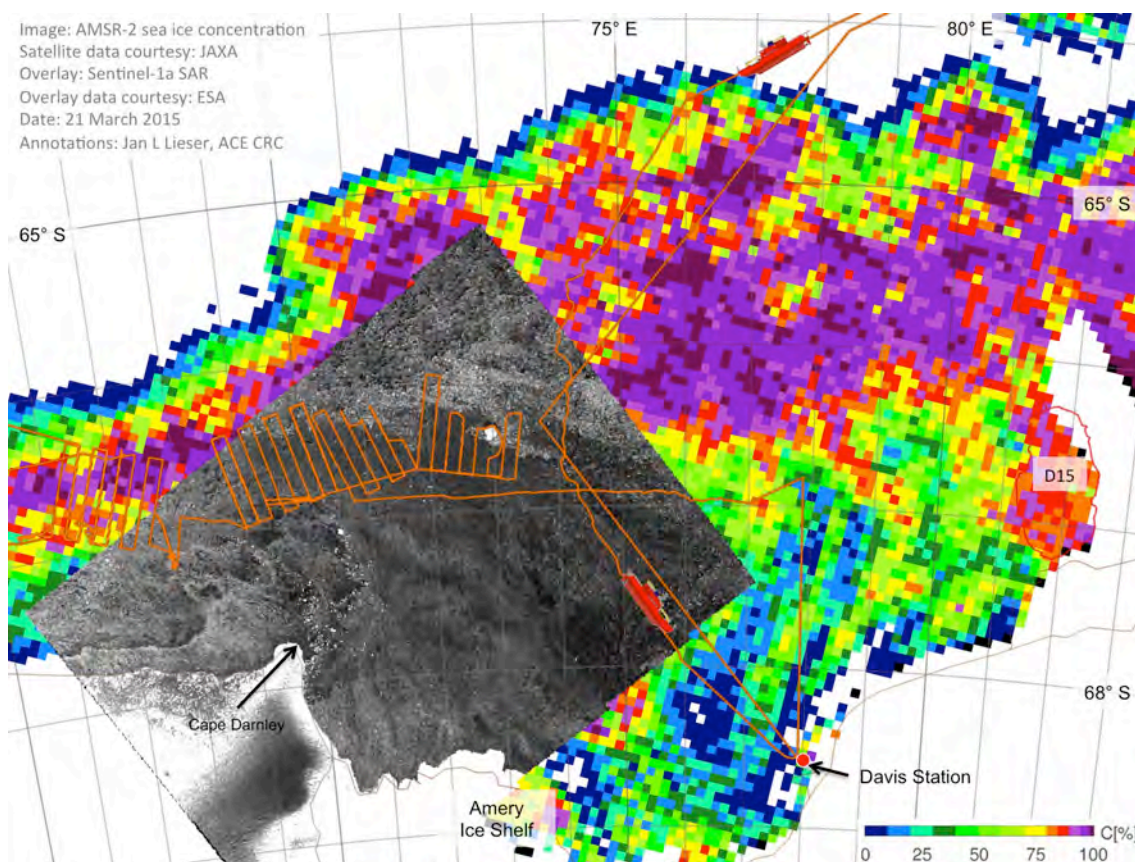
Figure 1: AMSR-2 sea-ice concentration; overlay: Sentinel-1a SAR scene, both data sets acquired 21/03/2015 and provided by PolarView.

Figure 1 provides a map of sea-ice concentration in Prydz Bay with an overlay of a SAR scene of the southwestern part of Prydz Bay. The orange line denotes the cruise track of RSV *Aurora Australis* (up until 22/03/2015 02:00 UT).

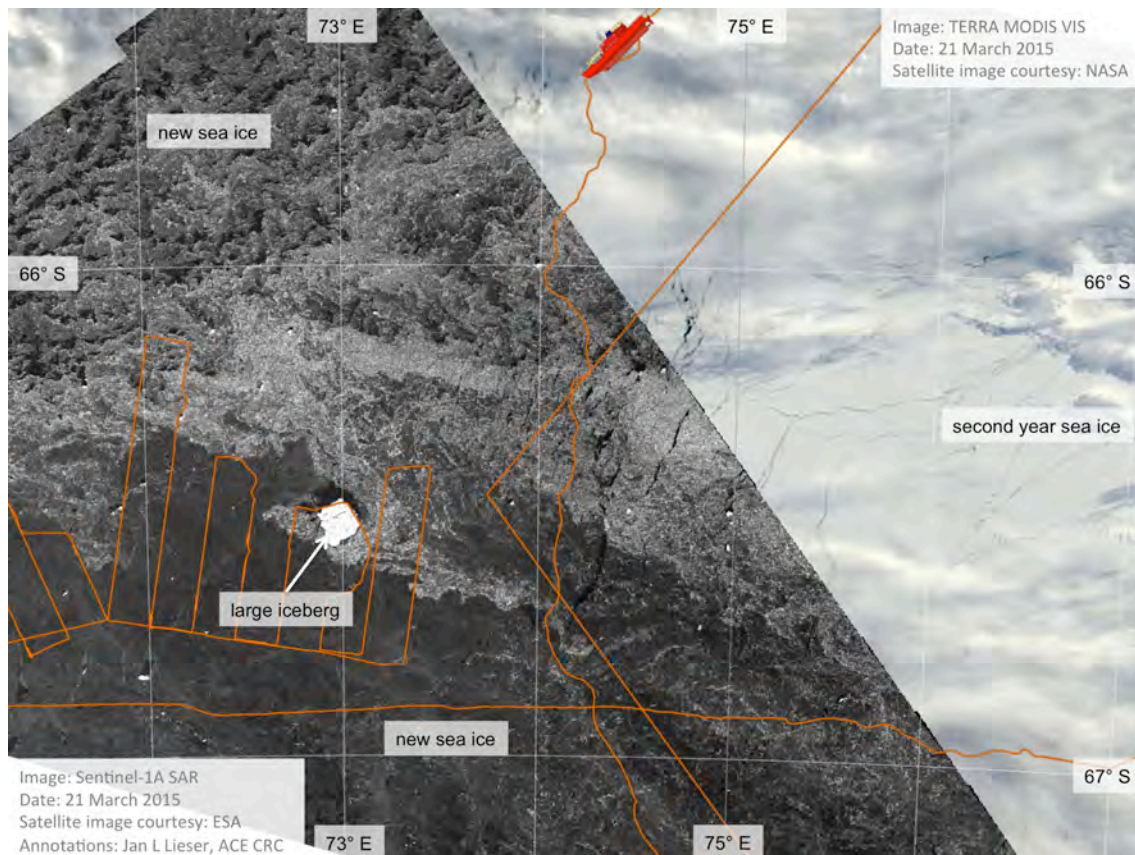
Figure 2: MODIS image (northeast part of the figure) acquired 21/03/2015 and provided by NASA; Sentinel-1a SAR scene (southwest part of the figure), acquired 21/03/2015 and provided by PolarView.

The marginal sea-ice zone is expanding northward and the central part of the sea-ice pack is showing signs of increasing concentration. The region of comparatively lower concentration appears to be still meandering between 74° E and 75° E (see Figure 2). East of 75° E where the clouds do not obscure the view on the sea ice in Figure 2, some large cracks/leads can be seen criss-crossing throughout the

second year sea ice. Between 74° E and 75° E, some major cracks appear to be more north-south oriented.
