Sea ice reports for the Antarctic shipping season 2014 - 2015

Prepared by: Dr Jan L Lieser (Jan.Lieser@acecrc.org.au), Dr Robert A Massom (Rob.Massom@acecrc.org.au) & Dr Petra Heil (Petra.Heil@acecrc.org.au)
Antarctic Climate & Ecosystems Cooperative Research Centre, May 2015

The sea ice reports compiled in this document are weekly reports on sea-ice conditions for East Antarctica, including sub-weekly updates. They were prepared to support ship operations in East Antarctica during the 2014/2015 shipping season. These reports were primarily used to guide the Australian Antarctic program, but were partly provided to other Antarctic operators. In particular, we assisted Chinese National Antarctic Research Expeditions (RSV *Xue Long*), the Royal New Zealand Navy, the New Zealand National Institute of Water and Atmospheric Research (RV *Tangaroa* Voyage 2), the Australian Marine National Facility (RV *Investigator*) and the US Antarctic Program (RVIB *Nathaniel B. Palmer* Voyage 15-03). During the season, these reports informed eight voyages, all of which returned within schedule or early due to navigational choices made by the ships' captains based on sea-ice reports.

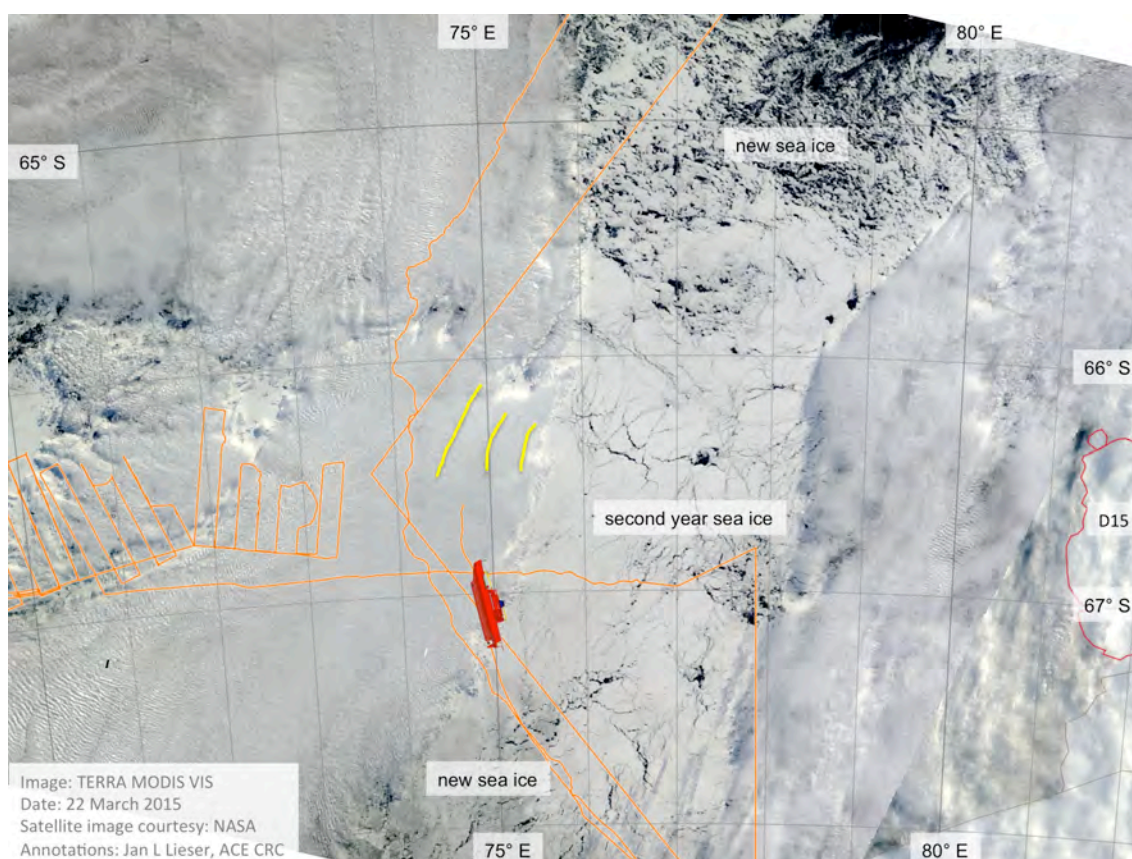
Figure 1: MODIS image acquired 22/03/2015 and provided by NASA.

Some cracks and leads are indicated by the yellow lines ahead of the ship's location. North of 66° S begins the transition from second year sea ice to newly formed sea ice. North of 65° 30' S, only a loose sea-ice cover is identified.

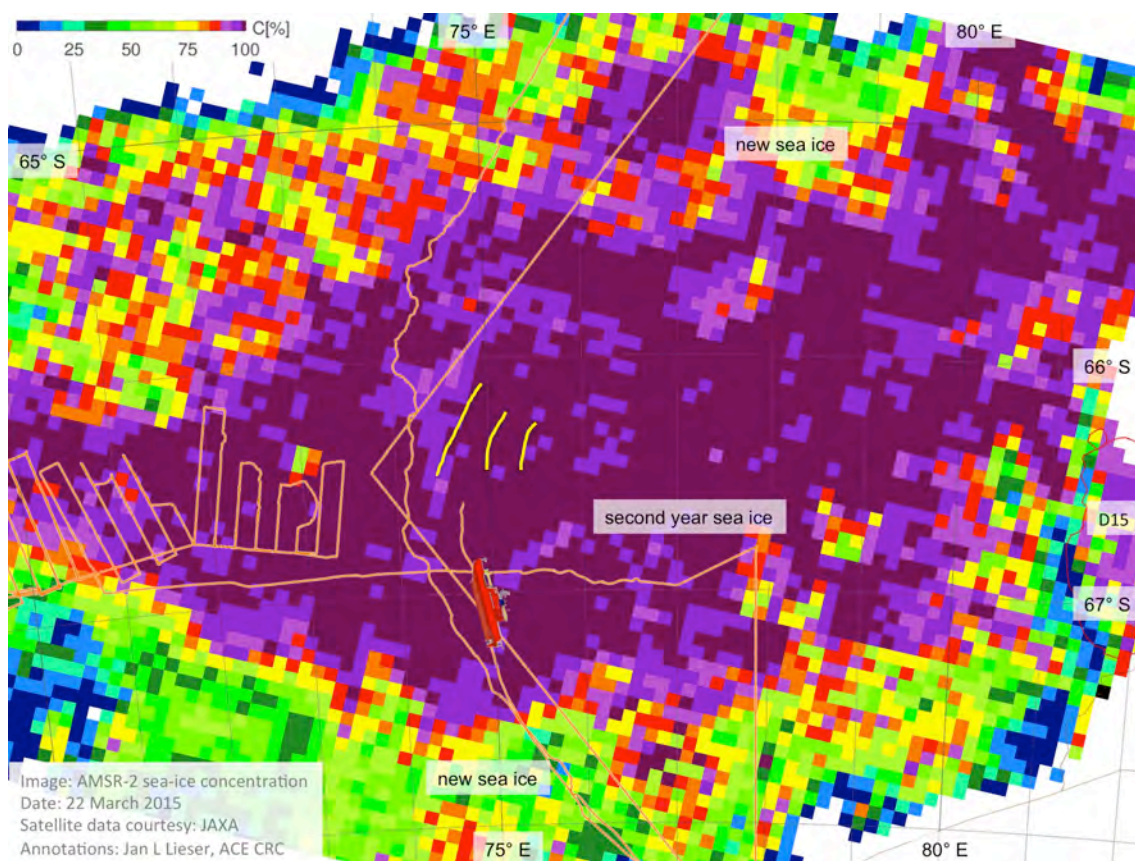
Figure 2: AMSR-2 image acquired 22/03/2015 and provided by PolarView.

The sea-ice concentration map of Figure 2 is provided for reference. From this map, it appears that the slightly more western (southbound) track still has probably a little less sea-ice concentration.

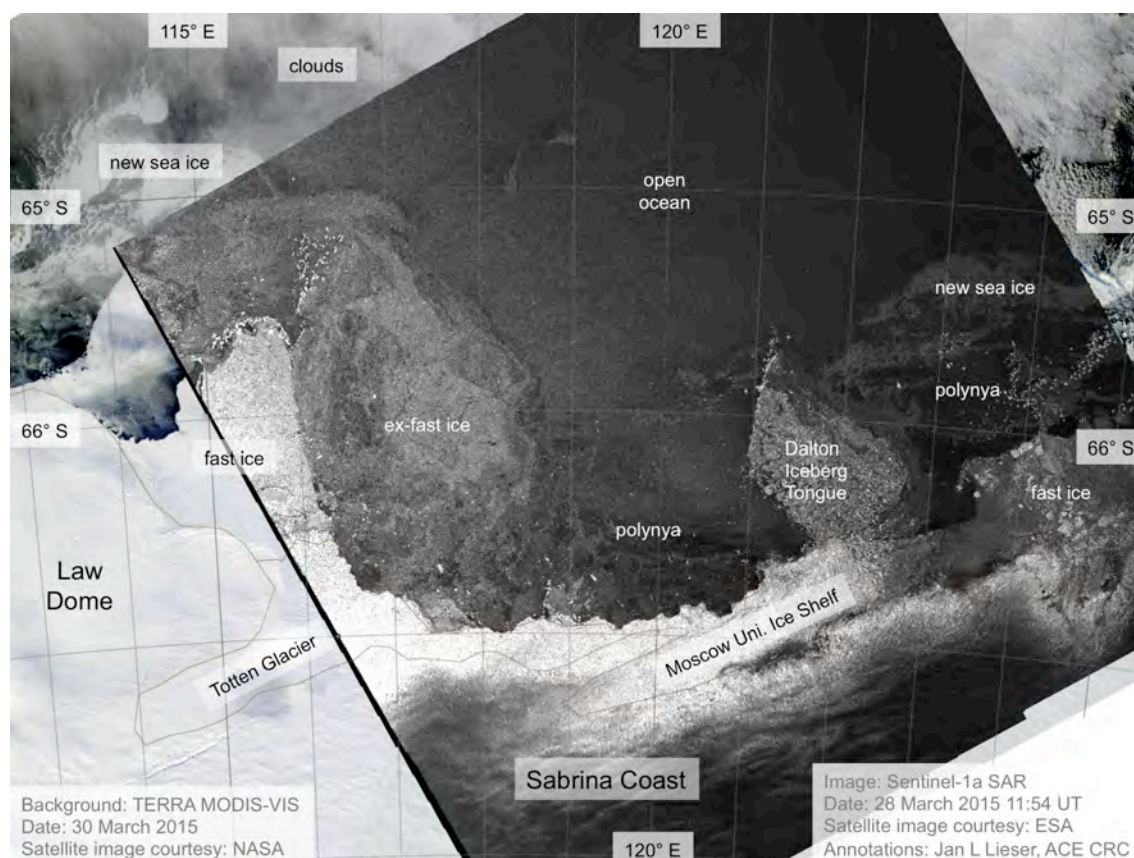
Figure 1: Sentinel-1a image acquired 28/03/2015 and provided by PolarView.

Figure 1 shows a Synthetic Aperture RADAR (SAR) image of the region between the Totten Glacier and the Moscow University Ice Shelf. West of the Dalton Iceberg Tongue, new sea ice is forming in the polynya, which spans between 118° 30' E and 121° E, at 66° S. The fast ice between the icebergs of the Dalton Iceberg Tongue was broken into pieces (presumably by a major swell event, see Sea Ice Report #10.3/2015), and some larger ex-fast ice floes are escaping the icebergs, and are drifting westwards across the polynya.

West of 119° E, newly formed sea ice accumulates against the ex-fast ice that had survived the summer season, off the face of the Totten

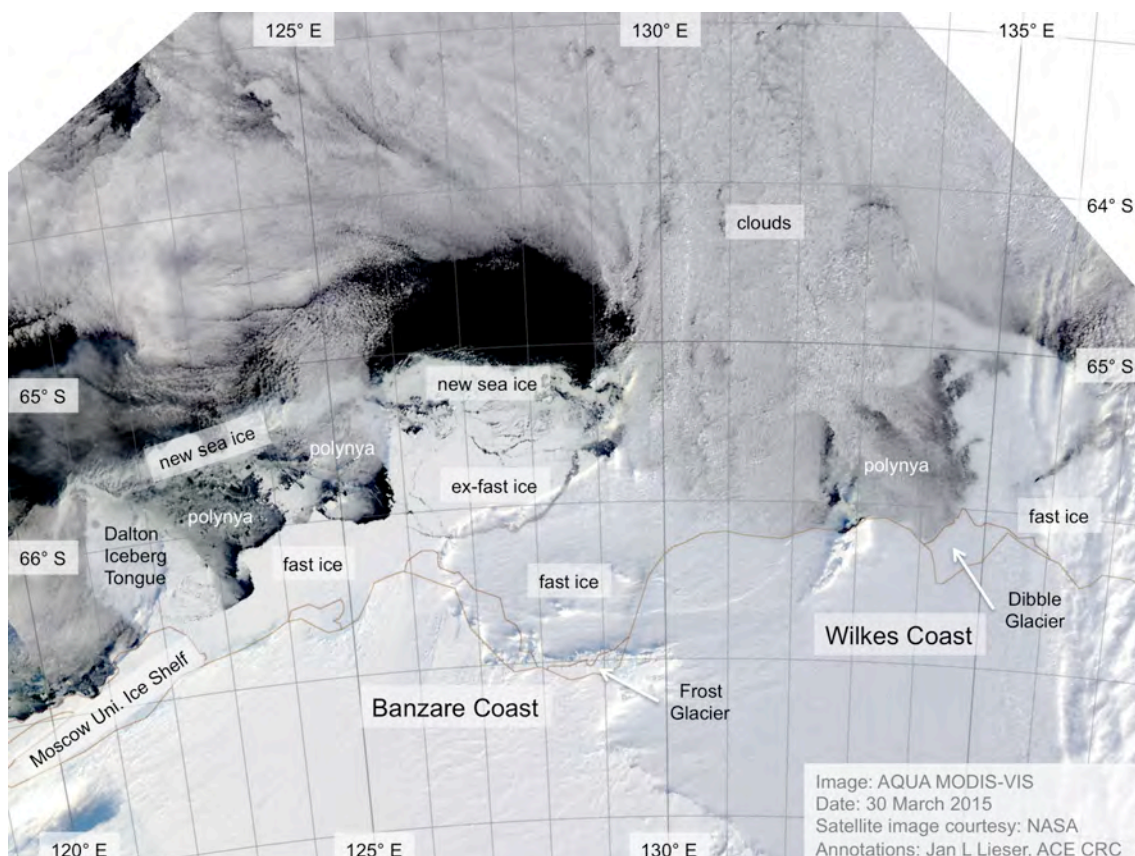
Figure 2: MODIS image acquired 30/03/2015 and provided by NASA.

Between 125° E and 135° E, the sea-ice edge follows roughly the 1000 m bathymetry contour. Off Banzare Coast, fast ice spans about 85 nautical miles in north-south direction, off Frost Glacier.

West of 130° E, the pack-ice zone is only about 25 nautical miles wide (north-south extent), but as the freezing season has started in Antarctica, this zone is steadily growing.

East of 131° E, sea-ice conditions are lighter, including close to the coast. Off the face of Dibble Glacier, a polynya is active, which is separated from the open ocean in the north by a tongue of a mixture of old and new sea ice that is drifting westwards around a barrier of icebergs, which are grounded along 135° E.

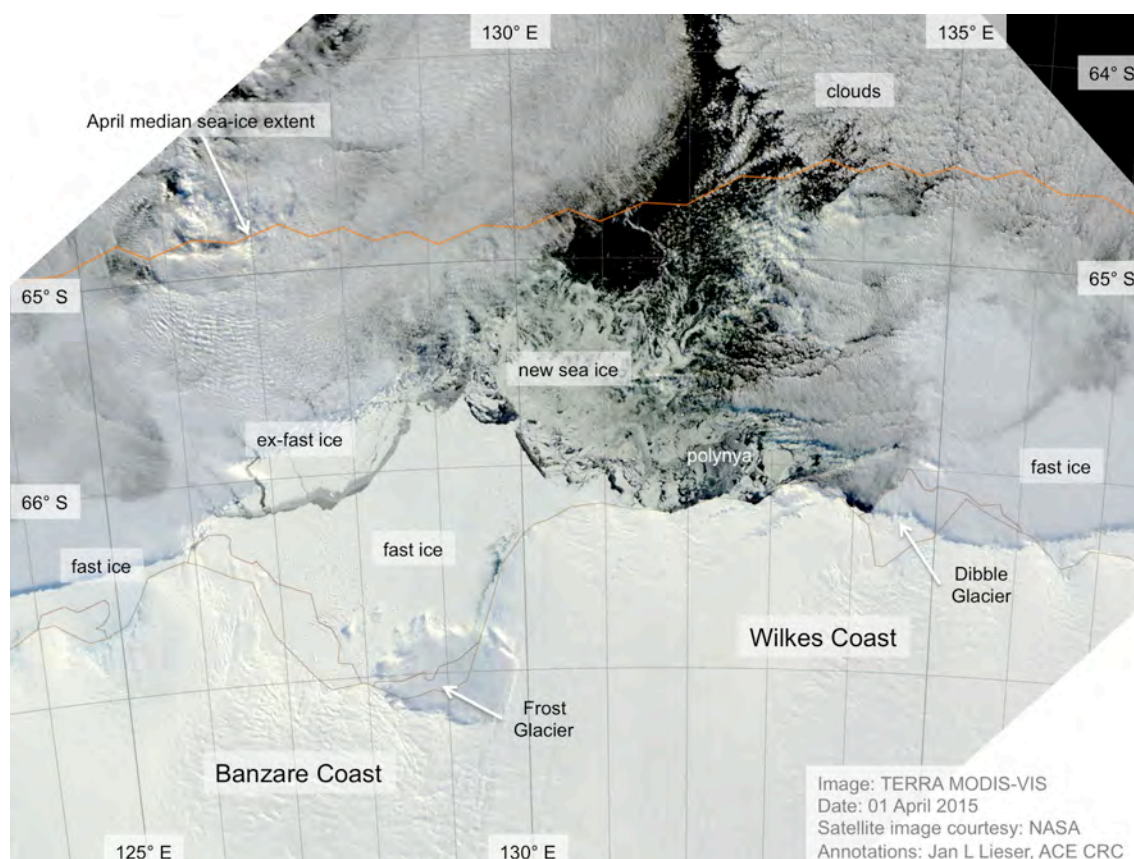
Figure 1: MODIS image acquired 01/04/2015 and provided by NASA.

Figure 1 shows a visible image of Banzare Coast and Wilkes Coast. The thin orange line denotes the long-term (1980-2010) median April sea-ice extent (minimum 15% sea-ice concentration), in the region.

Currently, the sea-ice extent is below (south of) the median for April.

The sea-ice zone is partly obscured by thin clouds, but Davis Bay, off Dibble Glacier, shows only light sea-ice conditions, medium high to high sea-ice concentration (50% to 80%) consisting mainly of new sea ice. The westward drift accumulates this newly forming sea ice against the fast ice and ex-fast ice off Banzare Coast and the Frost Glacier.

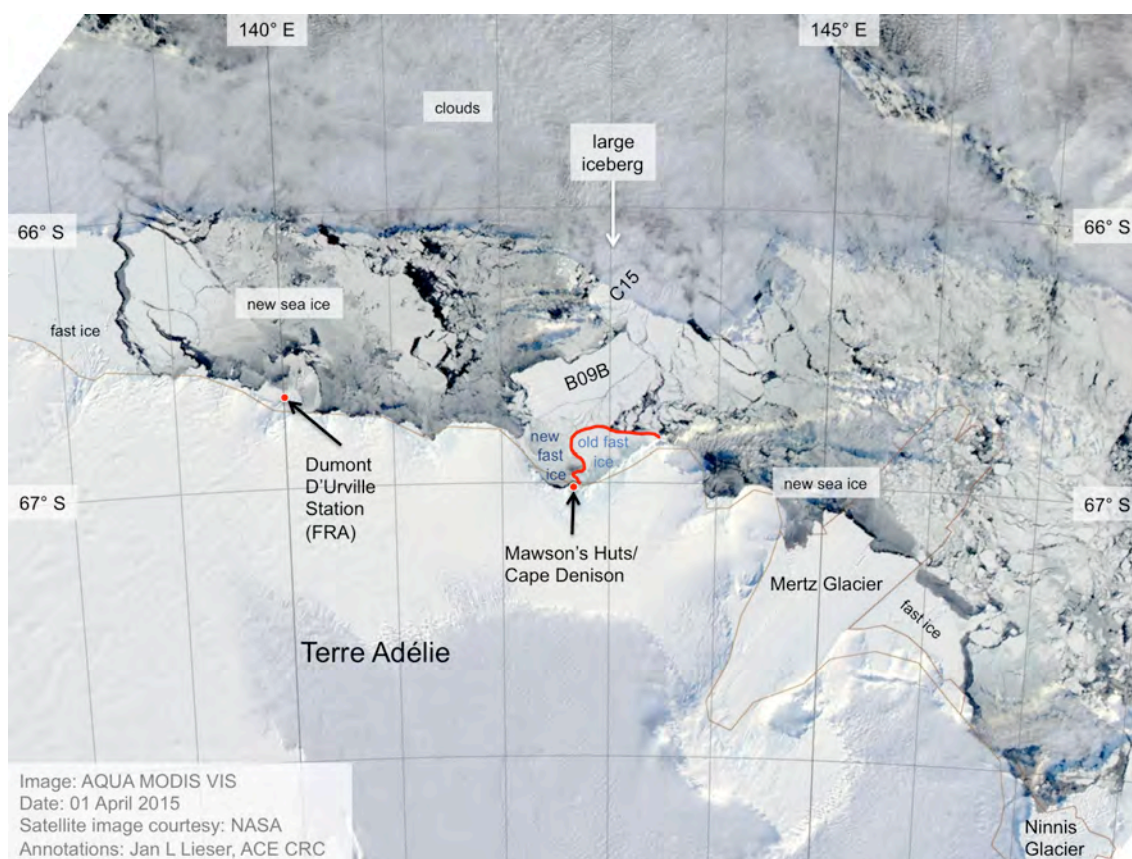
Figure 1: MODIS image acquired 01/04/2015 and provided by NASA.

Further to Sea Ice Report #12.5/2015, Figure 1 shows a visible image of the region between Dumont d'Urville Station and the Mertz Glacier.

Along 143° E and south of 66° S, the three icebergs (plus one large slab of ice) have established a formidable barrier in the westward drift of the pack ice, which is moving along the coast past the Ninnis and Mertz glaciers.

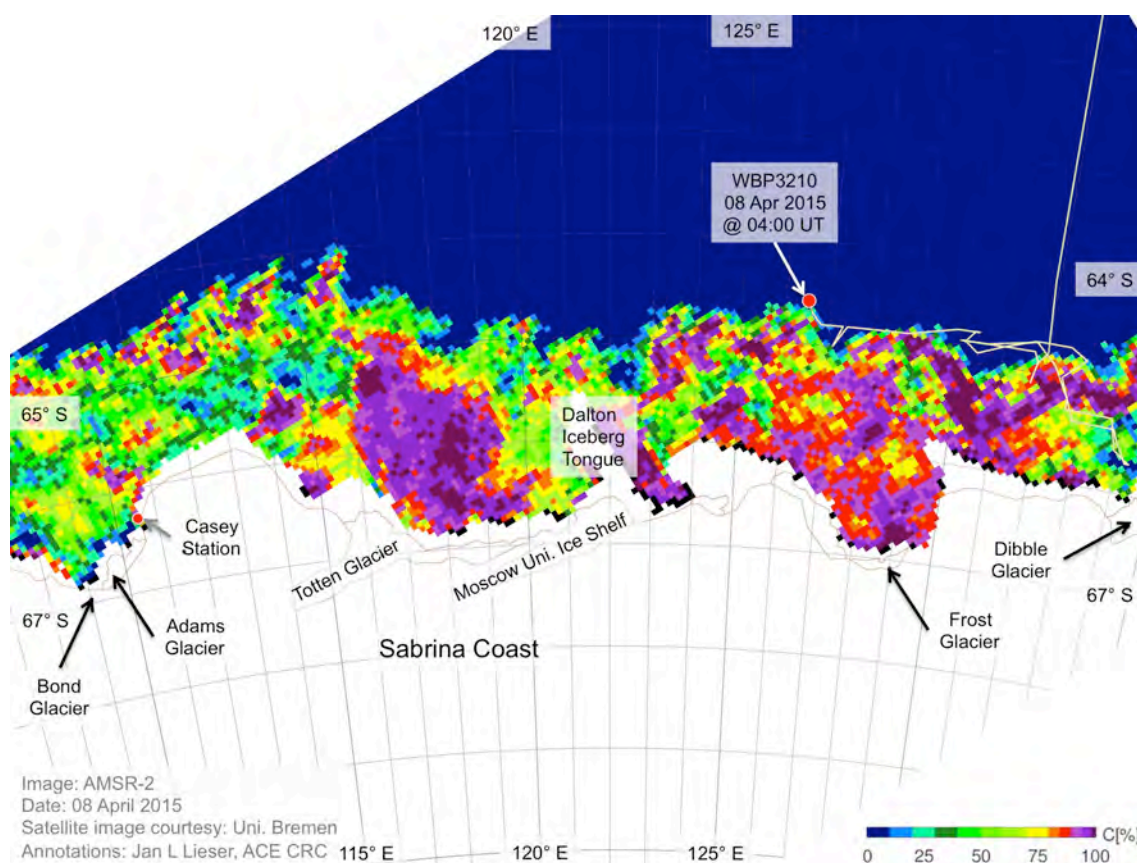
Figure 1: AMSR-2 image acquired 08/04/2015 and provided by PolarView.

East of 125° E, sea ice is growing steadily off Banzare and Wilkes coasts. Further west from there, the polynya west of the Dalton Iceberg Tongue is also growing over by newly forming sea ice, even though it is showing only moderate concentration in Figure 1. The thin yellow line (ending with a red dot) in the figure denotes the voyage track of RVIB *Nathaniel B Palmer* (WBP3210), until 08/04/2015 04:00 UT.

Since 02/04/2015, the sea-ice edge has advanced up to 30 nautical miles northward and has crossed 65° S in most places.

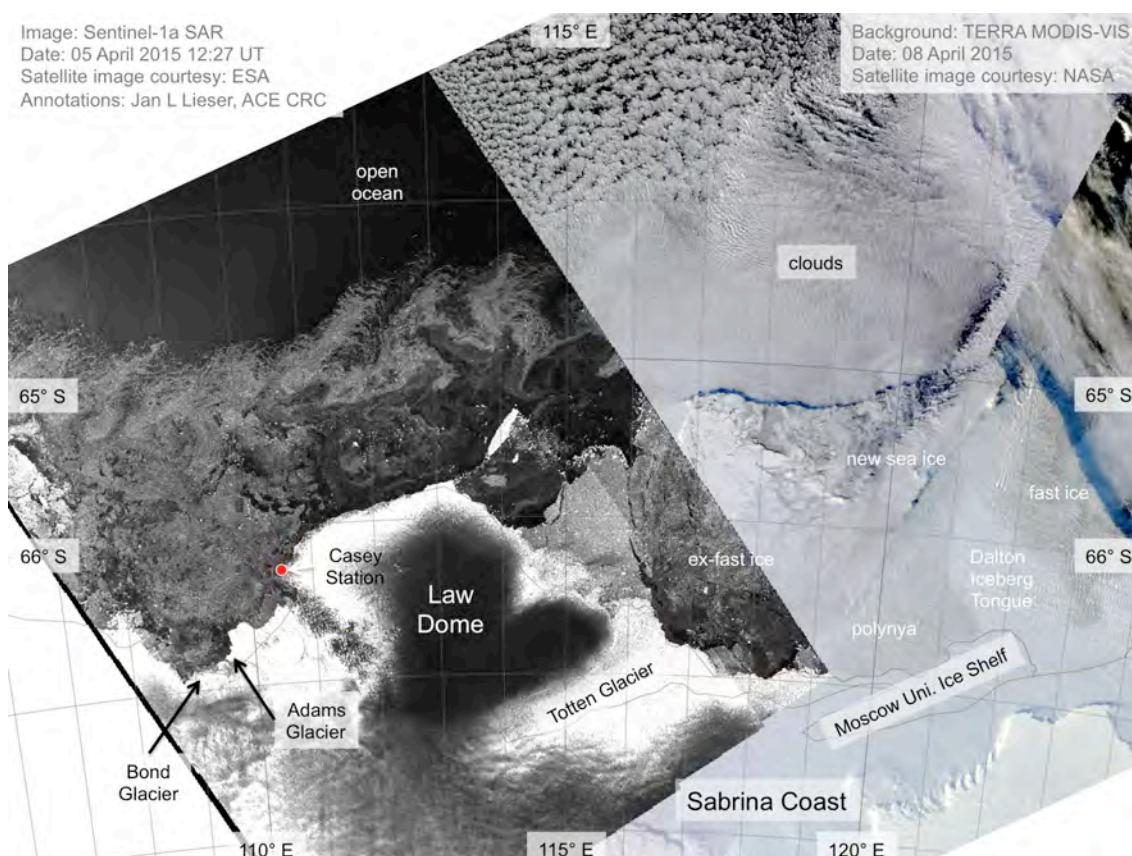
Figure 2: Sentinel-1a SAR image acquired 05/04/2015 and provided by PolarView; background: MODIS visible image acquired 08/04/2015 and provided by NASA.

Figure 2 shows a combination of a SAR scene and a largely cloud

Off the face of Totten Glacier appears still an area of thin ice, even though it is of high concentration, between the ex-fast ice and the glacier.

The polynya to the west of the Dalton Iceberg Tongue is obscured by clouds, but the shape of the iceberg tongue is still perceivable and the sea ice in the polynya is not expected to be of great thickness at this stage. However, as stated above, sea ice is growing quickly under autumn conditions.

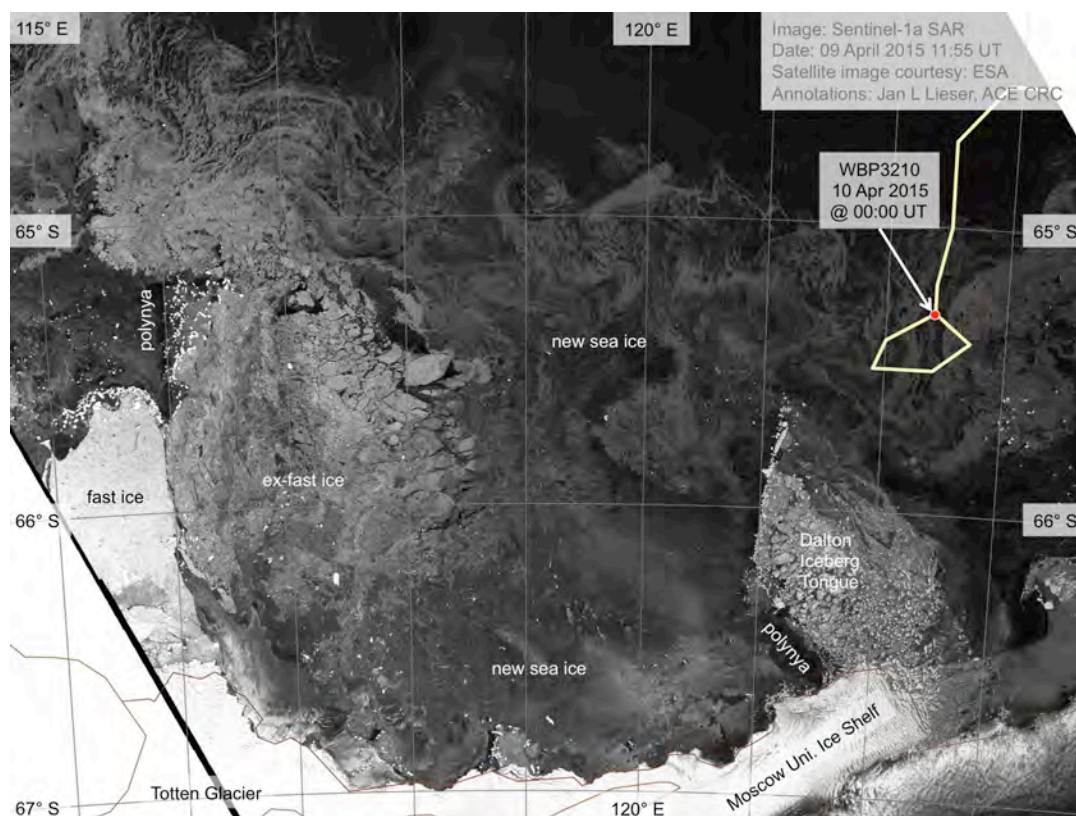
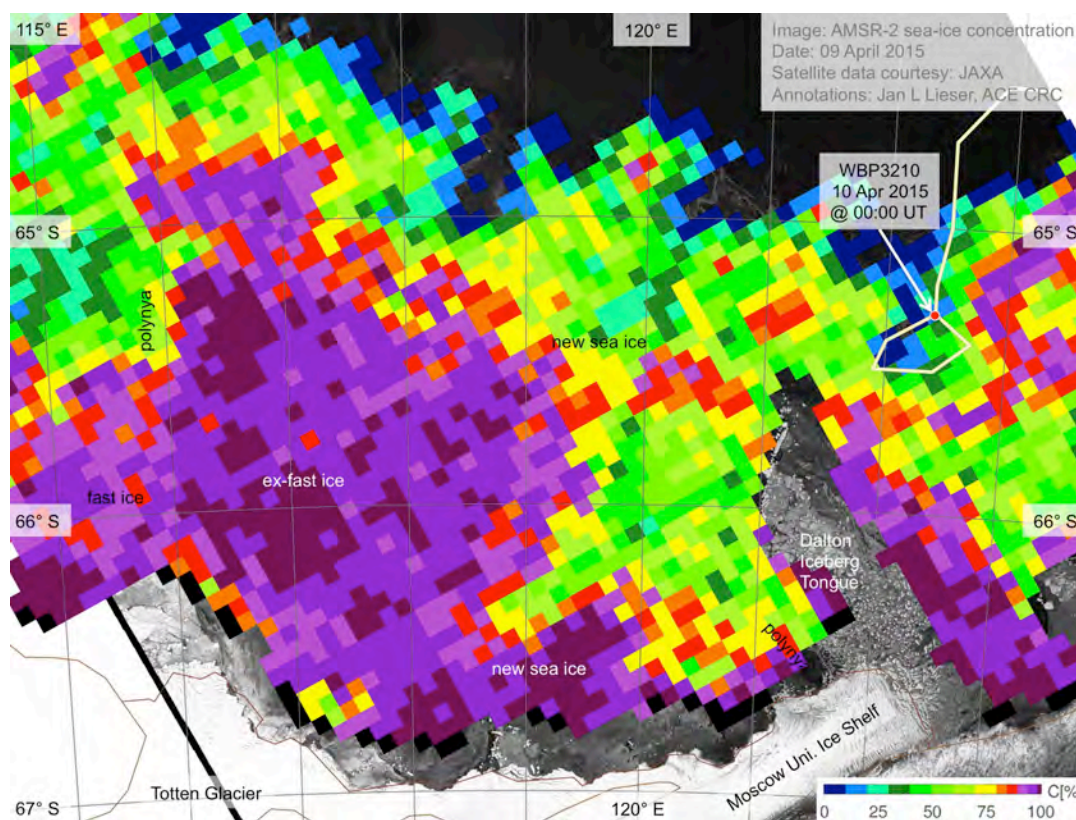
New sea ice has advanced northward beyond 65° S, in the entire frame of the two figures. The sea-ice edge exhibits many small-scale swirl structures, which are likely visible manifestations of eddies of the surface ocean in low wind conditions. One complete eddy can be seen centred at 119° E and 64° 55' S.

East of the fast ice attached to the eastern flank of Law Dome, northwest of the Totten Glacier, the gaps that were visible in a SAR scene acquired 05/04/2015 (see Sea Ice Report #15.1/2015) between the fast ice and the ex-fast ice have temporarily closed again. The eastern edge of this old ex-fast ice is quite broken and some very large floes can be identified in the vicinity of 118° E (for example at 118° 09' E and 65° 30' S).

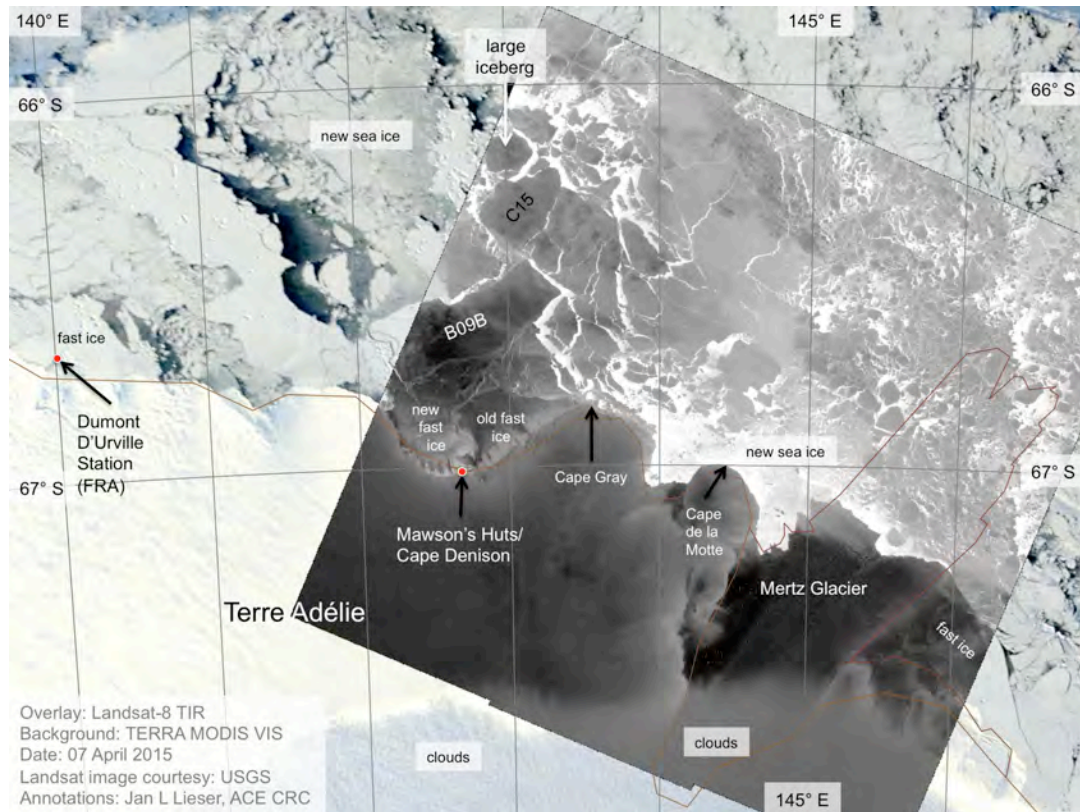
Figure 1: Landsat-8 TIR image acquired 07/04/2015 and provided by USGS.

Many cracks between the sea-ice floes expose the relatively warm ocean and can be therefore identified as white lines criss-crossing the pack ice, in the TIR image (Figure 1). Large bright (warm) patches of very thin sea ice and/or open ocean can be seen in the polynya off Cape de la Motte and to the northeast of the formation of large icebergs, which are lined up along 143° E.

Inside Commonwealth Bay, a difference in fast-ice surface signature between old and new fast-ice can be detected in the SAR scene (see Sea Ice Report #15.3/2015 for reference relating to differences in the Thermal Infrared spectrum).

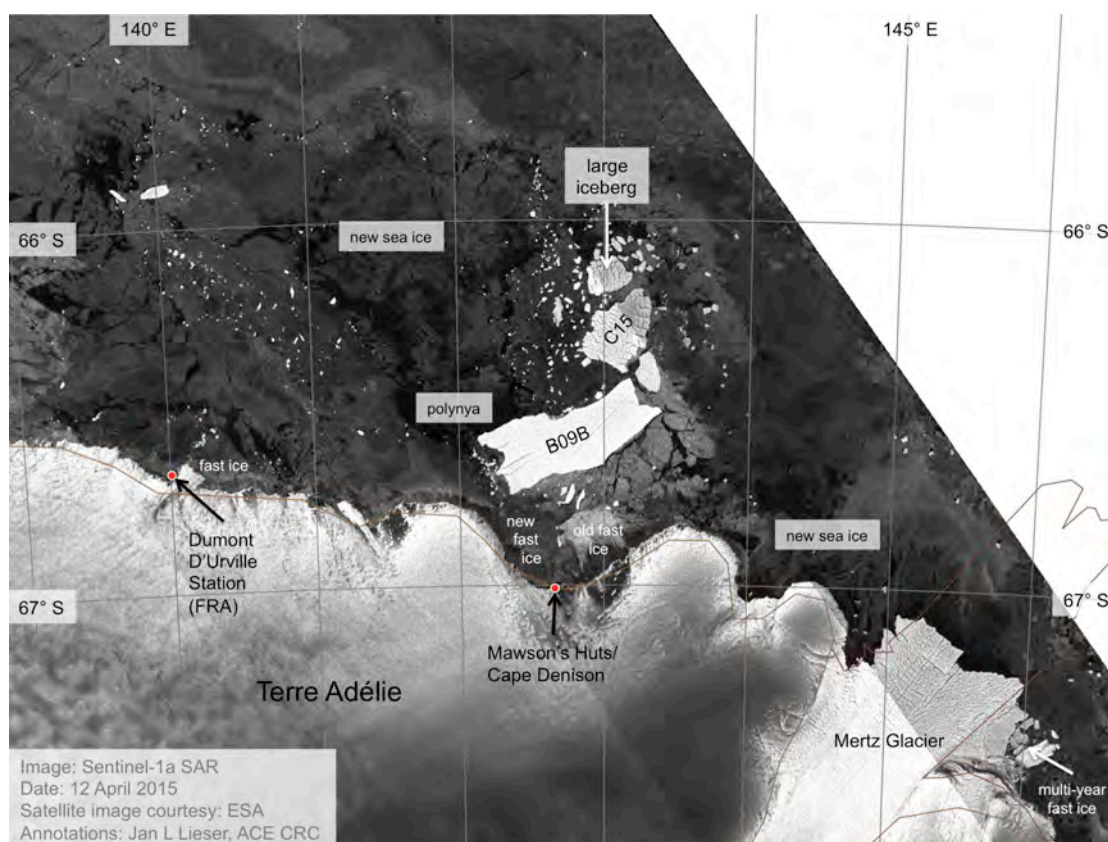
Figure 1: Sentinel-1a SAR scene acquired 12/04/2015 and provided by PolarView.

Along 143° E, the row of large tabular icebergs is now firmly surrounded by growing sea ice. A large number of smaller icebergs can also be identified in the region of Figure 1, particularly north of B09B and west of C15 and encircling the large northern berg. South of B09B, three larger icebergs can be seen, two of which are about 3.5 nautical miles long.

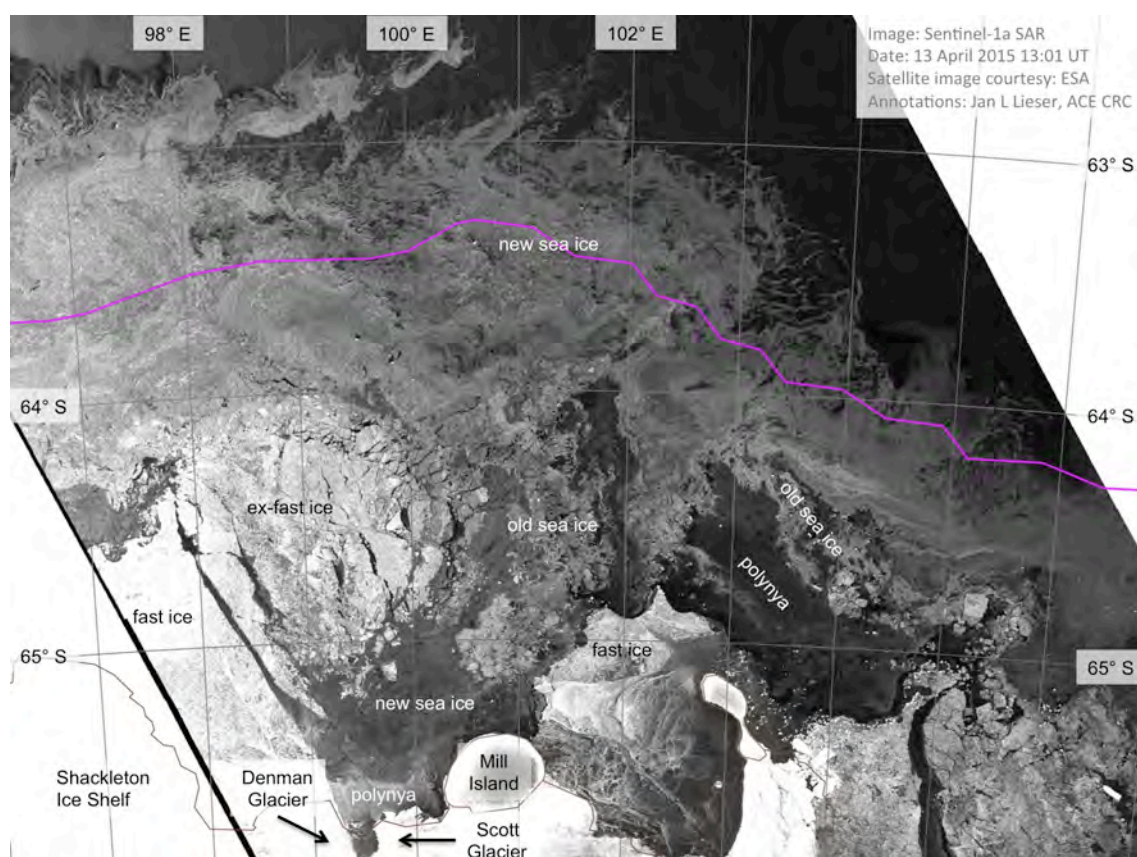
Figure 1: Sentinel-1a SAR scene, acquired 13/04/2015 and provided by PolarView.

Figure 1 shows a high resolution Synthetic Aperture RADAR (SAR) scene of the region northeast of the Shackleton Ice Shelf, at a resolution of 50 m × 100 m. The magenta line denotes the long-term (1981-2010) median sea-ice extent for April.

The front of Denman Glacier is covered by fast ice, the front of Scott Glacier shows a small polynya, between the fast ice attached to the northeastern side of the Shackleton Ice Shelf and Mill Island. The entire area shown in Figure 1 shows a large variety of different sea ice types, and an overall sea-ice extent well north of the long-term April median.

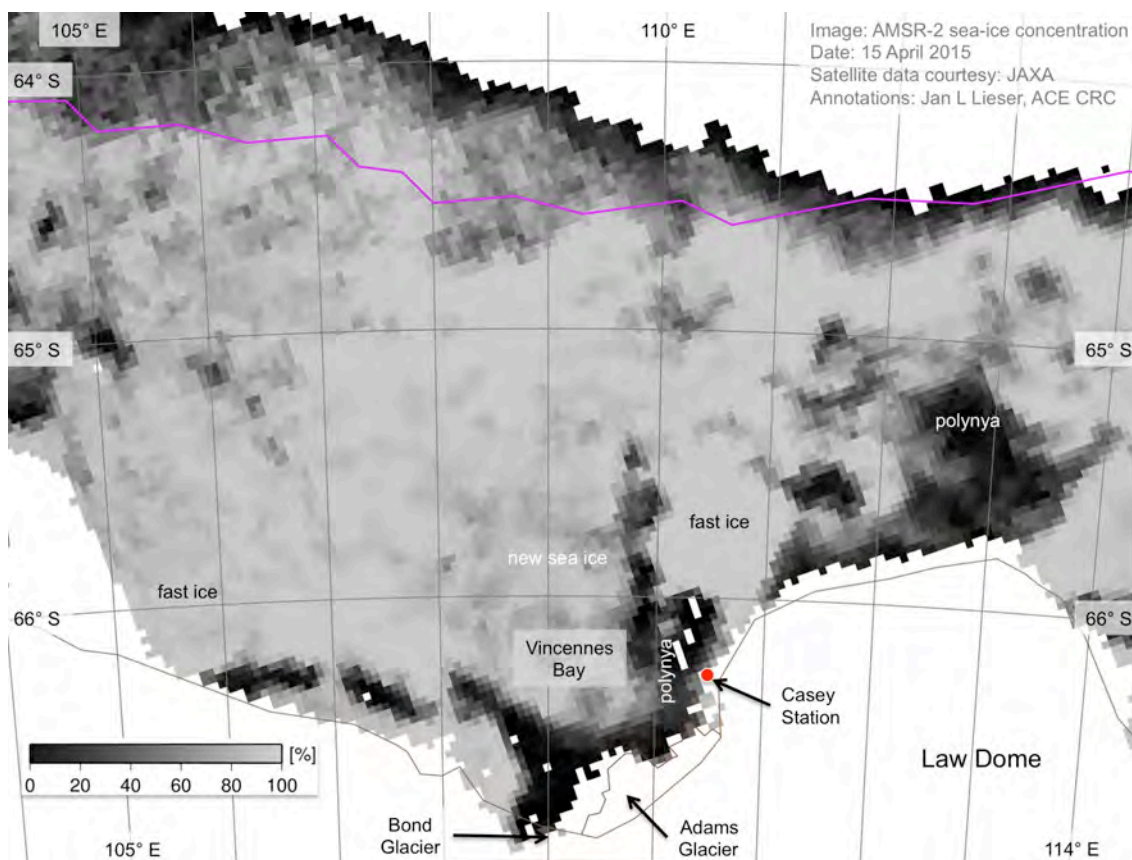
Figure 2 shows a sea-ice concentration map derived from AMSR-2 data, at a resolution of 3.125 km. As with Figure 1, the magenta line denotes the long-term (1981-2010) median sea-ice extent for April.

Figure 2: AMSR-2 sea-ice concentration, acquired 15/04/2015 and provided by Universität Hamburg.

Between 105° E and 115° E, sea ice has grown beyond (further north than) the April median extent. North of Law Dome, the polynya appears as a persistent feature, but north of Casey Station, between 110° E and 111° E and between 65° 30' S and 66° S, fast ice is consolidating locally between grounded icebergs.

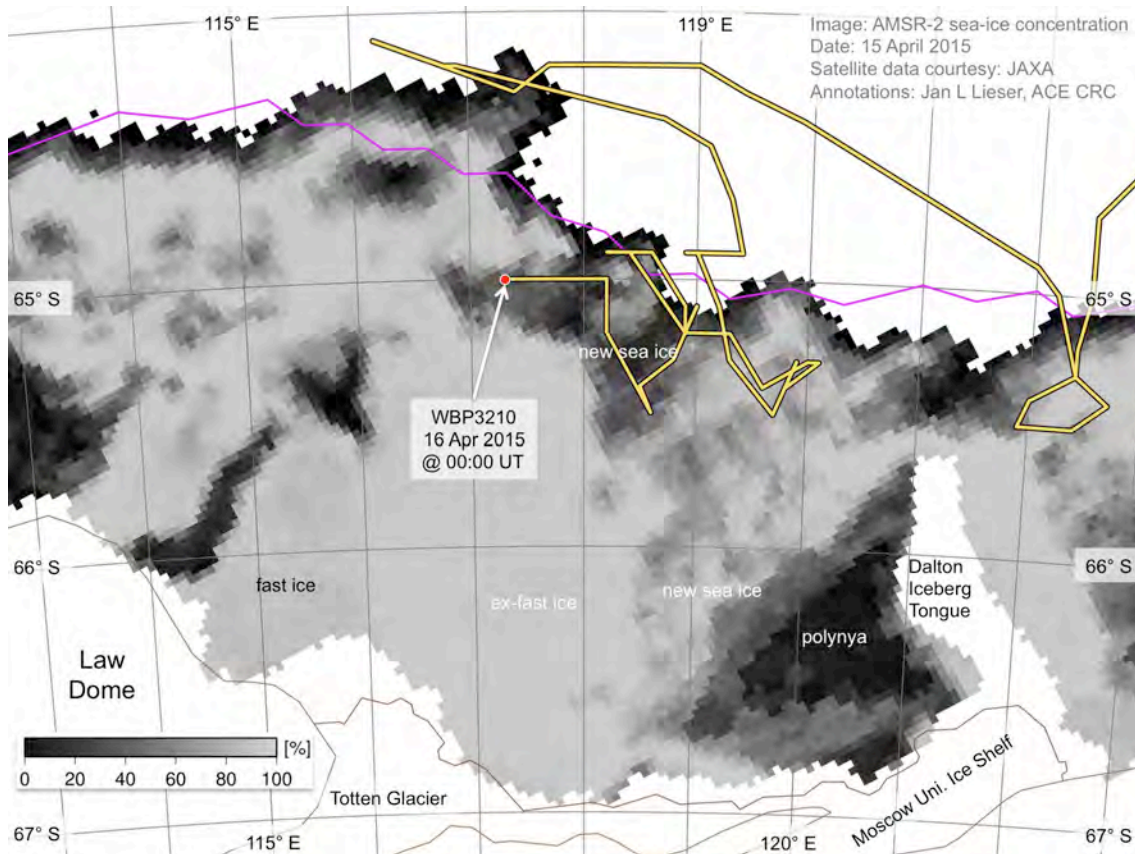
In addition to the features of Figure 2, Figure 3 shows a thin yellow line that denotes the cruise track of R/V *B Nathaniel B. Palmer* (WBP3210) in the region, up until 16/04/2015 00:00UT.

East of Law Dome, the sea-ice extent is close to the median extent, with only a few excursions to the north and south, most likely in

Figure 3: AMSR-2 sea-ice concentration, acquired 15/04/2015 and provided by Universität Hamburg.

consequence of local weather. North of the Totten Glacier, the ex-fast ice appears to be consolidating and new sea ice accumulates at its eastern edge, steadily filling the polynya west of the Dalton Iceberg Tongue.

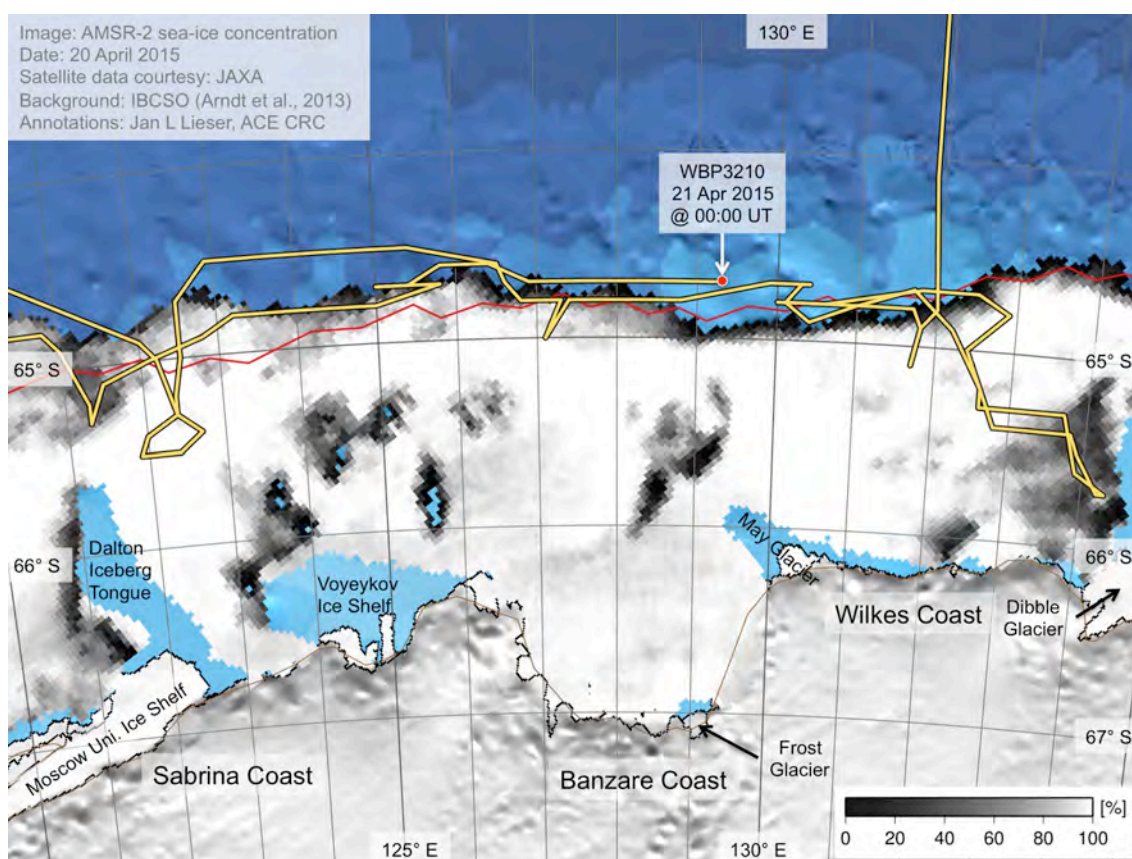
Figure 1 shows a high resolution (3.125 km²) sea-ice concentration map of the area between Sabrina Coast and Wilkes Coast. Near-shore regions of no sea-ice values (blueish background) have been masked during the computation of sea-ice concentration. The yellow line denotes the cruise track of RVIB *Nathaniel B. Palmer* up until 21/04/2015 00:00 UT. The thin red line gives the long-term median sea-ice extent for April.

Figure 1: AMSR-2 sea-ice concentration, acquired 20/04/2015 and provided by Universität Hamburg.

The sea ice in the area has consolidated and only minor openings can be seen within the pack ice. The sea-ice edge appears

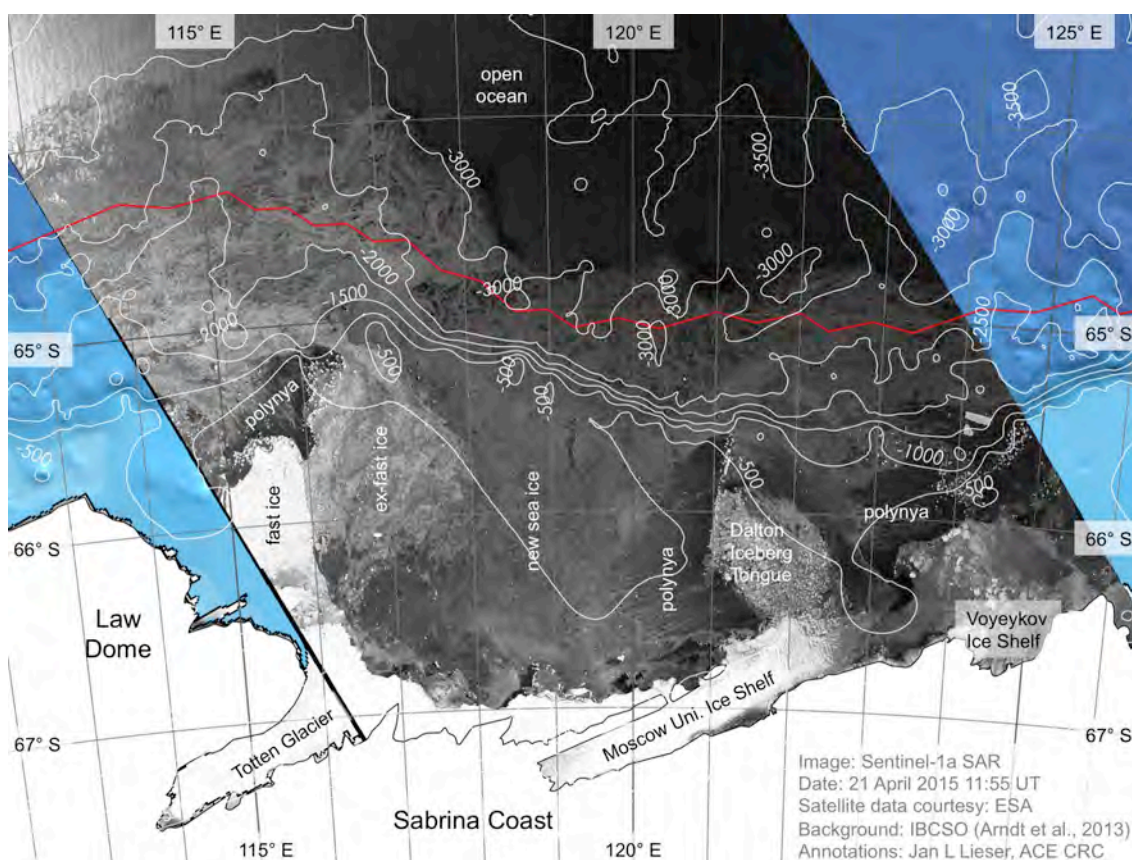
A high resolution SAR scene of the region between Law Dome and the Voyeykov Ice Shelf is provided in Figure 1. White contours denote known isobaths and the thin red line indicates the long-term median sea-ice extent for April.

Figure 1: Sentinel -1a SAR scene, acquired 21/04/2015 and provided by PolarView.

The sea-ice edge follows roughly the 3000 m isobath in the region and is between 5 nautical miles (at about 121° E) and 50 nautical miles (at about 117° E) north of the respective (longitudinal) median extent.
