Sea ice reports for the Antarctic shipping season 2017 - 2018

Prepared by Dr Jan L Lieser

Published by: Antarctic Climate & Ecosystems Cooperative Research Centre, May 2018

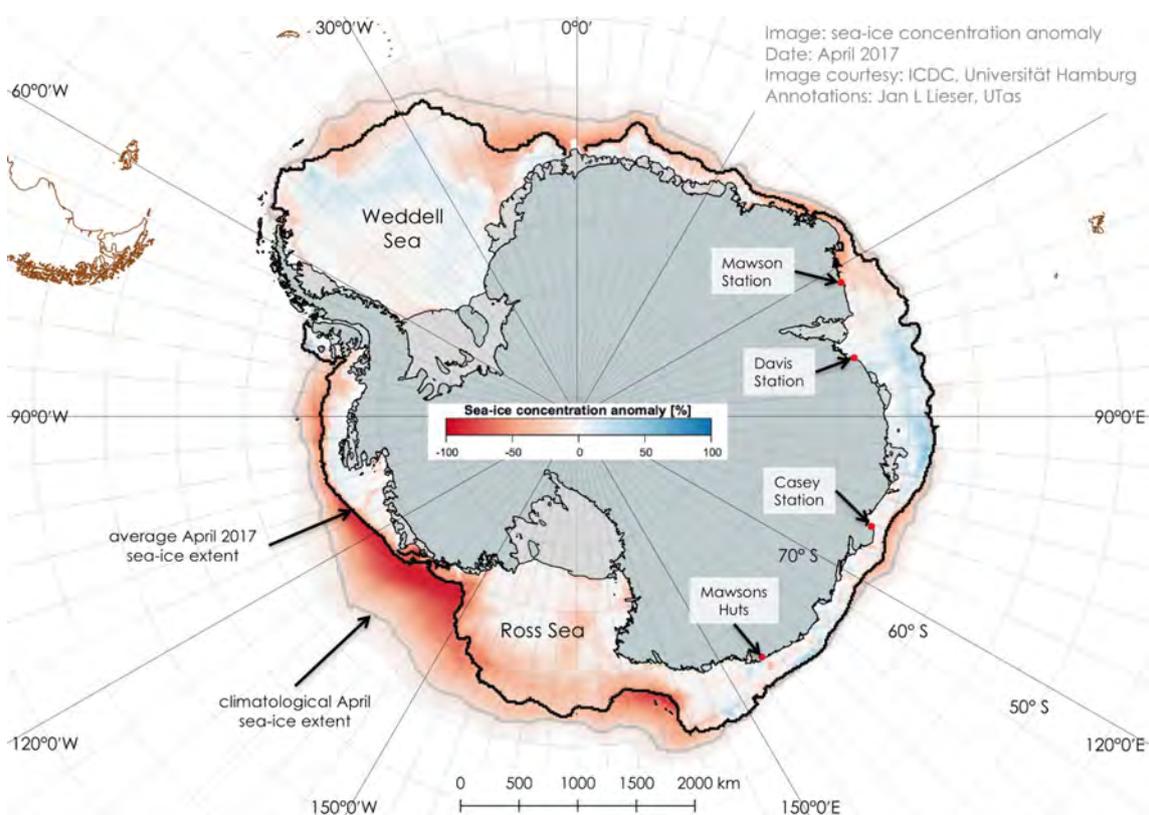
Figure 1: Sea-ice concentration anomaly, data provided by Universität Hamburg.

Colour coded is the anomaly of the April 2017 sea-ice concentration average relative to the climatology of April conditions of the reference period (1992 – 2016). The black line denotes the April 2017 average sea-ice extent (calculated for sea-ice concentration greater 15%) and the grey line gives the climatological April sea-ice extent for the reference period.

Figure 1 shows a map of pan-Antarctic sea-ice concentration anomaly for April 2017.

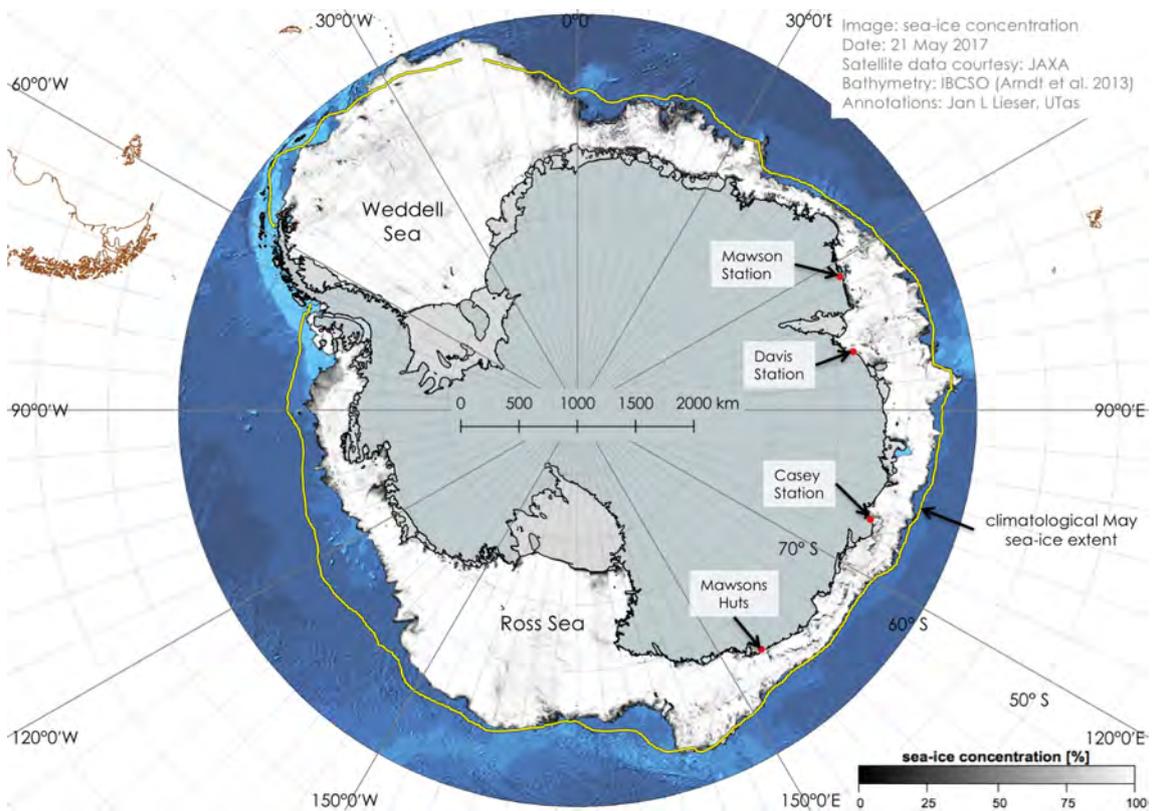
Figure 1: AMSR-2 sea-ice concentration, acquired 21/05/2017 and provided by Universität Hamburg.

Around Antarctica, sea-ice extent is well within the limit of the long-term median resulting in below average sea-ice area as well as extent. Only one region in the eastern Weddell Sea is currently experiencing slightly above average conditions.

Figure 1 shows a map of pan-Antarctic sea-ice concentration together with the median sea-ice extent for May (yellow line).

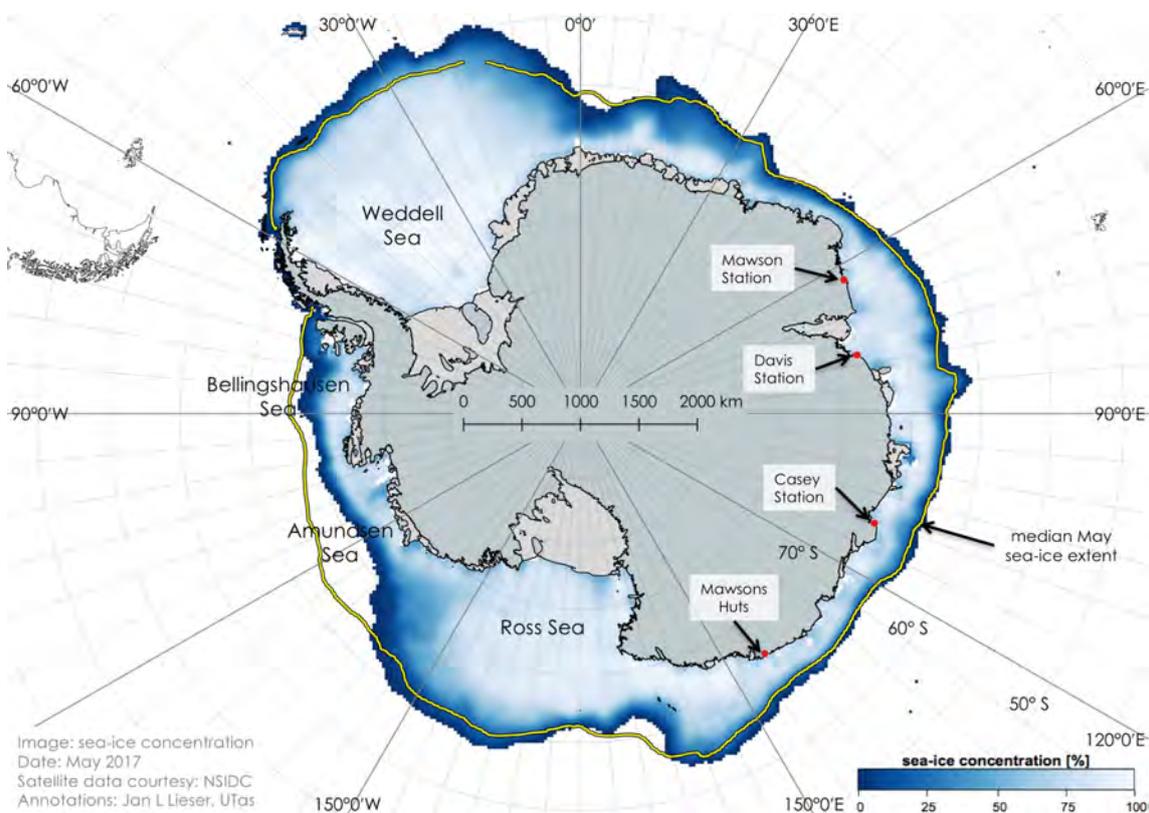
Figure 1: Average sea-ice concentration of May 2017 provided by NSIDC.

The pan-Antarctic sea-ice extent was generally below average during May, even though it appears to be largely within the boundaries of the median. Exceptions form the eastern Weddell Sea and eastern Ross Sea, which experienced above average extent (although the latter to a lesser degree). These above average conditions were more than outweighed by below average conditions in Bellingshausen Sea and Amundsen Sea and to a lesser degree the western Ross Sea.

Figure 1 shows the average sea-ice concentration around Antarctica, in May 2017. Also shown is the median sea-ice extent for May as a yellow line.

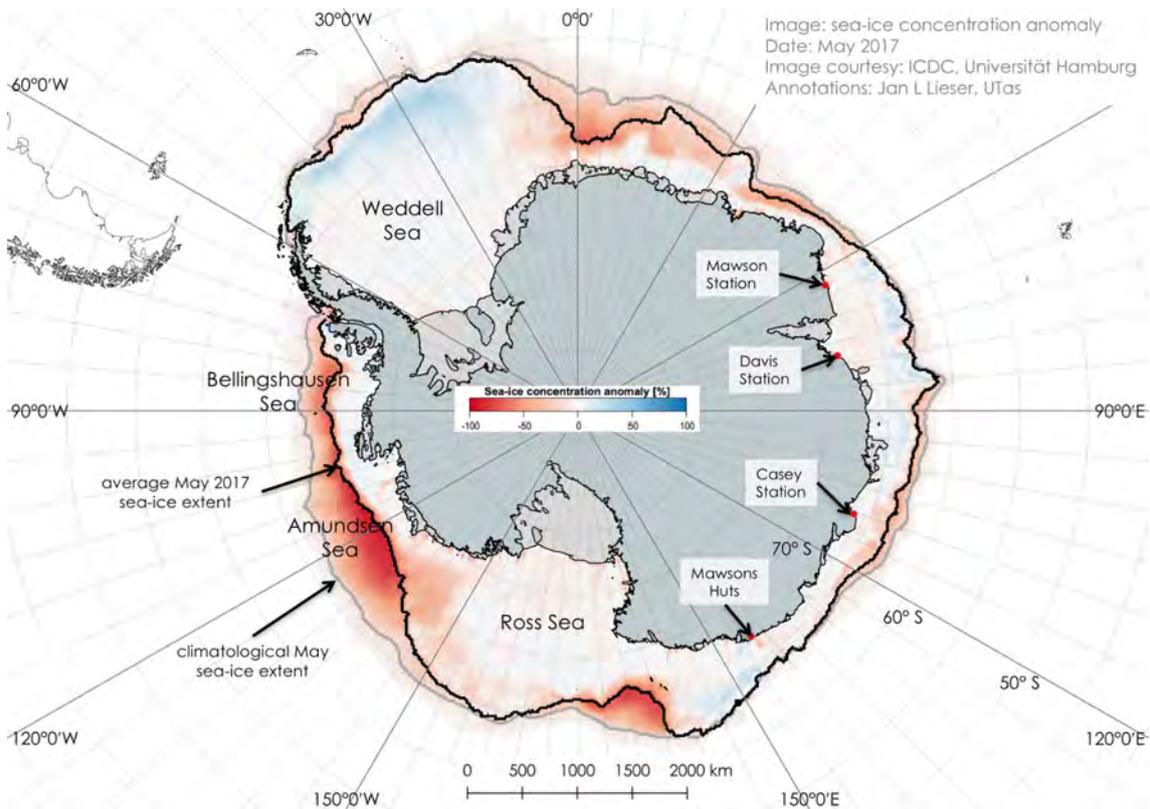
Figure 1: Sea-ice concentration anomaly of May 2017 provided by ICDC, Universität Hamburg.

Around Antarctica, the trend of negative sea-ice concentration anomalies continues in certain regions, which was already foreshadowed in the previous report (#24.1/2017). Amundsen Sea and western Ross Sea appear to be worst affected, followed by Bellingshausen Sea, while the eastern Weddell Sea shows a lesser degree of anomalously low (negative) sea-ice concentration. In East Antarctica a mixed signal of only slightly positive and negative deviations from the average is observed.

Figure 1 shows the Antarctic sea-ice concentration anomaly for May 2017. The black line is the average sea-ice extent for May 2017 and the grey line the climatological sea-ice extent for May.

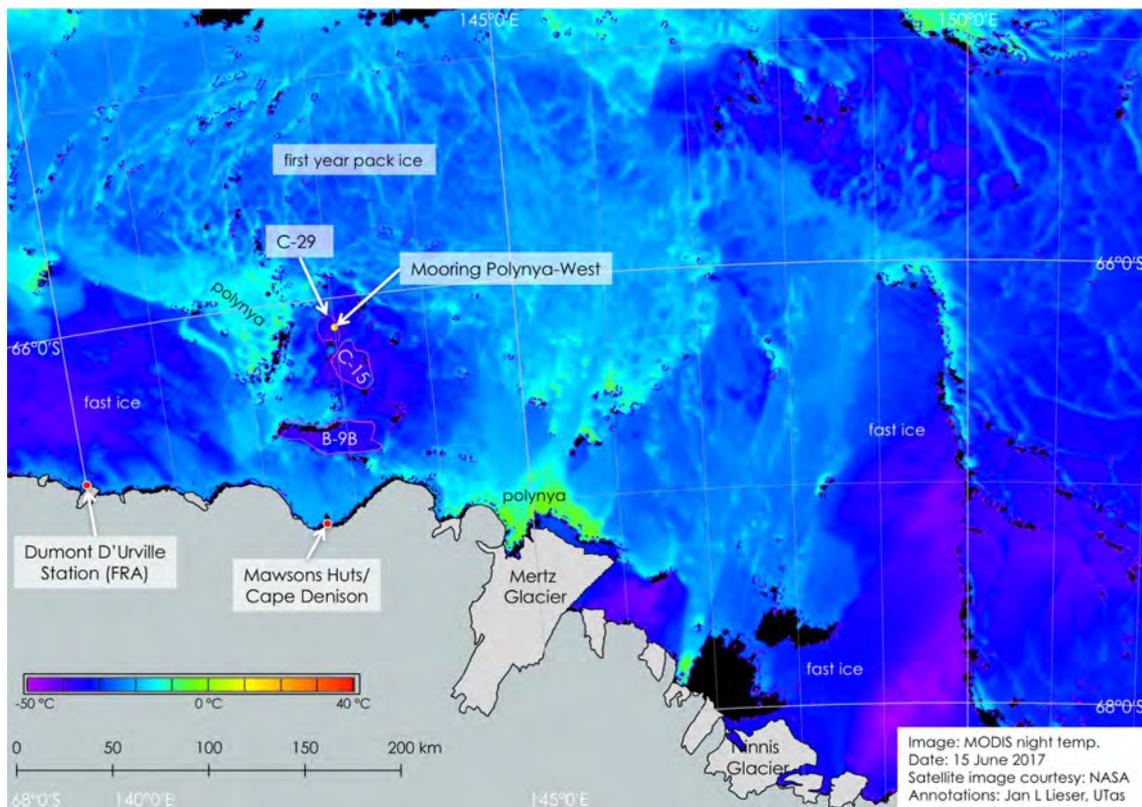
Figure 2: TERRA and AQUA MODIS night-time ice temperature composite acquired 15/06/2017 and provided by NASA.

During times of darkness, cloud-free scenes of the ice surface allow for thermal imaging. In the above figure, thin ice and open water shows in green (close to 0 °C), including cracks and leads in the pack ice. Icebergs and thick, snow-covered fast ice can be distinguished by their low surface temperature. The respective position and orientation of icebergs B-9B and C-15 are marked by their pink outline. Iceberg C-29 could not be positively identified and its last known position (on 02/05/2017) is marked by only a dashed, pink line.

Figure 2 shows a MODIS night-time ice temperature composite (combining data from both TERRA and AQUA spacecraft) of D'Urville Sea.

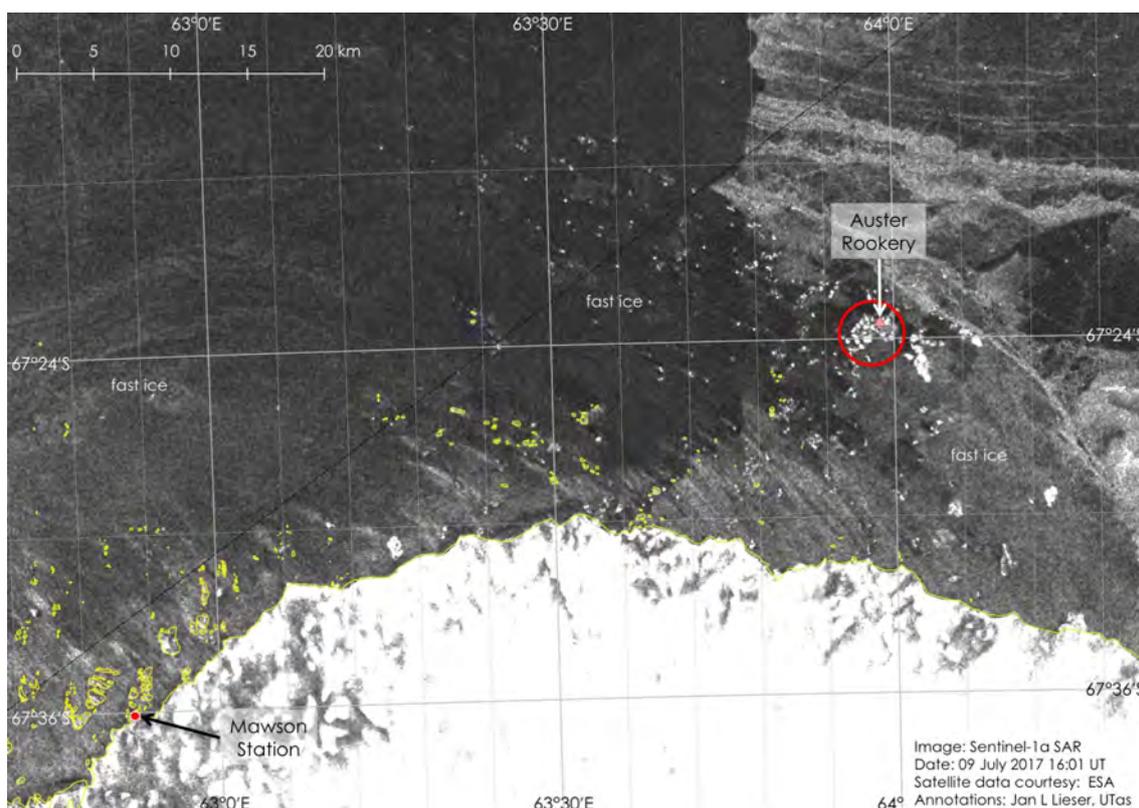
Figure 1: Sentinel-1a SAR scene; acquired 09/07/2017 at 16:01 UT and provided by PolarView. (A thin black diagonal line is an image artefact and the result of stitching two tiles.)

Various types of fast ice are seen in the scene, which formed at different times and under different conditions. Auster rookery is presumed to be close to a group of icebergs (red circle) and surrounded by fast ice of different age (note: all present fast ice only formed this season).

Figure 1 shows a high-resolution SAR scene of eastern Mawson Coast.

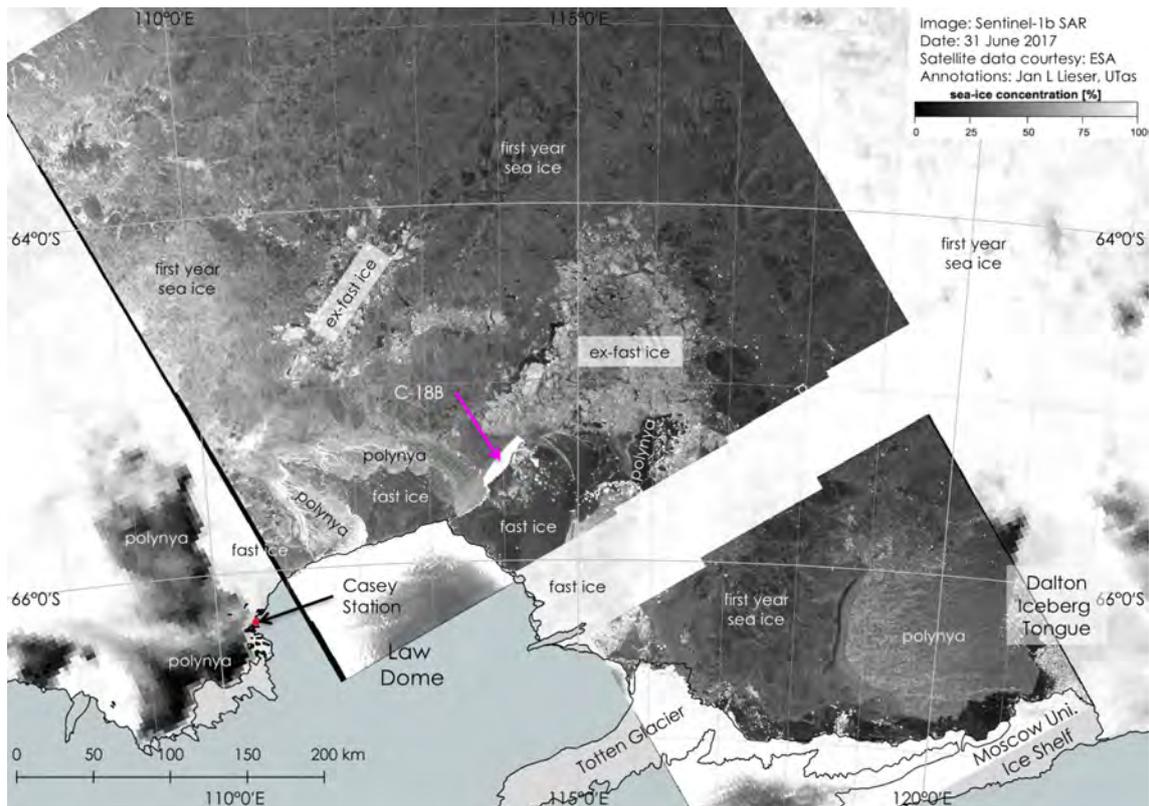
Figure 3: Sentinel-1b SAR scenes acquired 31/07/2017 (southeastern interferometric wide swath at 12:10 UT; northwestern extra-wide swath at 12:11 UT) and provided by PolarView; background: AMSR-2 sea-ice concentration chart, acquired 31/07/2017 and provided by ICDC, Universität Hamburg.

Figure 3 shows two high-resolution SAR scenes off Law Dome and Sabrina Coast.

In front of Totten Glacier, old ex-fast ice has almost completely been pushed northward into the westward sea-ice drift, where it can be tracked travelling at roughly 10 nautical miles per day. The space left behind by this old ex-fast ice has been replenished with new first-year sea ice. West of the Dalton Iceberg Tongue, a large polynya is present, where new sea ice is formed and immediately carried westward.

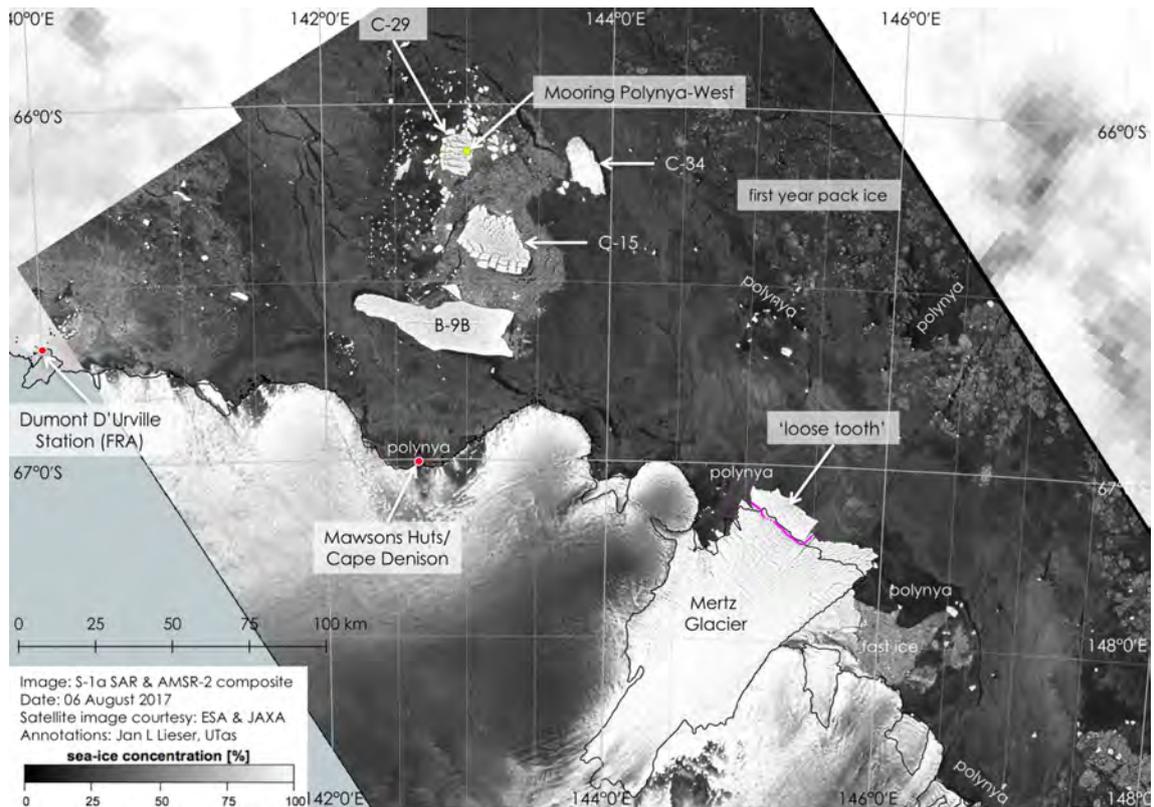
Figure 4: Sentinel-1a SAR scene acquired 06/08/2017 at 10:32 UT and provided by PolarView.

North of Cape Denison, the positions of four large tabular icebergs can be seen clearly. Off Mawsons Huts, a polynya is frozen over by only a thin sea-ice cover. At the northern edge of the Mertz Glacier, a 'loose tooth' of approximately 180 km² is connected to the glacier by a small bridge of roughly 4 km (dotted part of the pink line).

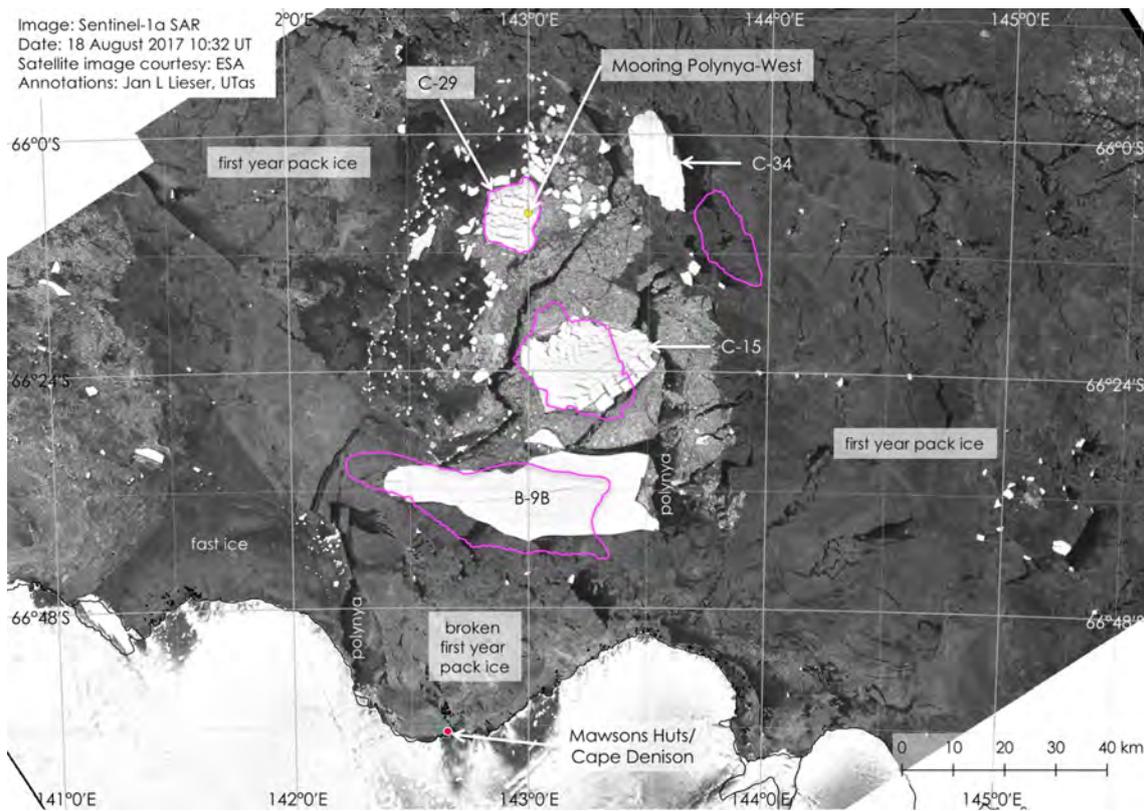
Figure 3: Sentinel-1a SAR scene acquired 18/08/2017 at 10:32 UT and provided by PolarView.

Off Mawsons Huts, a polynya is filled with broken new sea ice. Deformed old sea ice between the icebergs (now ex-fast ice) has large cracks and openings, which is another indicator of the ongoing dynamics of the region.

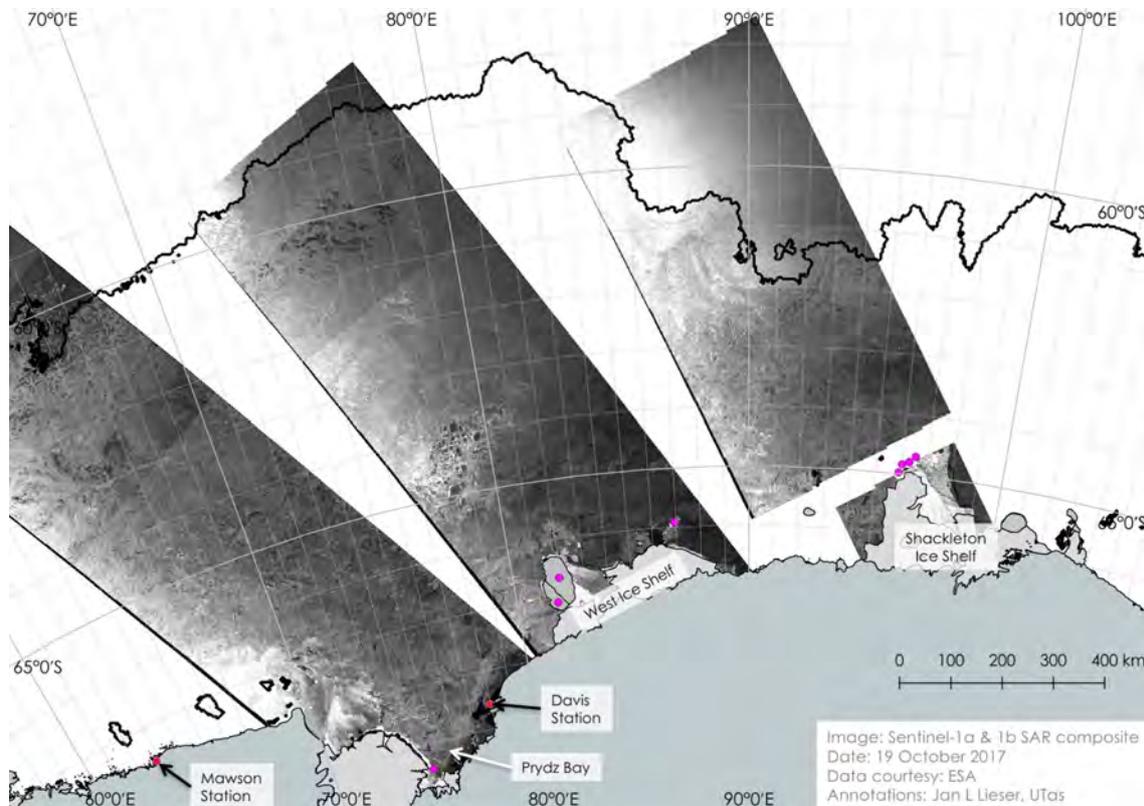
The SAR scenes reveal a more distinct picture of the sea ice, and clearly show an cluster of large, old sea-ice floes in the middle of the pack ice roughly north of 65° S and west of 80° E. These floes appear as dark patches in the SAR.

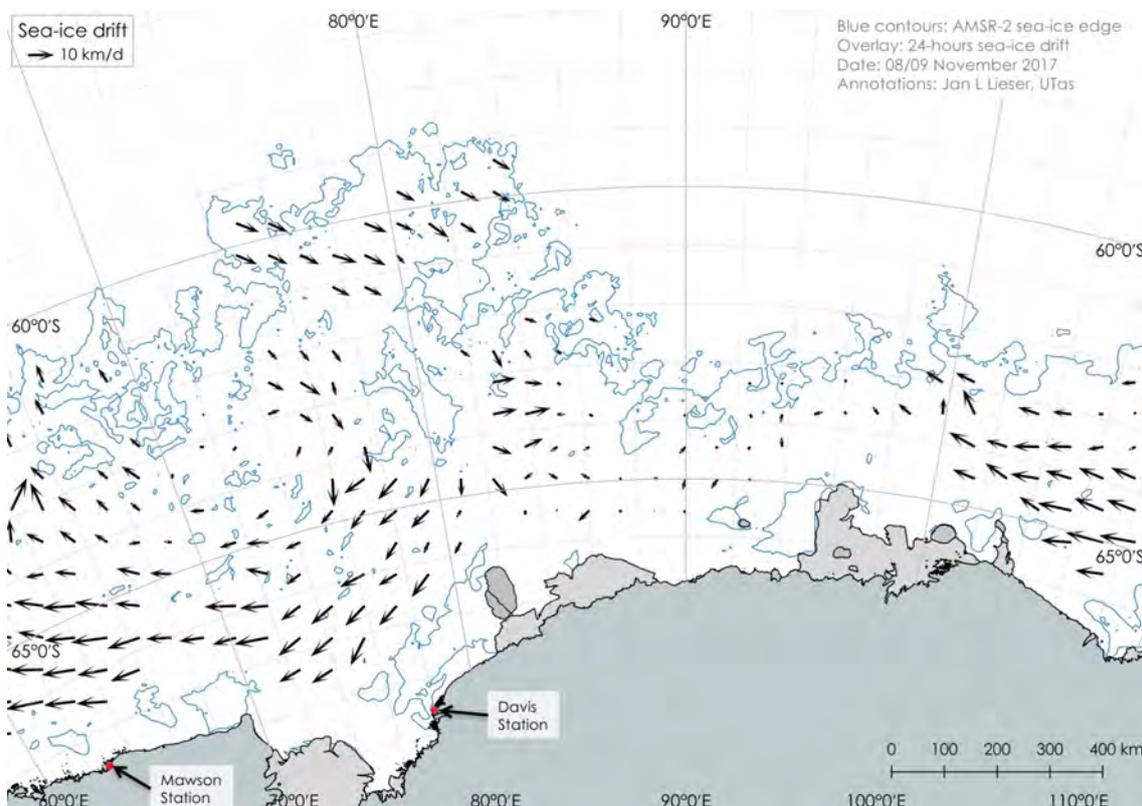
Figure 2: Sea-ice drift for 08/11/2017 provided by OSI SAF and sea-ice edge for 09/11/2017 provided by PolarView.

Figure 2 shows 24-hours sea-ice drift vectors (from 06/11/2017 12:00 UT to 08/11/2017 12:00 UT) and the sea-ice edge (blue contour), both derived from coarse-resolution sea-ice concentration data.

North of 65° S and west of 90° E, the patchiness of the sea-ice cover is illustrated by the ice-edge contours, which mark the edge of 15% sea-ice concentration, but the large polynya area north of Davis Station shows also clearly.
